**Central Kowloon Route**

**Yau Ma Tei East**

**Contract No. HY/2014/08**

Monthly EM&A Report No. 24

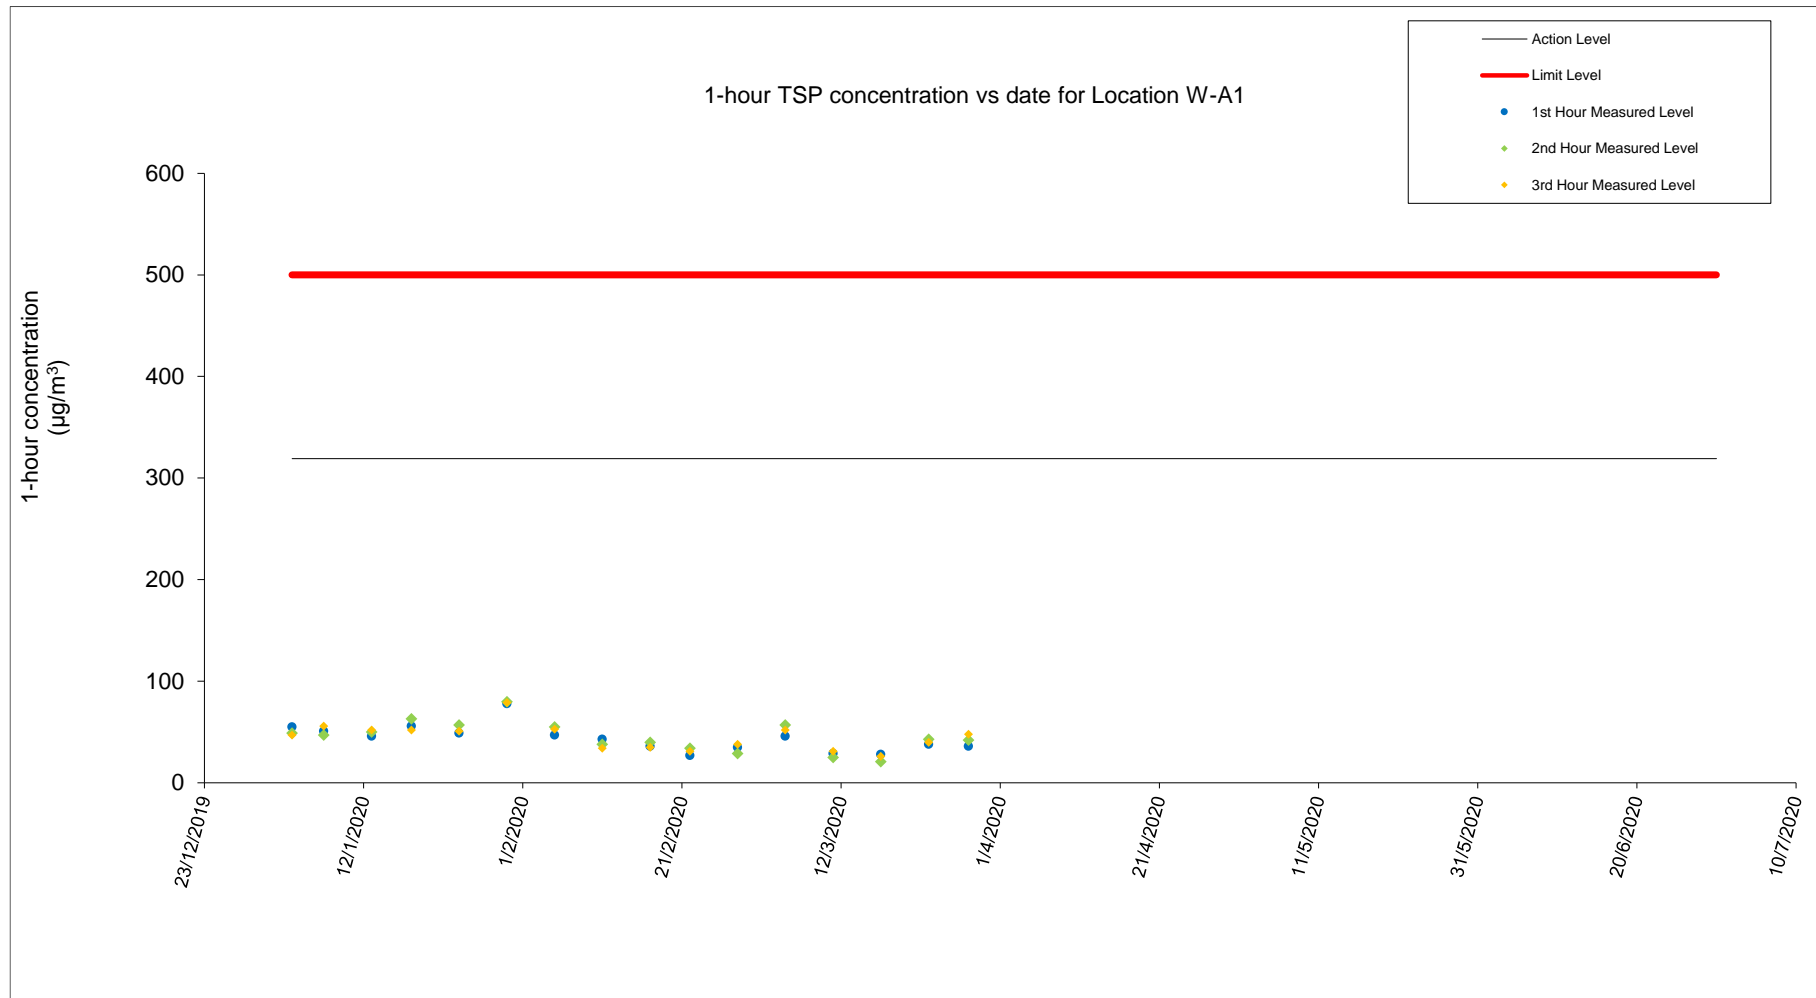
Figure 1: Graphical Illustration of Measured 1-hour TSP ( $\mu\text{g}/\text{m}^3$ ) Levels at W-A1

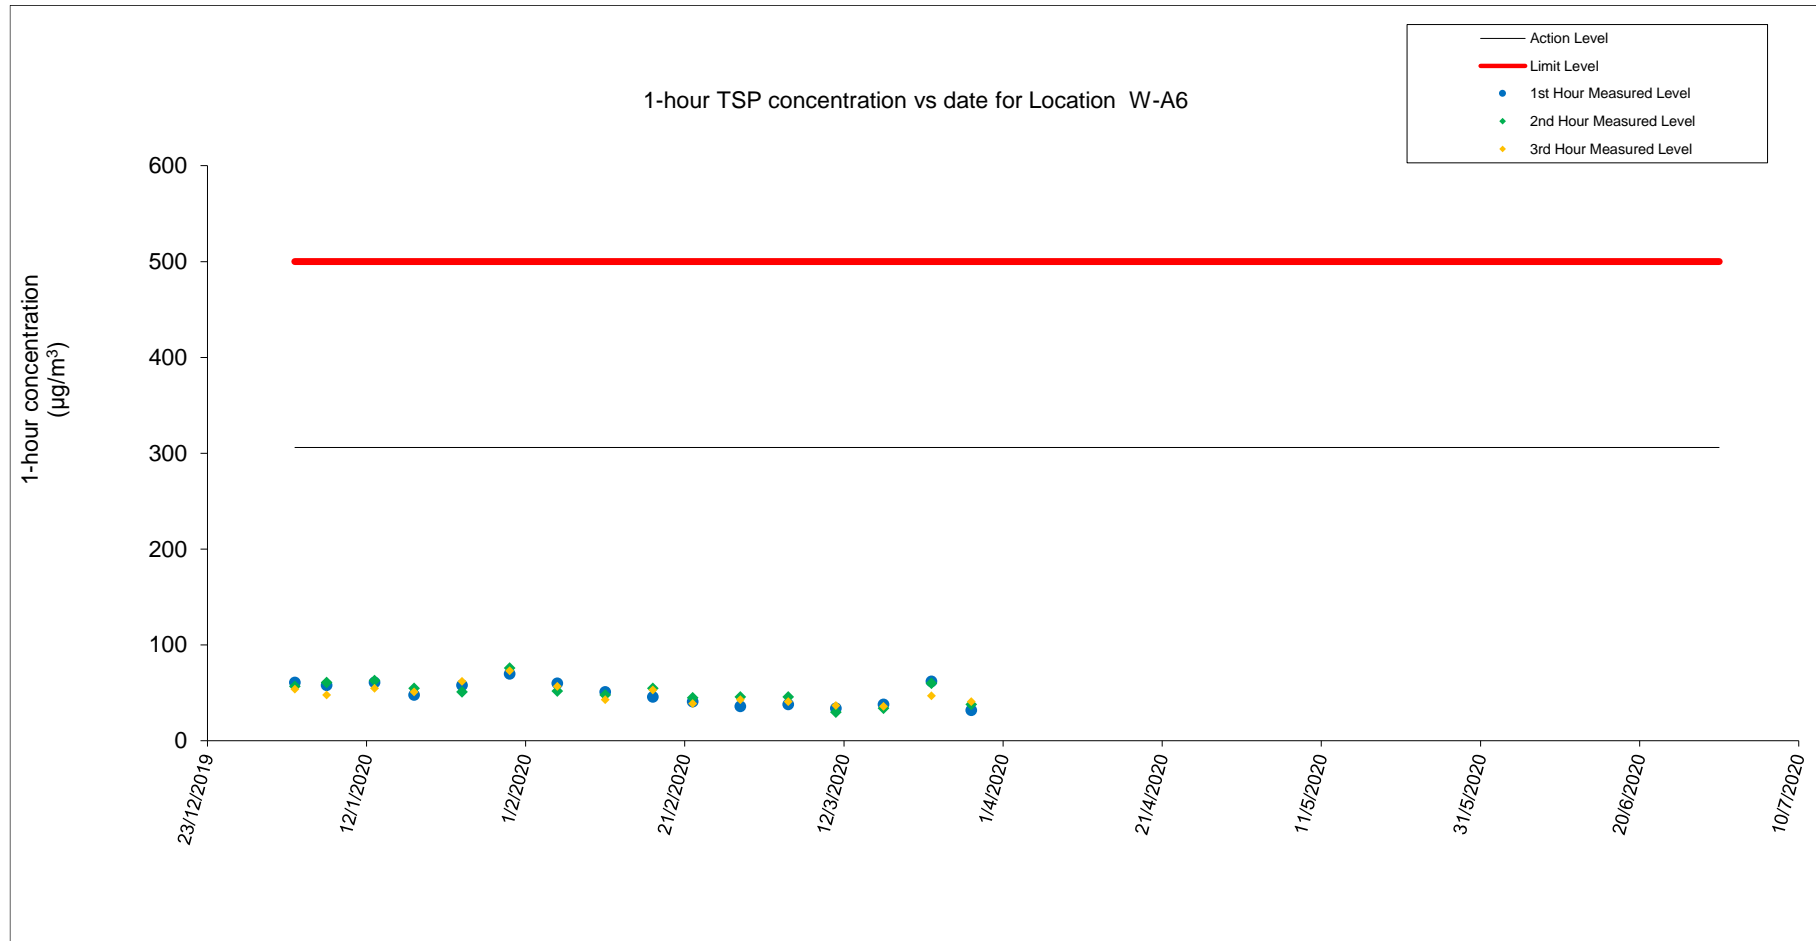
Location: Man Cheong Building (W-A6)  
Monitoring date: 5, 11, 17, 23, 28 March 2020  
Parameter : TSP 1-hour  
Other Factors Nearby traffic

Figure 2: Graphical Illustration of Measured 1-hour TSP ( $\mu\text{g}/\text{m}^3$ ) Levels at W-A6

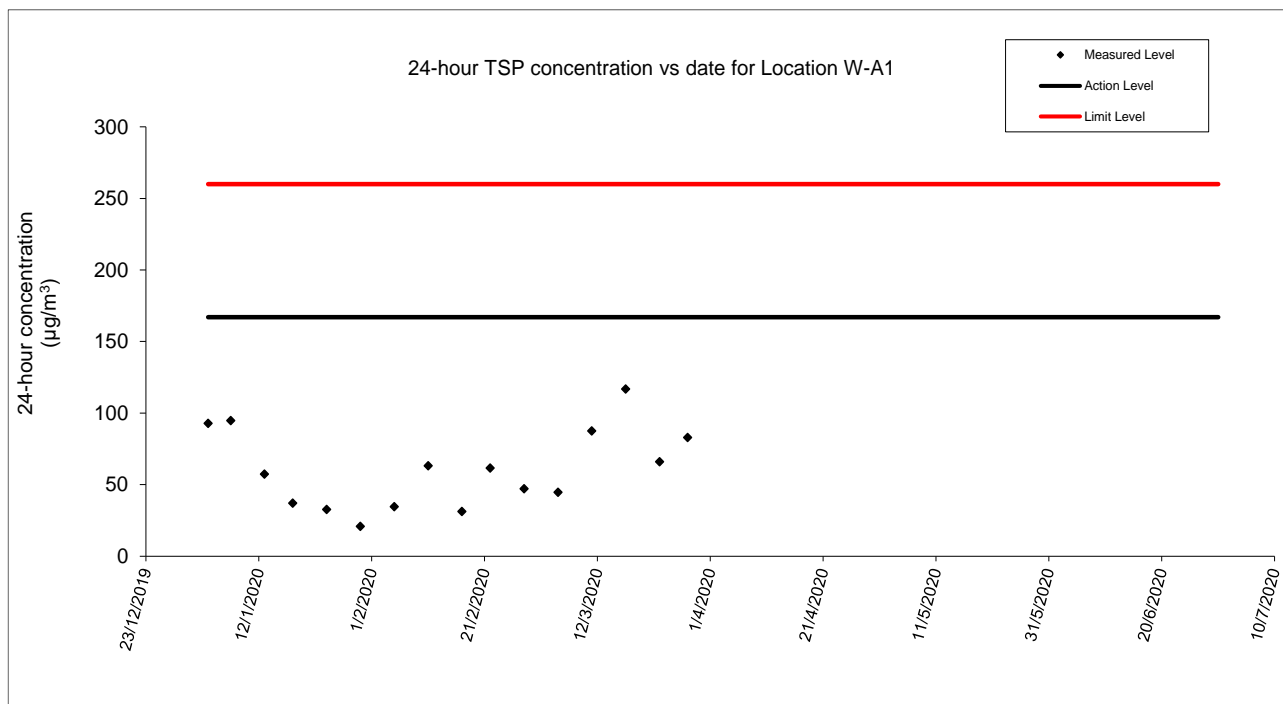
Figure 3: Graphical Illustration of Measured 24-hour TSP ( $\mu\text{g}/\text{m}^3$ ) Levels at W-A1

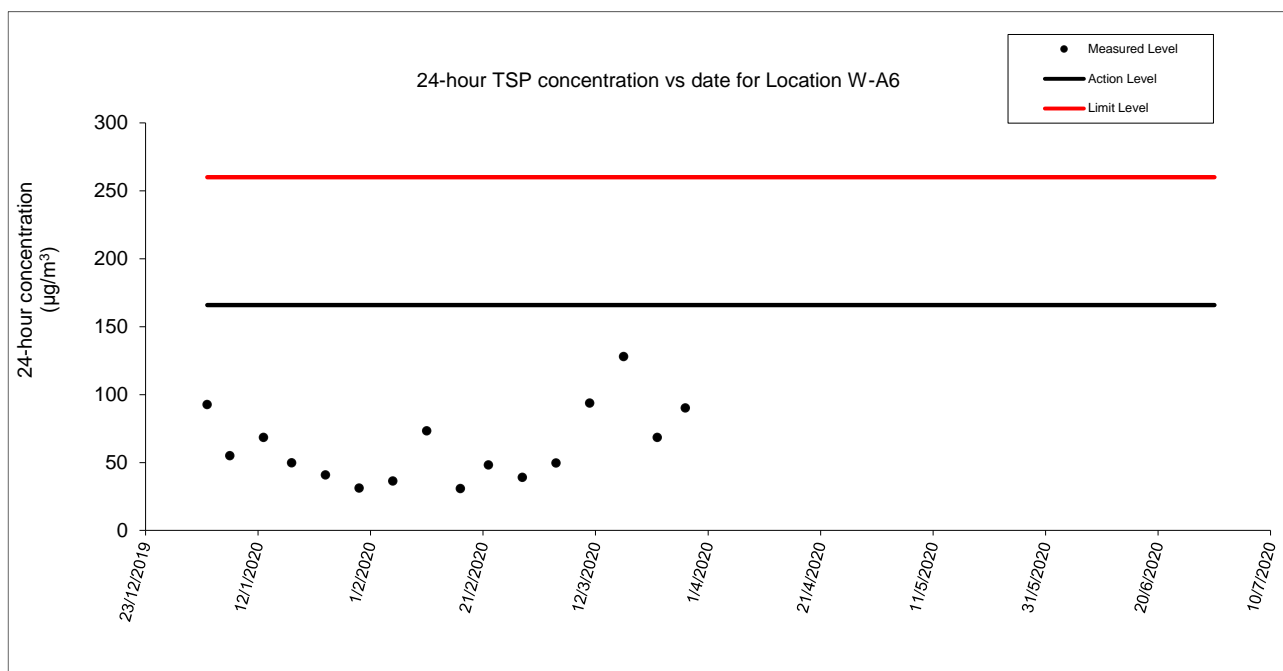
Figure 4: Graphical Illustration of Measured 24-hour TSP ( $\mu\text{g}/\text{m}^3$ ) Levels at W-A6

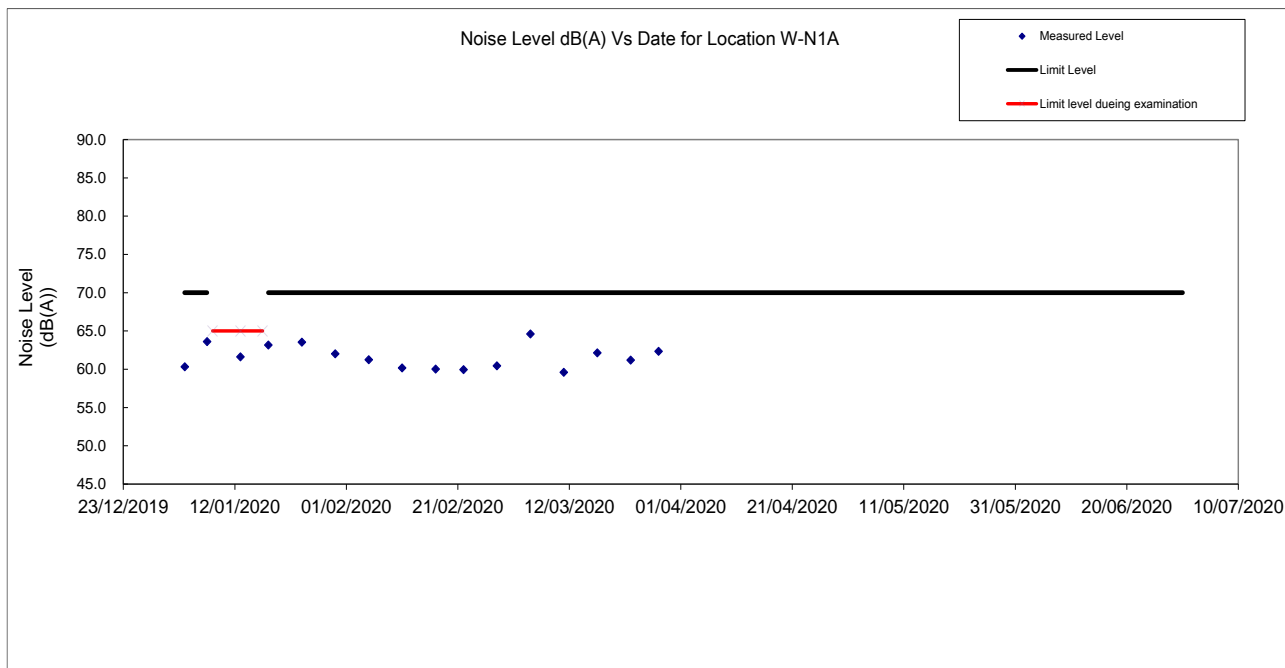
Figure 1: Graphical Illustration of Measured Noise Levels at W-N1A

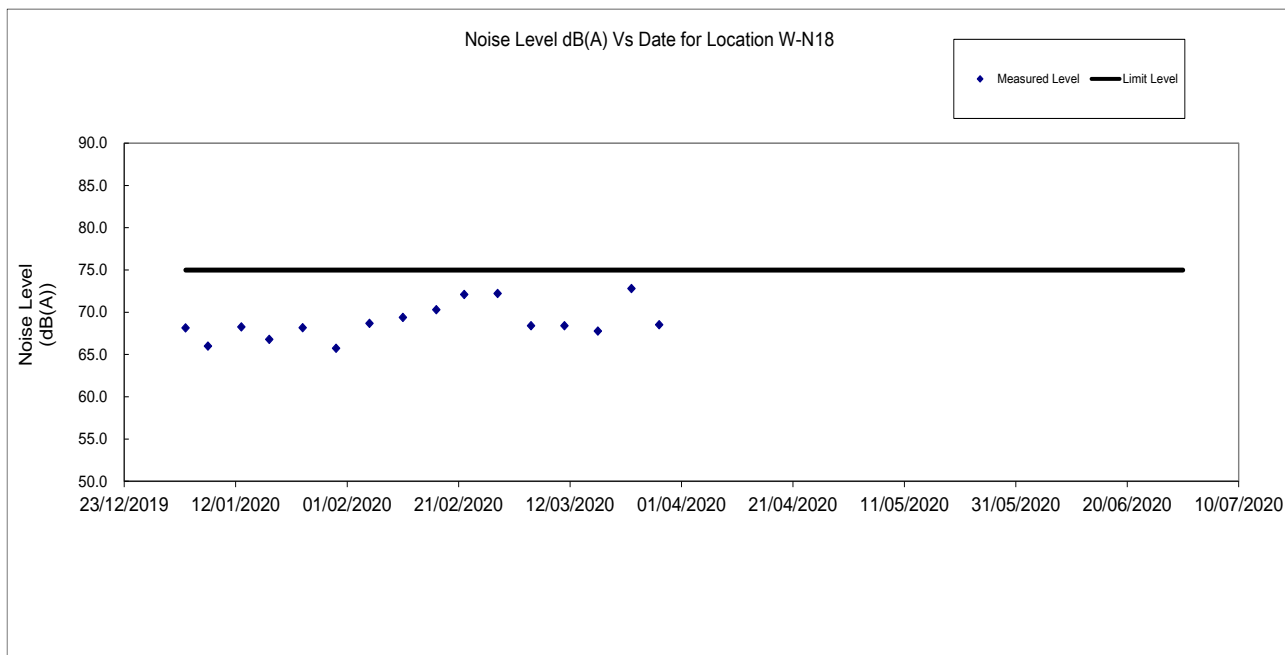
Figure 2: Graphical Illustration of Measured Noise Levels at W-N18

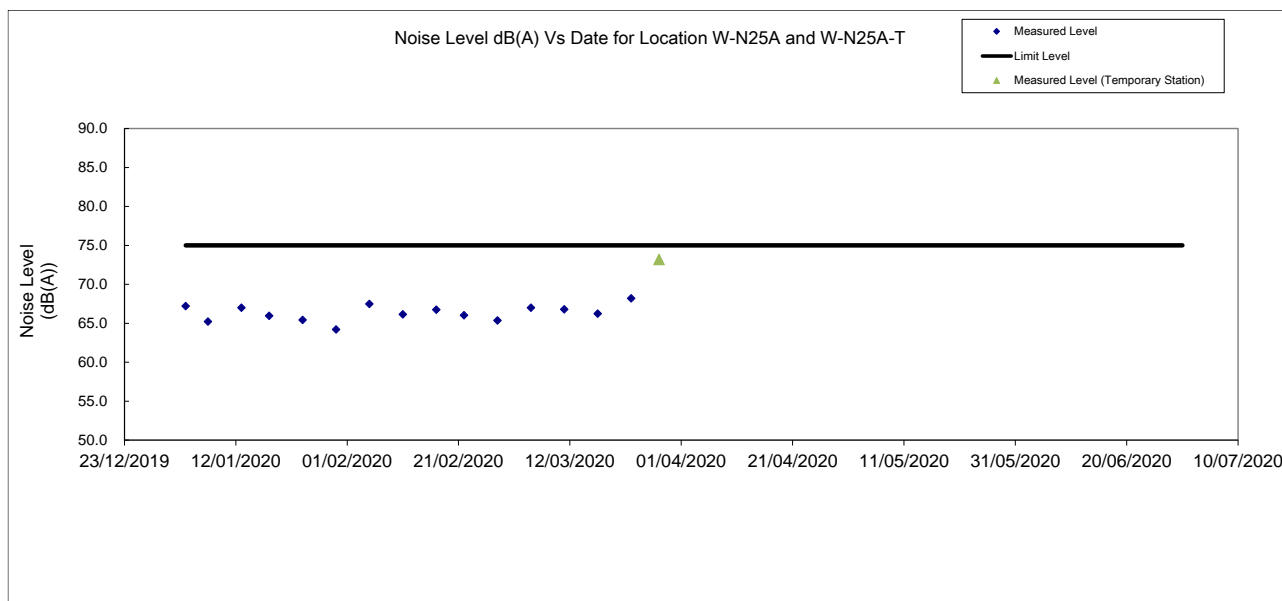
Figure 3: Graphical Illustration of Measured Noise Levels at W-N25A

Remark: Noise monitoring station at Prosperous Garden Block 1 (W-N25A) was temporarily suspended from 24 March 2020 to 6 April 2020 due to a case of novel coronavirus infection at the Prosperous Garden Block 4. A temporary alternative noise monitoring location, W-N25A-T was used on 28 March 2020. A correction of +3dB(A) was made to the free field measurement for W-N25A-T.

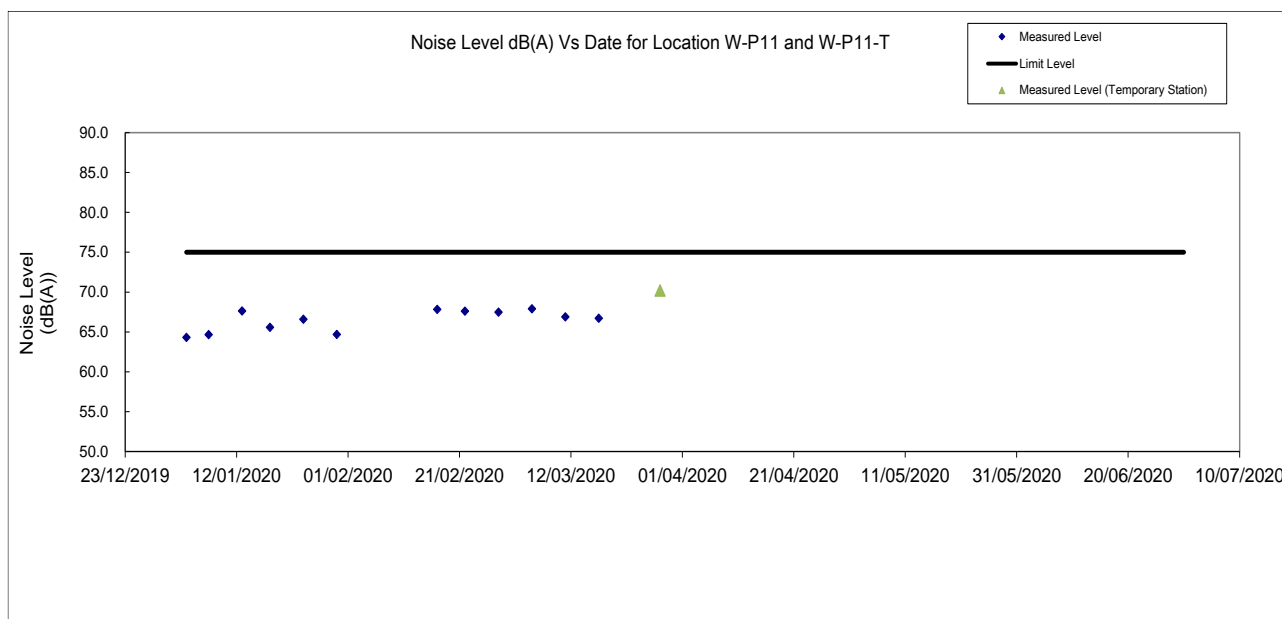
Figure 4: Graphical Illustration of Measured Noise Levels at W-P11

Remark: Noise monitoring station at the Coronation Tower 1 (W-P11) was temporarily suspended from 19 March 2020 to 1 April 2020 due to a case of novel coronavirus infection at the Coronation Tower 7. Noise monitoring at W-P11 on 23 March 2020 was cancelled and a temporary alternative noise monitoring location, W-P11-T was used on 28 March 2020. A correction of +3dB(A) was made to the free field measurement for W-P11-T.
