Central Kowloon Route Contract HY/2014/08

Section of Yau Ma Tei East

Monthly EM&A Report No. 14

(Period from 1 to 31 May 2019)

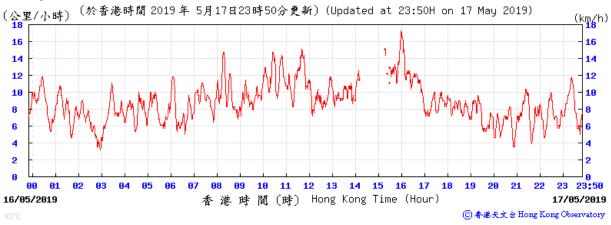
Wind Speed: (於香港時間 2019 年 5月18日23時50分更新)(Updated at 23:50H on 18 May 2019) (公里/小時) 19 (km/h) з 23:50 17/05/2019 閬 (時) Hong Kong Time (Hour) 18/05/2019 香港時 ⓒ 香港天文 含 Hong Kong Observatory
