Vol. 3 of 5 FEP-03/457/2013/D Central Kowloon Route Yau Ma Tei East Contract No. HY/2014/08 August 2022

Central Kowloon Route Contract HY/2014/08 Section of Yau Ma Tei East

Monthly EM&A Report No. 53

(Period from 1 to 31 August 2022)

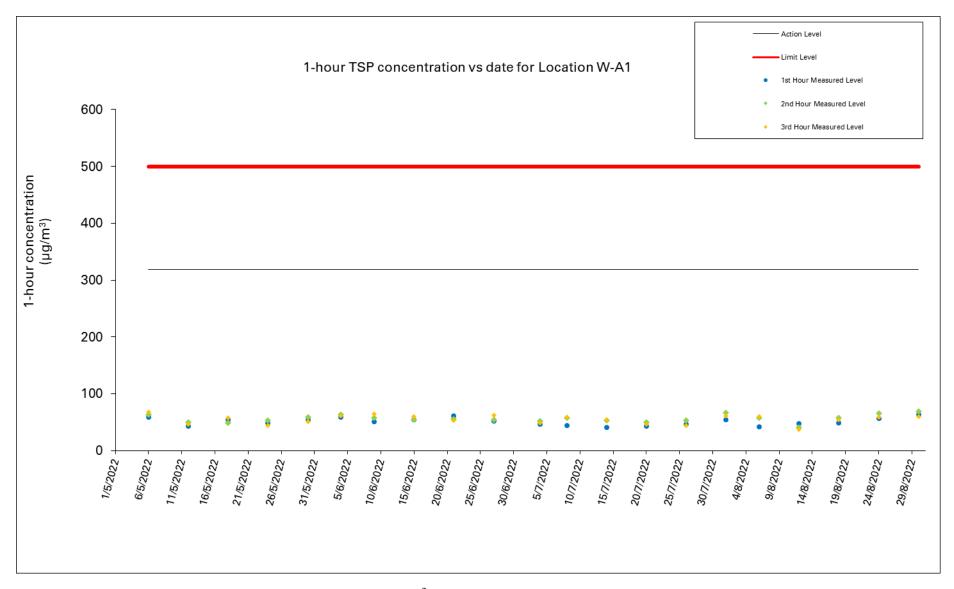
Figure 1: Graphical Illustration of Measured 1-hour TSP (μg/m³) Levels at W-A1

1-hour TSP (μg/m³)							
Date	Weather	Start Time	1 st Hour (μg/m³)	2 nd Hour (μg/m³)	3 rd Hour (μg/m³)			
01/08/2022	Sunny	12:56	61	78	69			
06/08/2022	Sunny	9:46	59	64	68			
12/08/2022	Cloudy	12:07	49	57	62			
18/08/2022	Fine	10:08	55	67	66			
24/08/2022	Sunny	9:32	67	69	71			
30/08/2022	Fine	12:00	60	69	69			
Minimum: 49 μg/m ³				Maximum: 78 μg	$/\mathrm{m}^3$

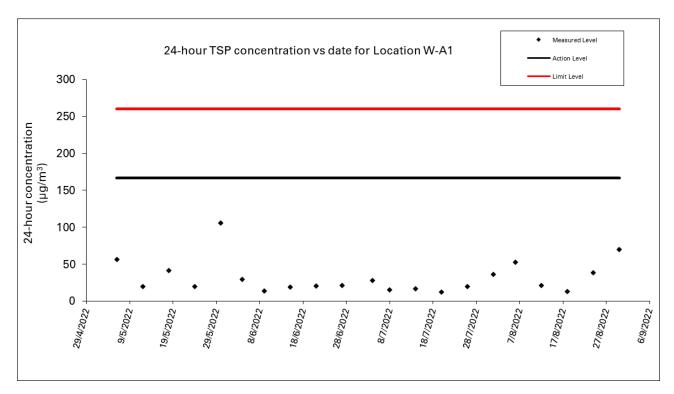
Figure 3: Graphical Illustration of Measured 24-hour TSP ($\mu g/m^3$) Levels at W-A1

Start Date	Weather Condition	Elapse Time			Chart Reading		Avg Air Temp	Avg Atmospheric Pressure	Flow Rate	Standard Air Filter Weigh Volume		ght (g) Particulate weight		Conc.	
		Initial	Final	Actual (min)	Min	Max	Avg	(°C)	(hPa)	(m³/min)	(m ³)	Initial	Final	(g)	$(\mu g/m^3)$
1/8/2022	Sunny	6598.9	6622.9	1440.00	41	41	41.0	27.2	1000.7	1.35	1944	2.7541	2.8055	0.0514	26
6/8/2022	Sunny	6622.9	6646.9	1440.00	40	41	40.5	28.8	1005.7	1.23	1772	2.7545	2.7846	0.0301	17
12/8/2022	Cloudy	6646.9	6670.9	1440.00	40	41	40.5	26.4	1009.6	1.32	1908	2.7632	2.8045	0.0413	22
18/8/2022	Fine	6671.3	6695.3	1440.00	40	40	40.0	27.7	1005.6	1.24	1790	2.7401	2.7723	0.0322	18
24/8/2022	Sunny	6695.3	6719.3	1440.00	41	41	41.0	30.6	1002.4	1.42	2050	2.7372	2.8416	0.1044	51
30/8/2022	Fine	6719.3	6743.3	1440.00	38	39	38.5	30.9	1006.3	0.79	1143	2.7233	2.7946	0.0713	62
										Maximum:	62	Minimum:	17	μg/m ³

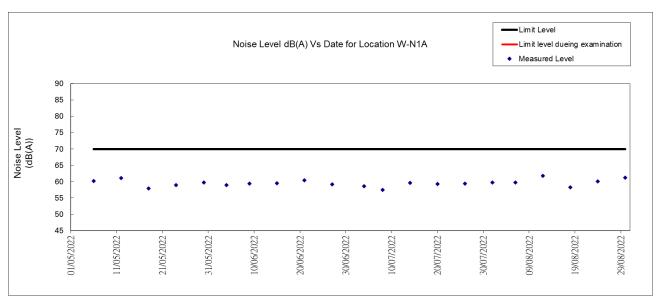
Figure 1: Graphical Illustration of Measured Noise Levels at W-N1A

Date	Weather	Start Time	-	End Time	Leq	L_{10}	L ₉₀	Wind speed (m/s)
01/08/2022	Sunny	16:23	-	16:53	66.4	67.8	64.2	3.2
06/08/2022	Sunny	12:27	-	12:57	65.3	67.0	62.9	2.5
12/08/2022	Cloudy	10:35	-	11:05	68.2	69.2	66.8	1.7
18/08/2022	Fine	9:11	-	9:41	64.8	66.4	63.0	0.9
24/08/2022	Sunny	16:14	-	16:44	65.0	66.6	62.7	4.9
30/08/2022	Fine	13:41	-	14:11	65.4	66.9	63.0	2.9

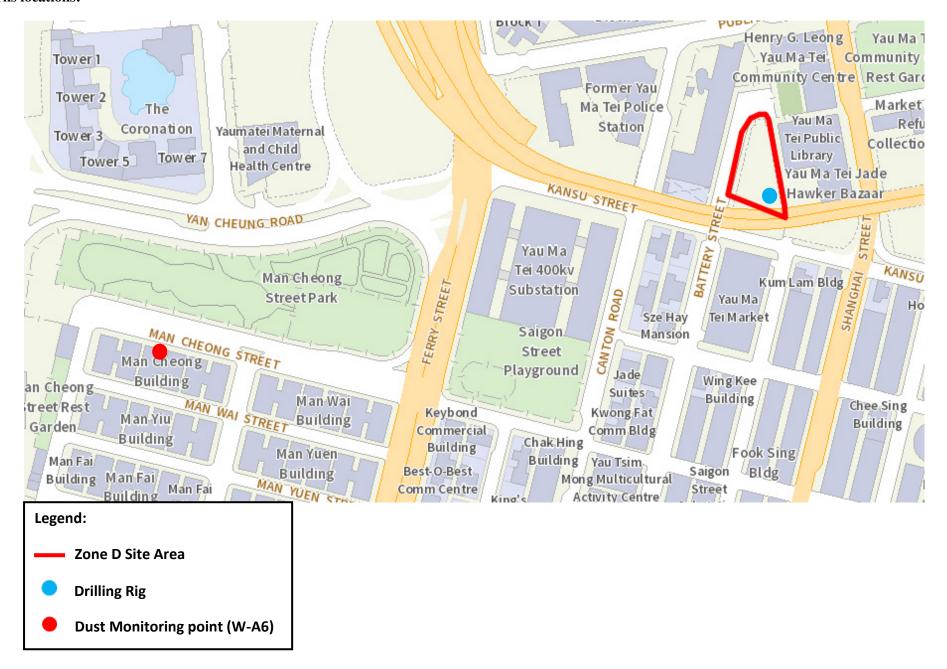
Works locations:

Project	Central Kowloon Route, Yau Ma Tei East Section		
Complaint Code	EC039-CKRYMTE20220804_001		
Complaint description	The complainant complained that the smoke or dust has blocked the driving eyesight at Gascoigne Road Flyover at 9:22AM. The construction sites of Highways Department were under the flyover. The complainant requested to follow up.		
	"我在9時22分時駕駛車經過加士居道天橋時發現大量不知道是煙定塵埃大量湧上 行車天橋,阻礙行車視線。橋下有地盤是屬路政署。請當局正視問題。"		
Parameter	Dust		
Investigation finding	The complainant made the complaint on 4 August 2022 and was concerned about the dust impacts from Zone D.		
	As noted from the Contractor, the drilling rig at Zone D functioned abnormally at concerned time on 4 August 2022. The drilling rig was confirmed as malfunctioning after checking and had been removed from the site immediately. Therefore, it is suspected that the smoke was generated from the malfunctioned drilling rig at Zone D which is nearest to Gascoigne Road Flyover.

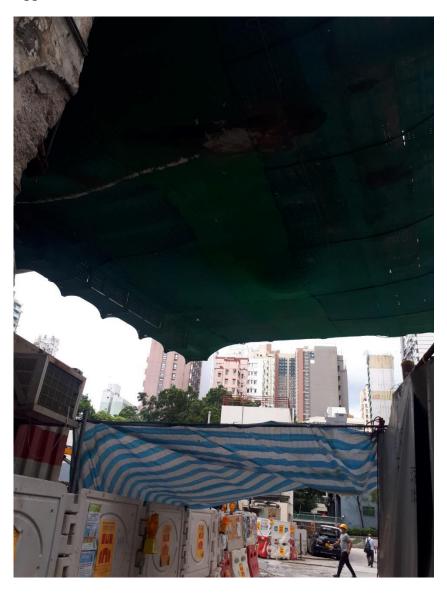
Figure A1: Impervious sheeting was added at the base of bridge at P6 site area.

Actions taken / to be taken	The Contractor had followed EM&A Manual strictly to implement mitigation measures in order to minimize nuisance to the public. The Contractor had added the impervious sheeting at the base of bridge to block the water dripping from the bridge and the rainwater will be diverted to the site for treatment. Supporting photo are provided in Appendix A.			
Remarks	Works locations: (Page 3)			
Prepared by ET (Acuity Sustainability Consulting Limited)	Katrina Chui	fil		
Reviewed by ETL (Acuity Sustainability Consulting Limited)	Kevin Li	K		
Verified by IEC (ERM-Hong Kong, Limited)	Mandy To	Mandy 2.		
Date	16 Aug	gust 2022

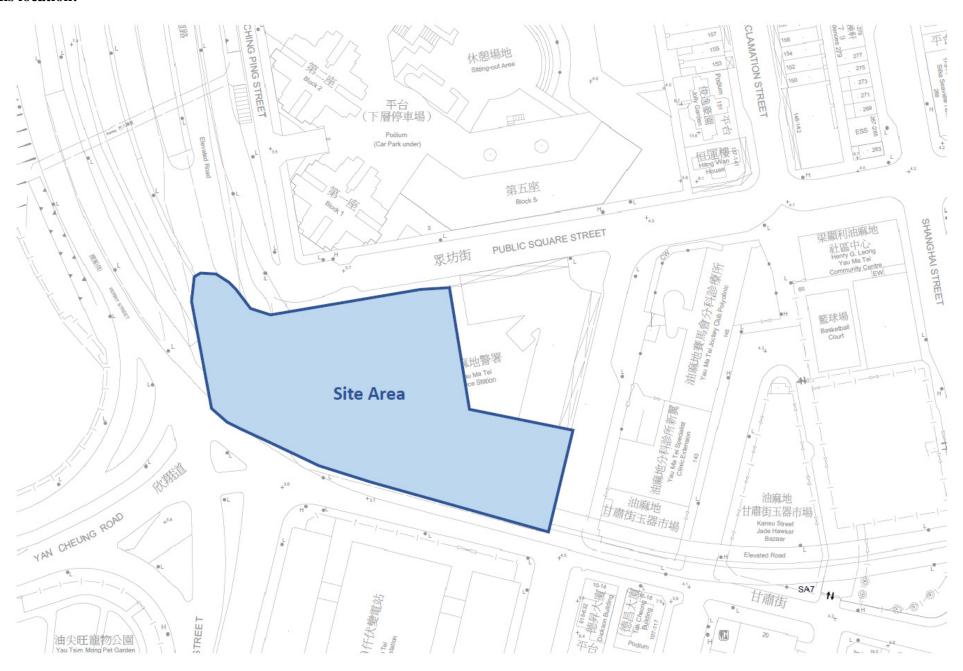
Works location:

Considering the fulfillment of stipulated requirements by the Contractor for CNP		
	(Permit No.: GE-RE0643-22) and EM&A manual, it is concluded that there was no non-		
	compliance to the EM&A requirement of the Project regarding noise pollution impact		
Actions taken / to be taken	from construction site. The Contractor had followed EM&A Manual strictly to implement mitigation measures		
Actions taken / to be taken	in order to minimize nuisance to the public.		
Remarks	Works locations:		
	(next page.)		
Prepared by ET	-	1	
(Acuity Sustainability	Janice Lee	h	
Consulting Limited)	V W M M M M M M M M M M M M M M M M M M	9	
		а	
Reviewed by ETL		^	
(Acuity Sustainability	Kelvin Li	/X	
Consulting Limited)			
Verified by IEC		Mandyto.	
(ERM-Hong Kong,	Mandy To	1. Manolyto.	
Limited)		/W 0000 /	
Date	23 Augi	ıst 2022	
			-
