**Central Kowloon Route**

**Yau Ma Tei East**

**Contract No. HY/2014/08**

Document/ <del>Plan</del> to be <del>Certified</del> / Verified:	Monthly EM&A Report No.33 (December 2020)
Date of Report:	11 January 2021 (Rev.1)
Date received by IEC:	11 January 2021

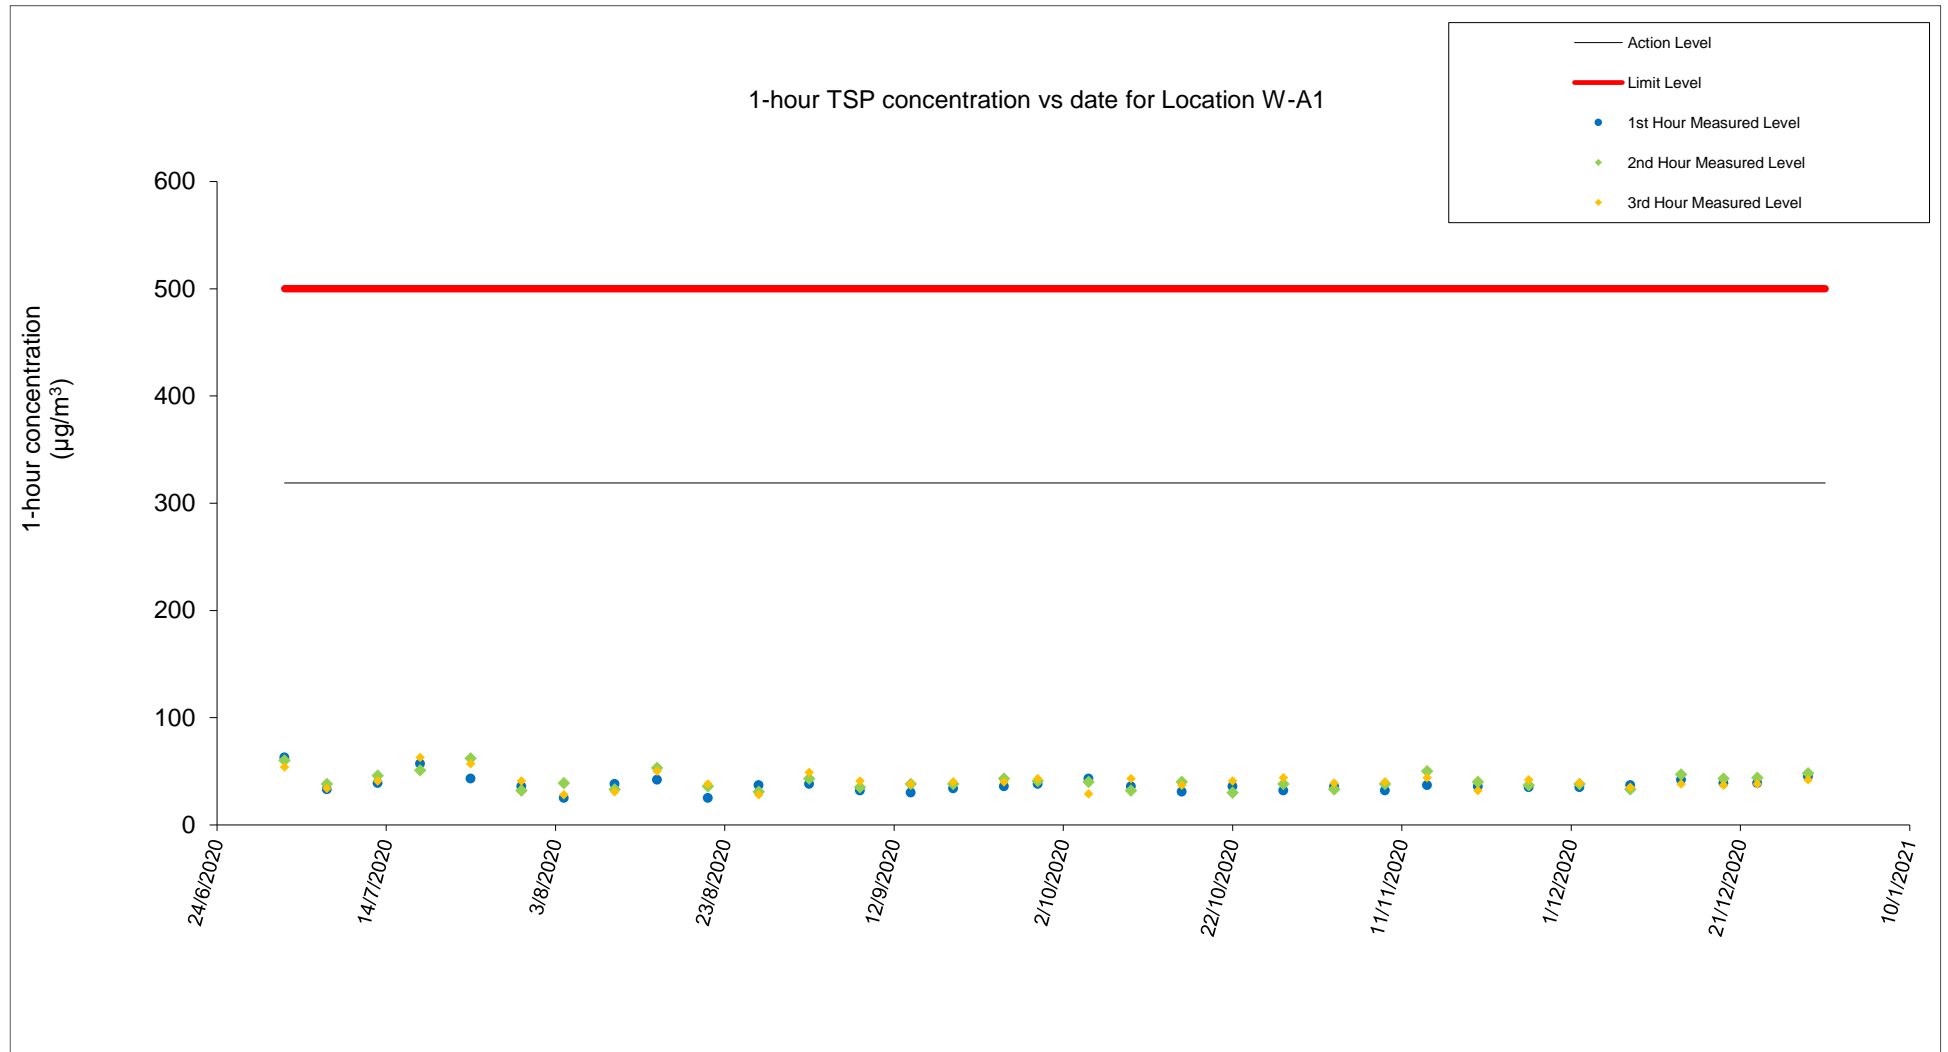
Figure 1: Graphical Illustration of Measured 1-hour TSP ( $\mu\text{g}/\text{m}^3$ ) Levels at W-A1

3.6.3. The results for 1-hour TSP and 24-hour TSP are summarized in Table 3.7 and Table 3.8. The measurement data and details of influencing factors such as weather conditions and site observation are presented in Appendix L.

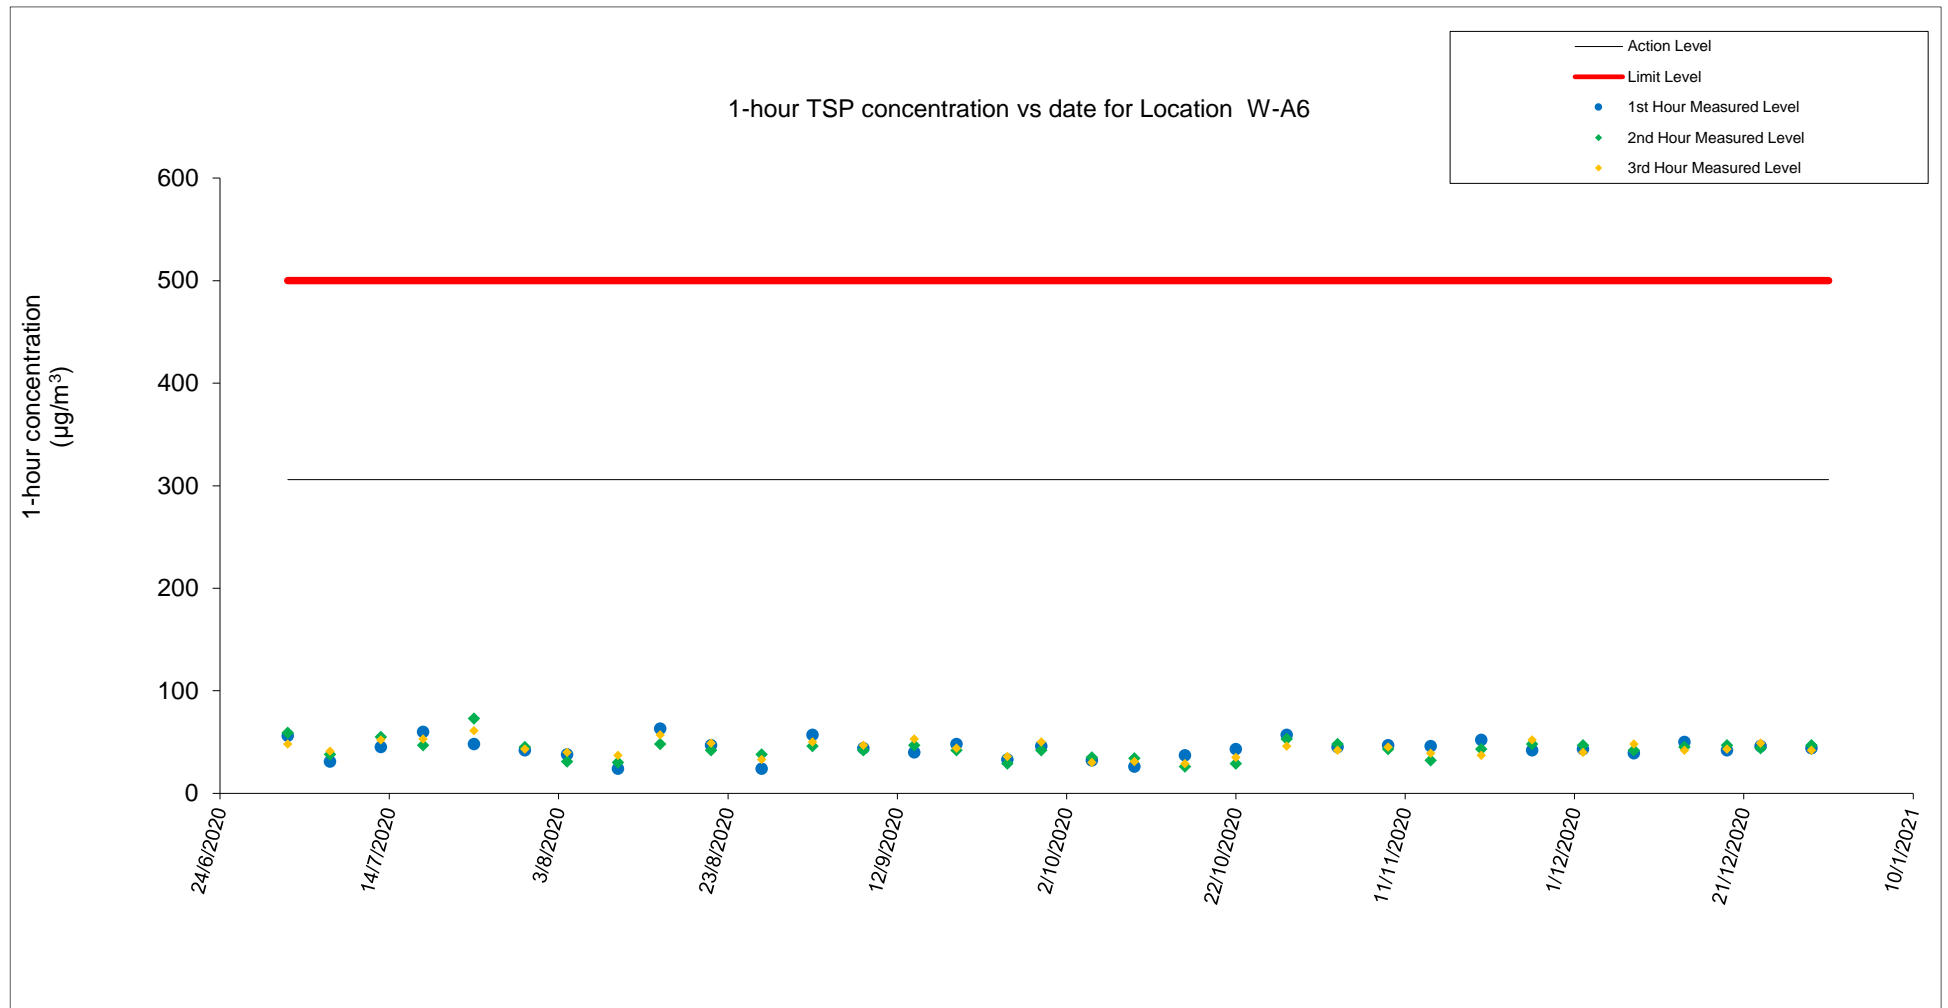
Figure 2: Graphical Illustration of Measured 1-hour TSP ( $\mu\text{g}/\text{m}^3$ ) Levels at W-A6

Location: Man Cheong Building (W-A6)  
Monitoring date: 2, 8, 14, 19, 23, 29 December 2020  
Parameter : TSP 1-hour  
Other Factors Nearby traffic

Date	1-hour TSP ( $\mu\text{g}/\text{m}^3$ )				
	Weather	Start Time	1 <sup>st</sup> Hour ( $\mu\text{g}/\text{m}^3$ )	2 <sup>nd</sup> Hour ( $\mu\text{g}/\text{m}^3$ )	3 <sup>rd</sup> Hour ( $\mu\text{g}/\text{m}^3$ )
02/12/2020	Sunny	9:10	43	47	40
08/12/2020	Fine	9:18	39	42	48
14/12/2020	Cloudy	8:53	50	45	42
19/12/2020	Sunny	10:43	42	47	43
23/12/2020	Cloudy	15:45	46	44	49
29/12/2020	Sunny	12:31	44	47	42

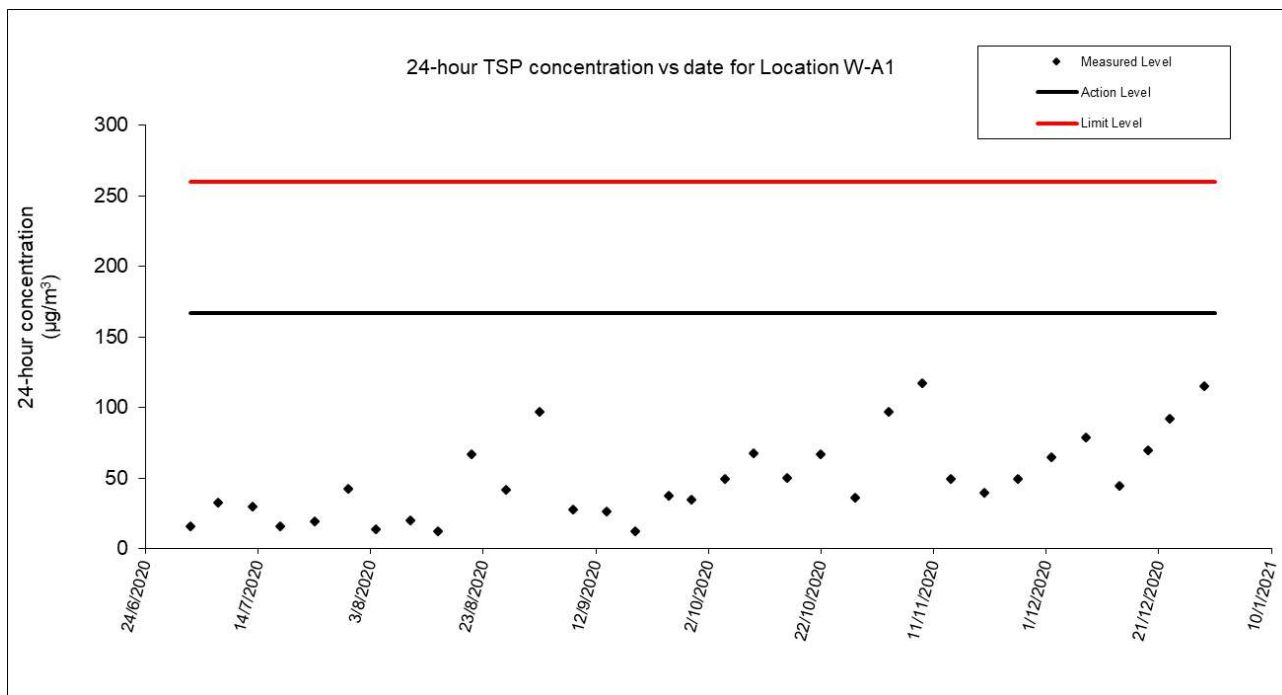
Figure 3: Graphical Illustration of Measured 24-hour TSP ( $\mu\text{g}/\text{m}^3$ ) Levels at W-A1

Location: Yau Ma Tei Catholic Primary School (Hoi Wang Road) (W-A1)  
 Monitoring date: 2, 8, 14, 19, 23, 29 December 2020  
 Parameter : TSP 24-hour  
 Other Factors Nearby traffic

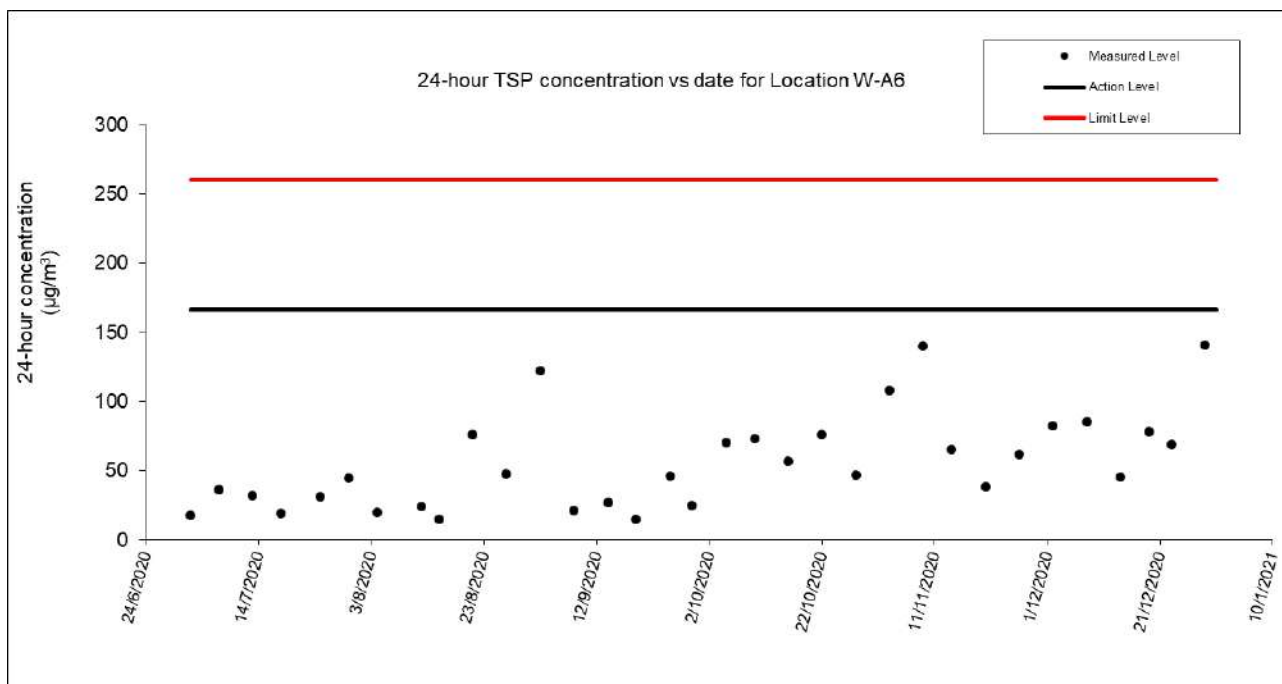
Figure 4: Graphical Illustration of Measured 24-hour TSP ( $\mu\text{g}/\text{m}^3$ ) Levels at W-A6

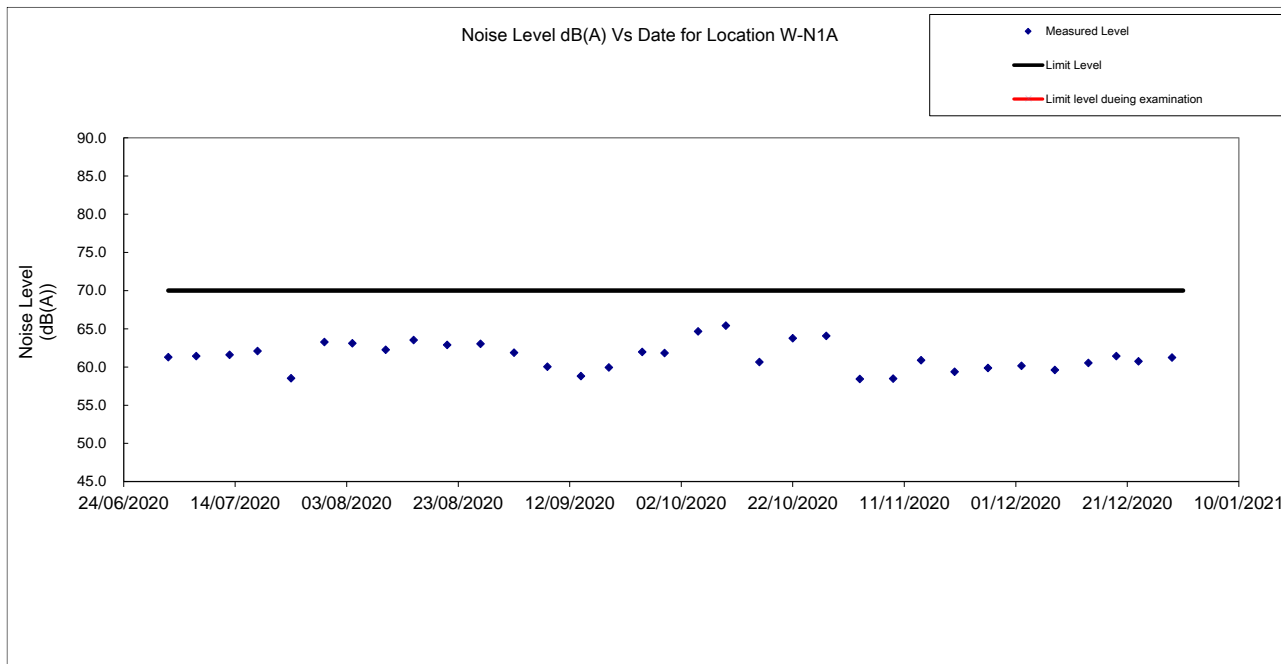
Figure 1: Graphical Illustration of Measured Noise Levels at W-N1A

Date	Weather	Start Time	-	End Time	$L_{eq}$	$L_{10}$	$L_{90}$	Wind speed (m/s)
02/12/2020	Sunny	10:26	-	10:56	65.2	67.0	63.3	2.1
08/12/2020	Fine	10:10	-	10:40	68.3	70.4	65.5	1.7
14/12/2020	Cloudy	9:10	-	9:40	67.2	69.2	64.1	3.3
19/12/2020	Sunny	9:22	-	9:52	68.9	71.0	65.3	2.5
23/12/2020	Sunny	15:04	-	15:34	68.1	70.5	65.3	2.4
29/12/2020	Sunny	16:57	-	16:30	68.2	70.2	64.4	1.3

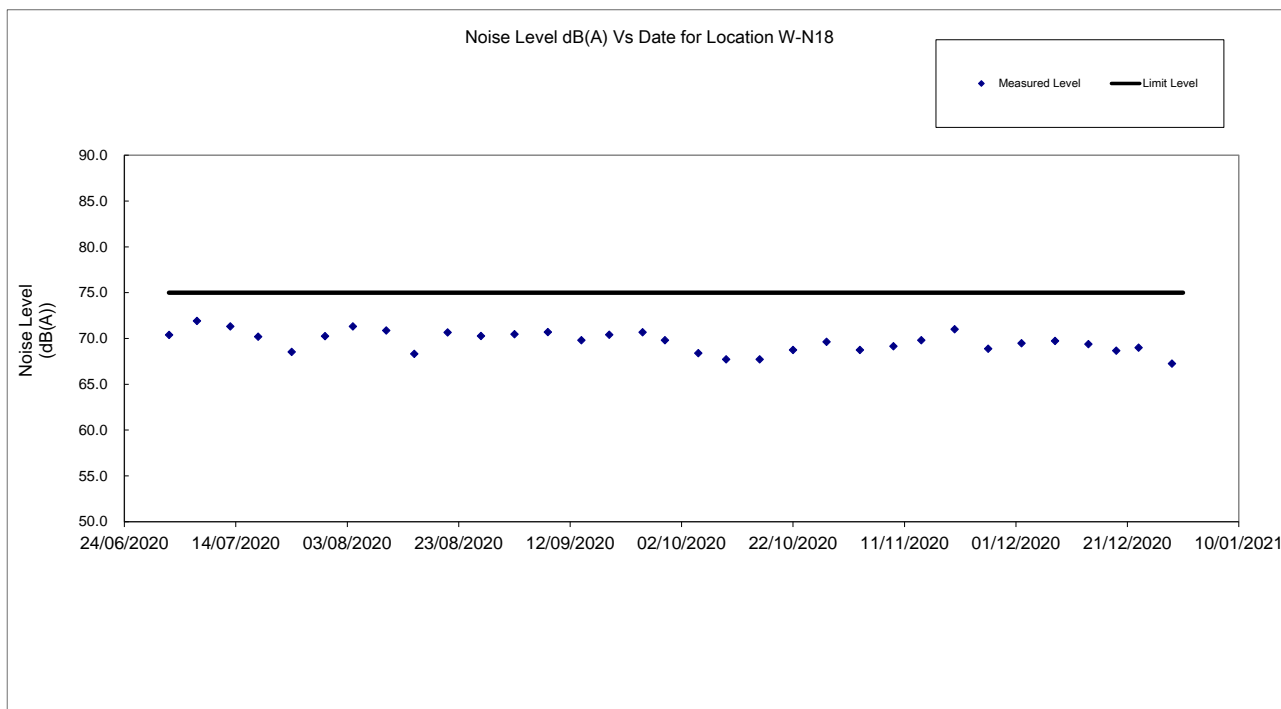
Figure 2: Graphical Illustration of Measured Noise Levels at W-N18

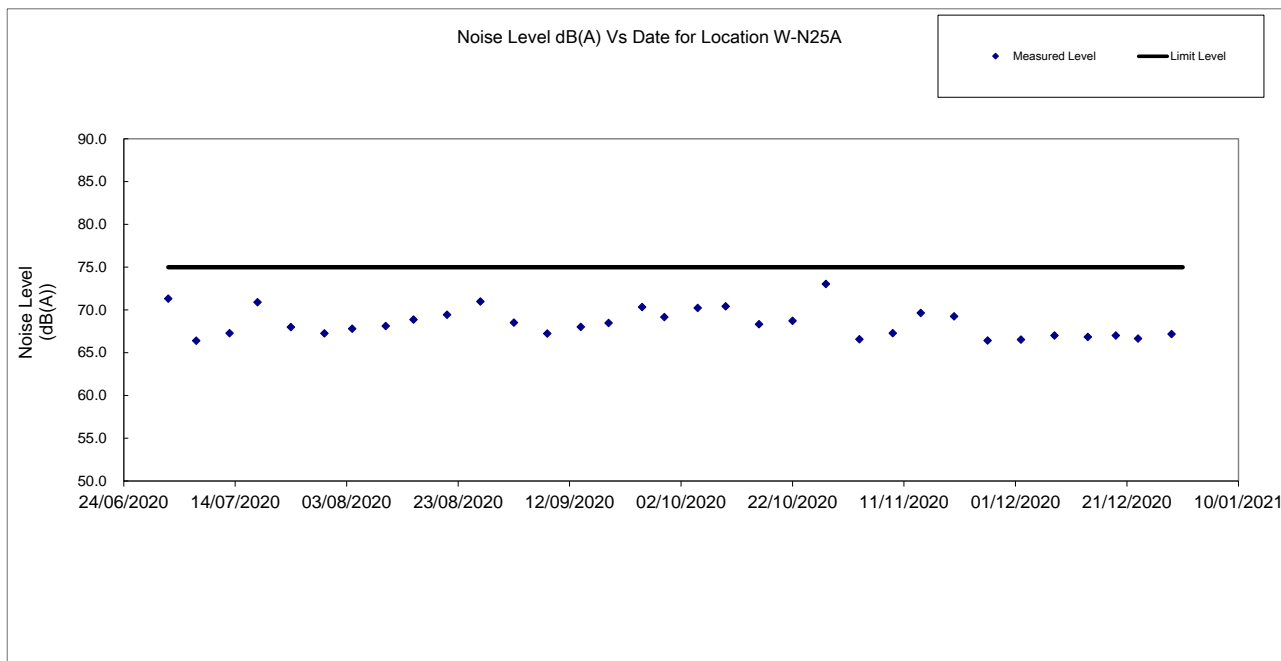
Figure 3: Graphical Illustration of Measured Noise Levels at W-N25A

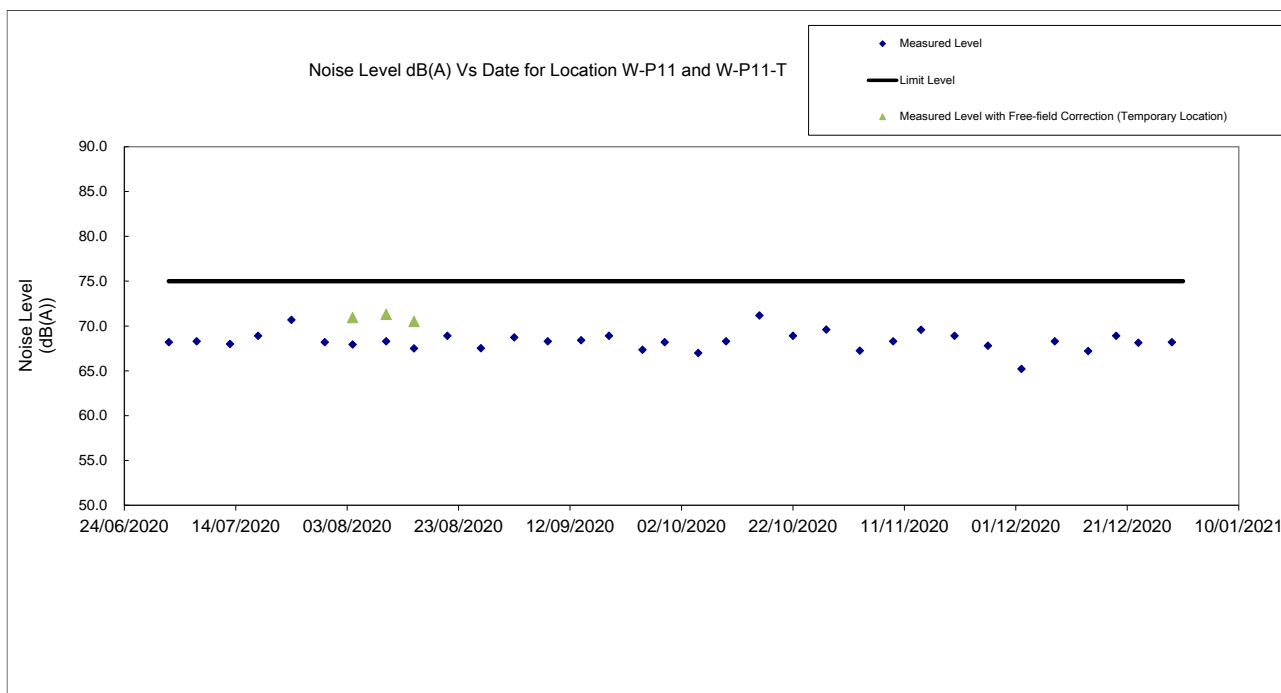
Figure 4: Graphical Illustration of Measured Noise Levels at W-P11
