**EP-457/2013/C**

**Central Kowloon Route**

**Yau Ma Tei West**

**Contract No. HY/2014/20**

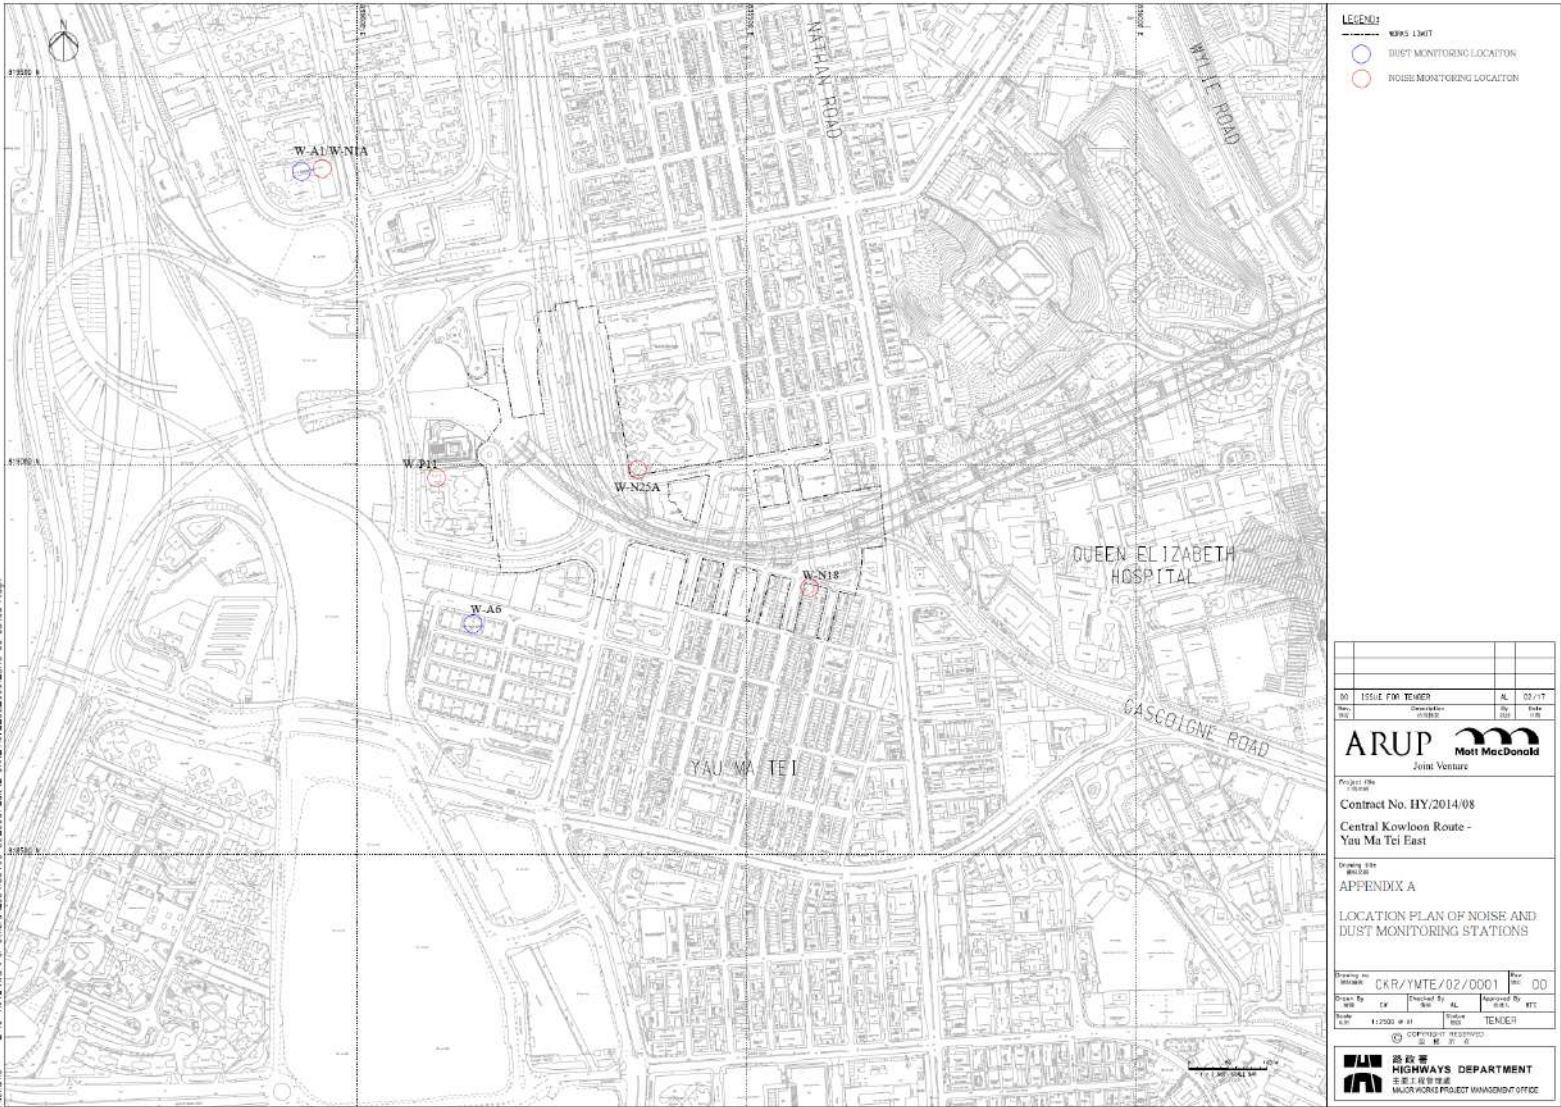
## Location Plan of Noise and Air Quality Monitoring Station

- 3.4.1. During the site visit, both of the original proposed dust monitoring locations were rejected due to the condition at The Coronation was not favorable for monitoring and the access was declined by the management office of Hong Kong Community College (HKCC) of PolyU. Two alternative air monitoring stations Yau Ma Tei Catholic Primary School (Hoi Wang Road) and Man Cheong Building had been proposed by ET and approved by IEC. 2 designated air monitoring locations were identified and agreed with IEC and EPD. Details of air monitoring stations are described in Table 3.3. The location plan of air quality monitoring stations is shown in Appendix K.
