**Central Kowloon Route**

**Yau Ma Tei West**

**Contract No. HY/2014/20**

Monthly EM&A Report No. 59

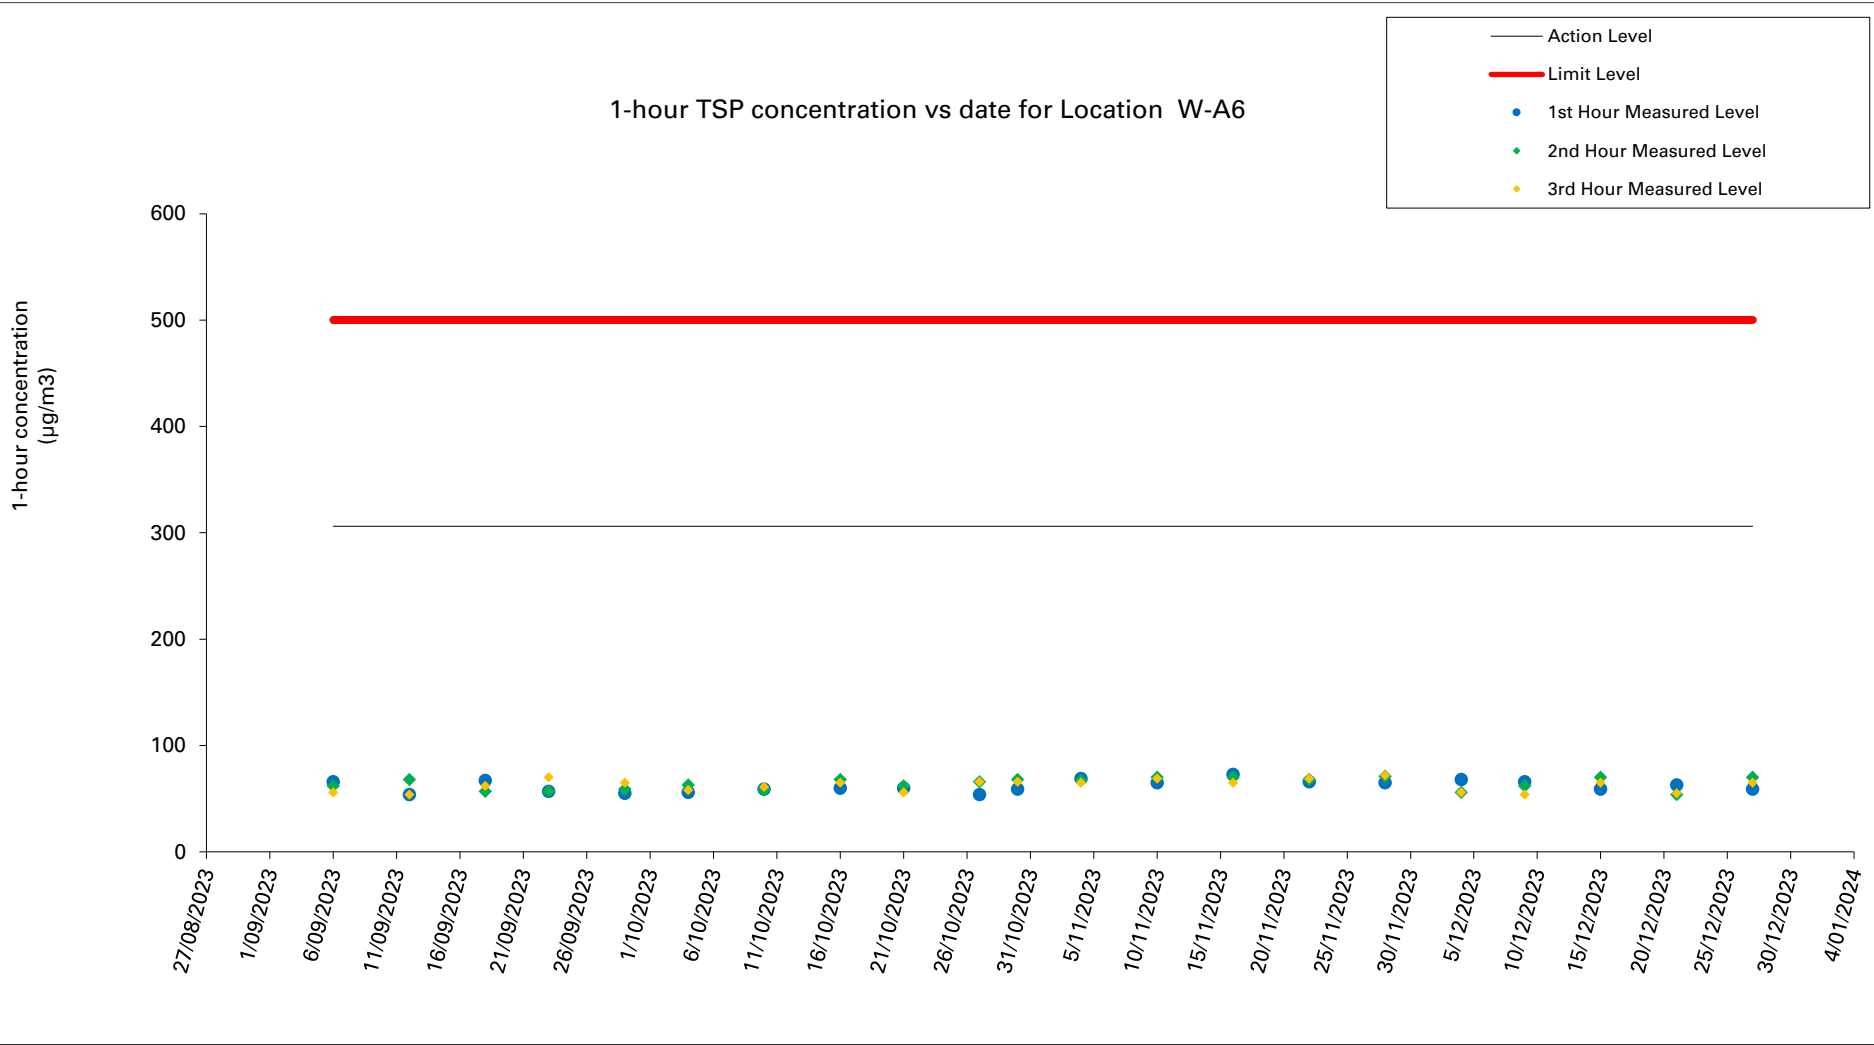
Figure 2: Graphical Illustration of Measured 1-hour TSP ( $\mu\text{g}/\text{m}^3$ ) Levels at W-A6

Location: Man Cheong Building (W-A6)  
Monitoring date: 4, 9, 15, 21 and 27 December 2023  
Parameter : TSP 1-hour  
Other Factors Nearby traffic
