Vol. 4 of 5 EP-457/2013/C Central Kowloon Route Yau Ma Tei West Contract No. HY/2014/20 &

Buildings, Electrical and Mechanical Works

Independent Environmental Checker Verification

Monthly EM&A Report No. 25

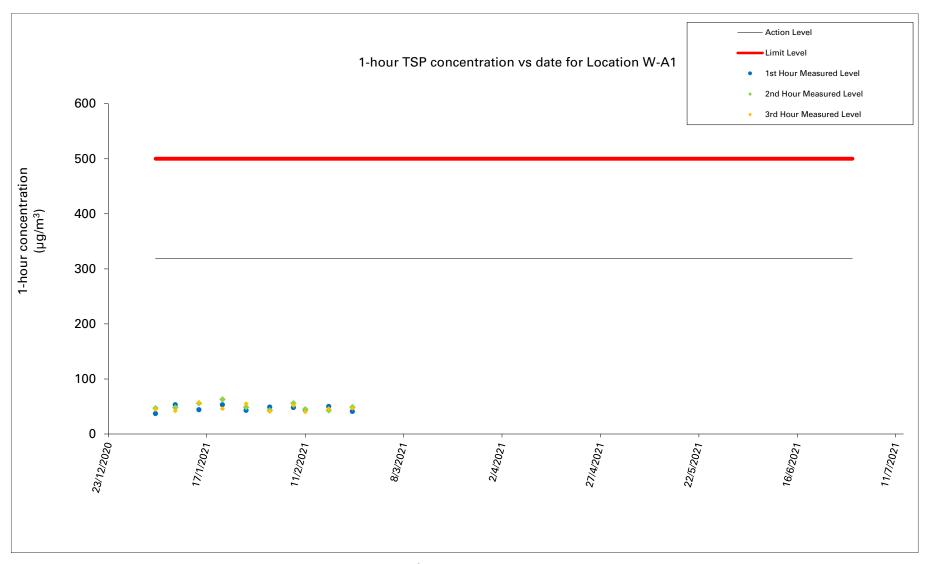
Figure 1: Graphical Illustration of Measured 1-hour TSP ($\mu g/m^3$) Levels at W-A1

1-hour TSP (μg/m³)						
Date	Weather	Start Time	1 st Hour (μg/m³)	2 nd Hour (μg/m³)	3 rd Hour (μg/m³)			
02/02/2021^	Sunny	Suspension of monitoring due to COVID-19						
08/02/2021^	Sunny		Suspension of monitoring due to COVID-19					
11/02/2021	Fine	14:33	66	63	59			
17/02/2021	Sunny	14:57	67	54	63			
23/02/2021	Sunny	9:35	74	61	64

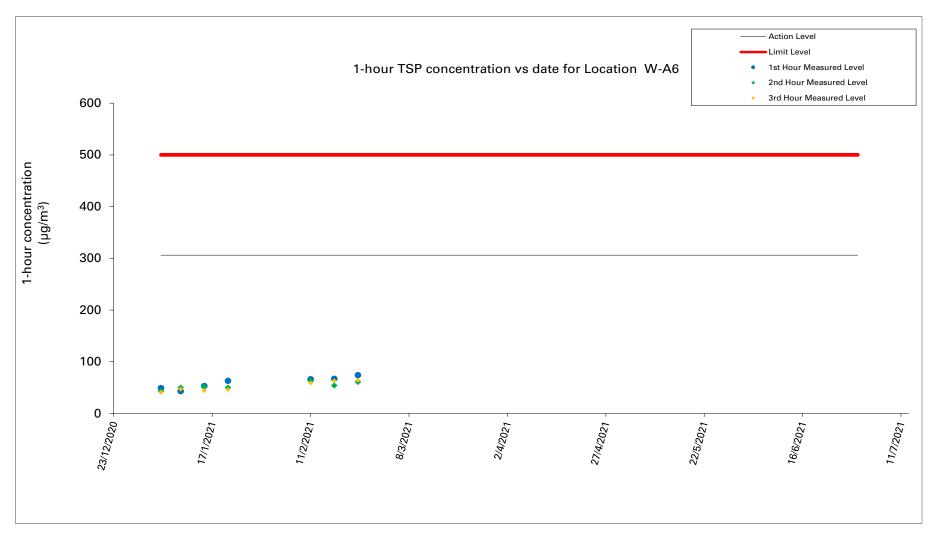
Figure 2: Graphical Illustration of Measured 1-hour TSP (μg/m³) Levels at W-A6

Remark: 1-hour TSP monitoring at W-A6 was temporarily suspended from 27 January 2021 to 9 February 2021 as this station was located inside the specified area due to COVID-19.

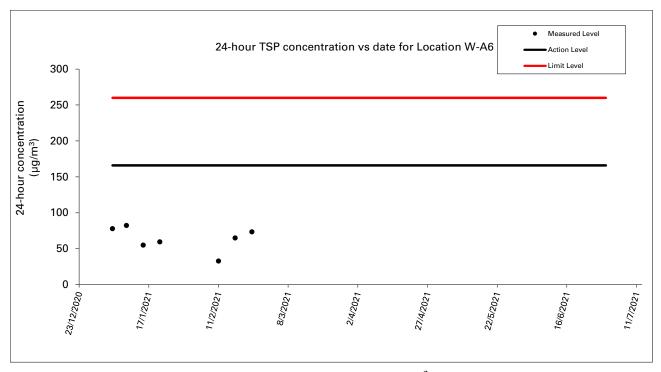
Figure 4: Graphical Illustration of Measured 24-hour TSP ($\mu g/m^3$) Levels at W-A6

Remark: 24-hour TSP monitoring at W-A6 was temporarily suspended from 27 January 2021 to 9 February 2021 as this station was located inside the specified area due to COVID-19.

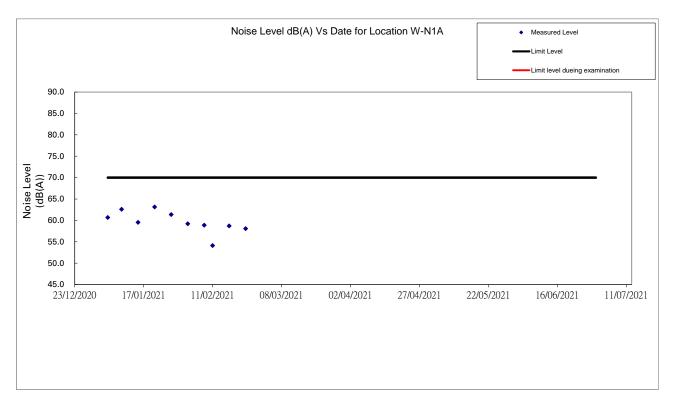
Figure 1: Graphical Illustration of Measured Noise Levels at W-N1A

Date	Weather	Start Time	_	End Time	$L_{\rm eq}$	L_{10}	L ₉₀	Wind
Bute	Weather	Start Time	- End Time		Leq	1210	1290	speed (m/s)
02/02/2021	Sunny	11:02	-	11:32	68.0	70.6	65.5	1.3
08/02/2021	Sunny	9:38	-	10:08	71.3	73.7	67.0	2.8
11/02/2021	Fine	16:15	-	16:45	60.6	61.4	59.4	2.1
17/02/2021	Sunny	15:19	-	15:49	68.9	71.0	65.3	1.7
23/02/2021	Sunny	11:31	-	12:01	66.8	68.6	62.5	2.6

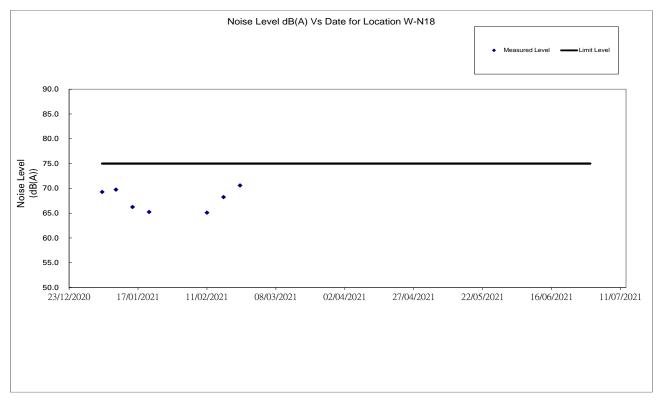
Figure 2: Graphical Illustration of Measured Noise Levels at W-N18

Remark: Noise monitoring at W-N18 was temporarily suspended from 27 January 2021 to 9 February 2021 as this station was located inside the specified area due to COVID-19.

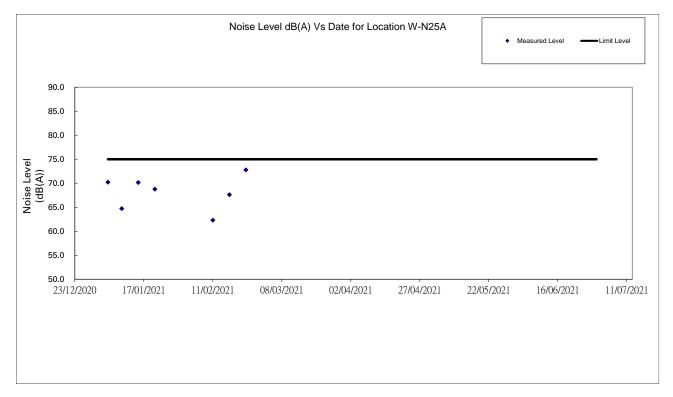
Figure 3: Graphical Illustration of Measured Noise Levels at W-N25A

Remark; Noise monitoring at W-N25A/W-N25A-T were temporarily suspended from 27 January 2021 to 9 February 2021 as these stations were located inside or in proximity to the specified areas due to COVID-19.

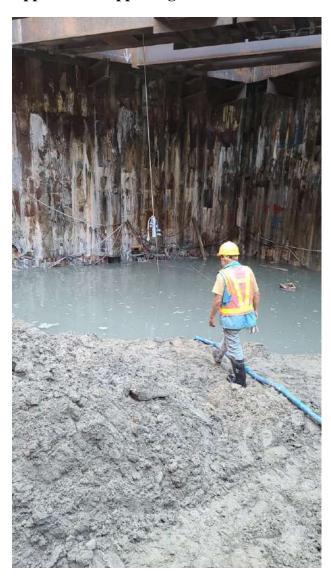
Figure A1: Water seepage at the cofferdam of ventilation adit in Portion 1D

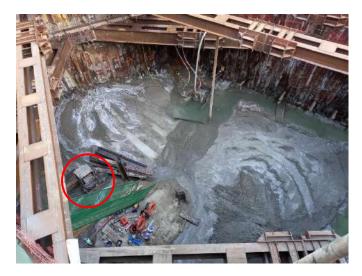
Figure A2: Welding machine was switched off when it was not in use

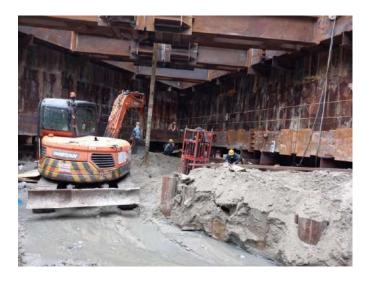
Figure A3: Excavator was switched off when it was not in use

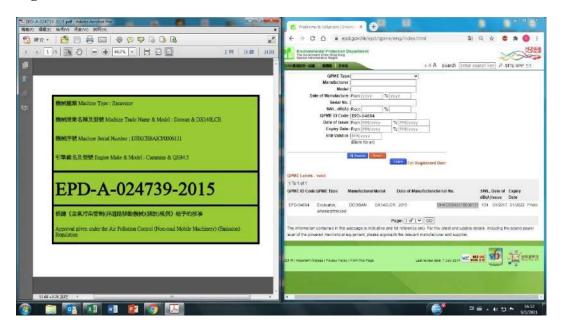
Figure A4: Quality Powered Mechanical Equipment (QPME), excavator with Sound Power Level of \leq 105 dB(A) was used.

3. Quality Powered Mechanical Equipment (QPME), excavator with Sound Power
	Level of ≤ 105 dB(A) was used.
	Supporting photos are provided in Appendix A.
Remarks	PME used on 7 February 2021 during daytime:
	Welding machine x1
