Central Kowloon Route

Yau Ma Tei East

Contract No. HY/2014/08

Monthly EM&A Report No. 10

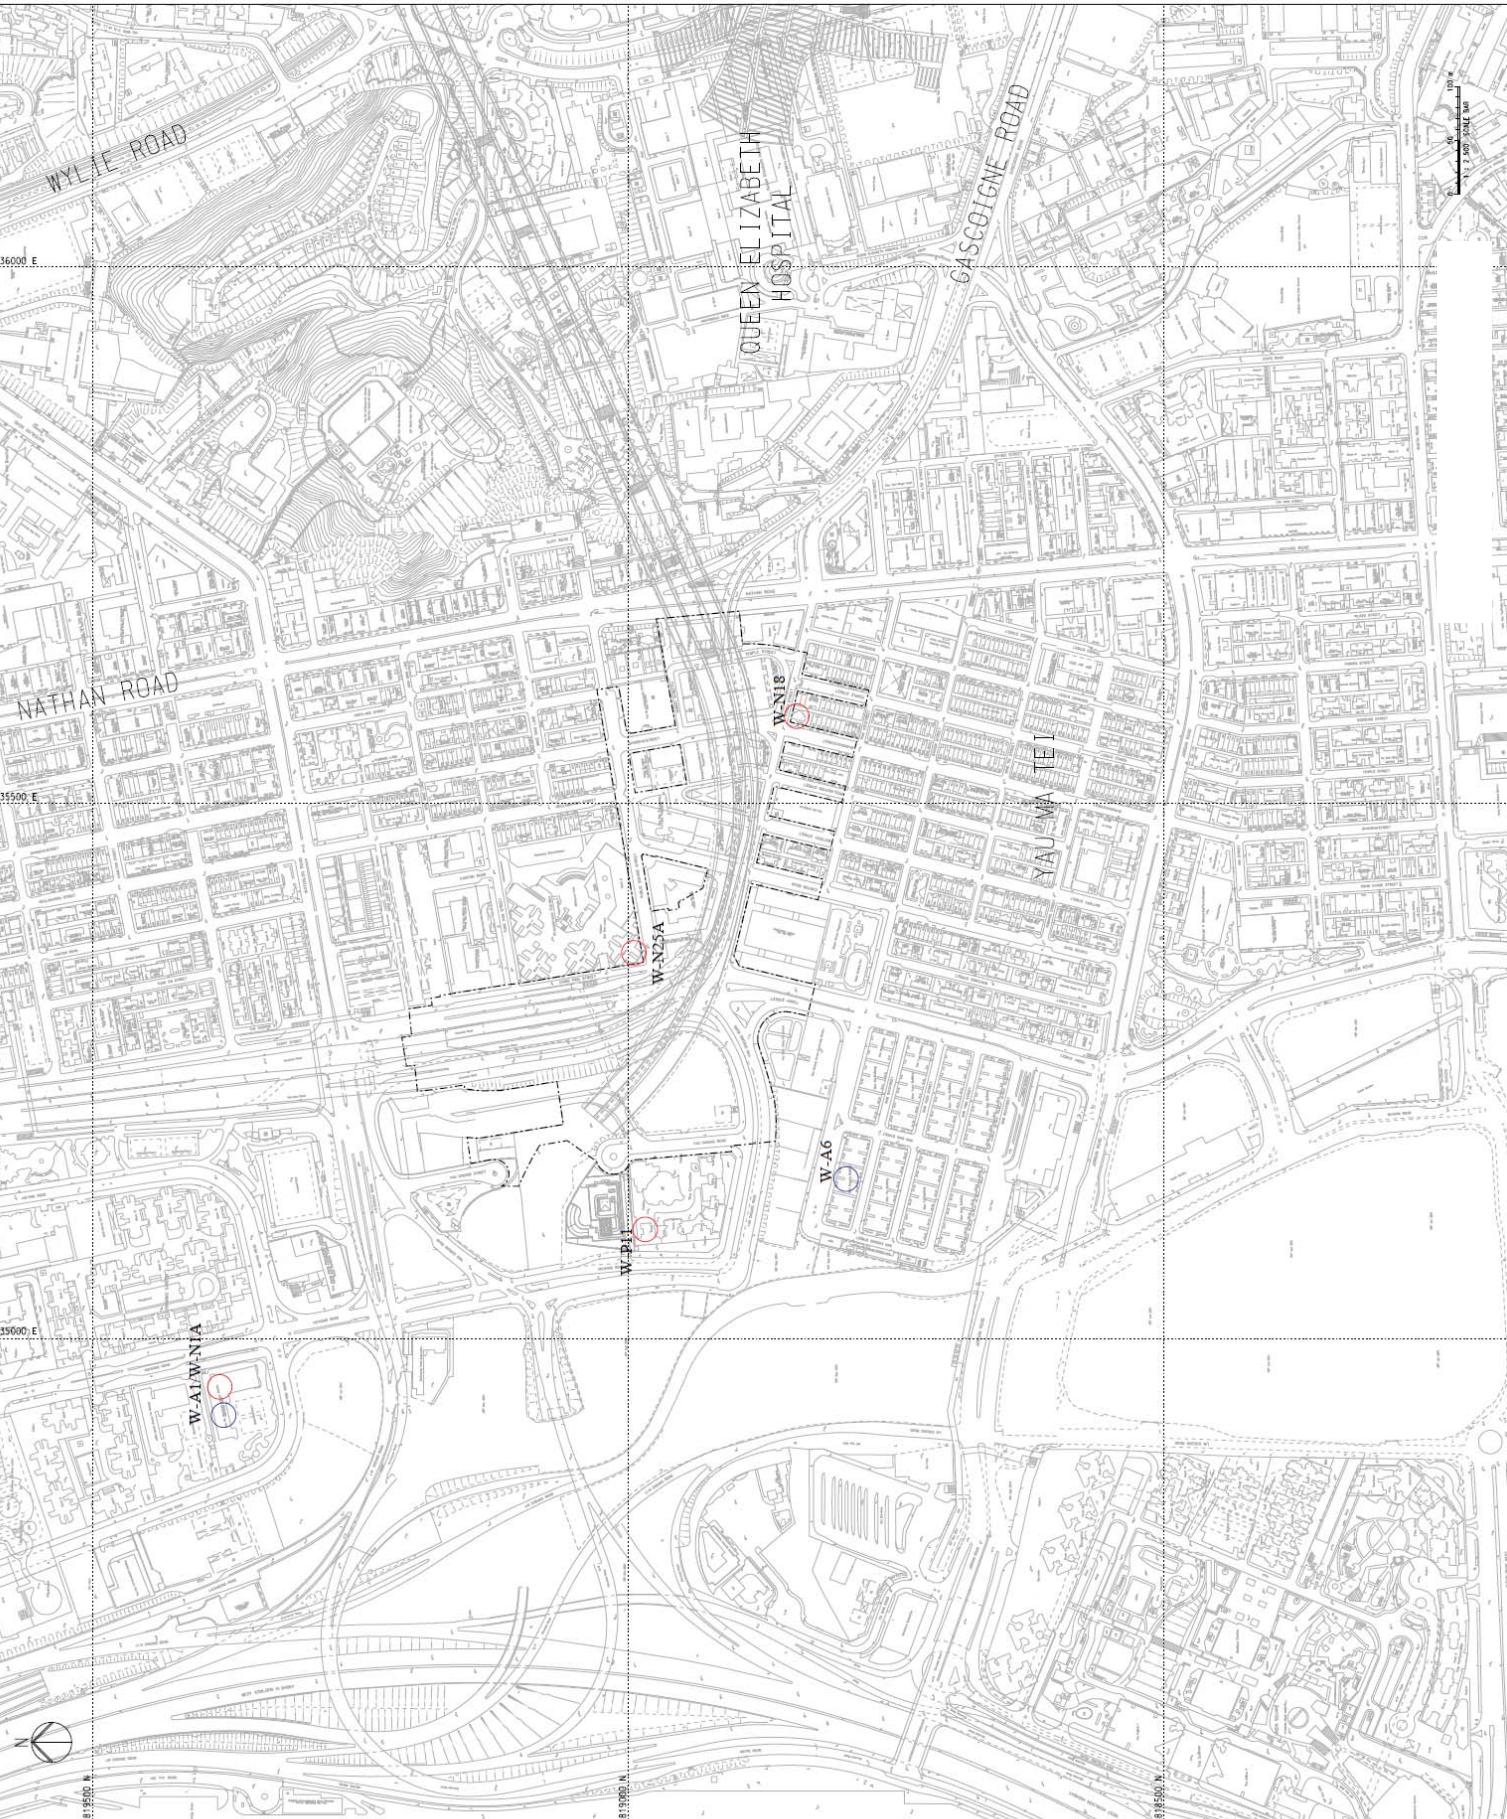
- WORKS LIMIT
- DUST MONITORING LOCATION
- NOISE MONITORING LOCATION

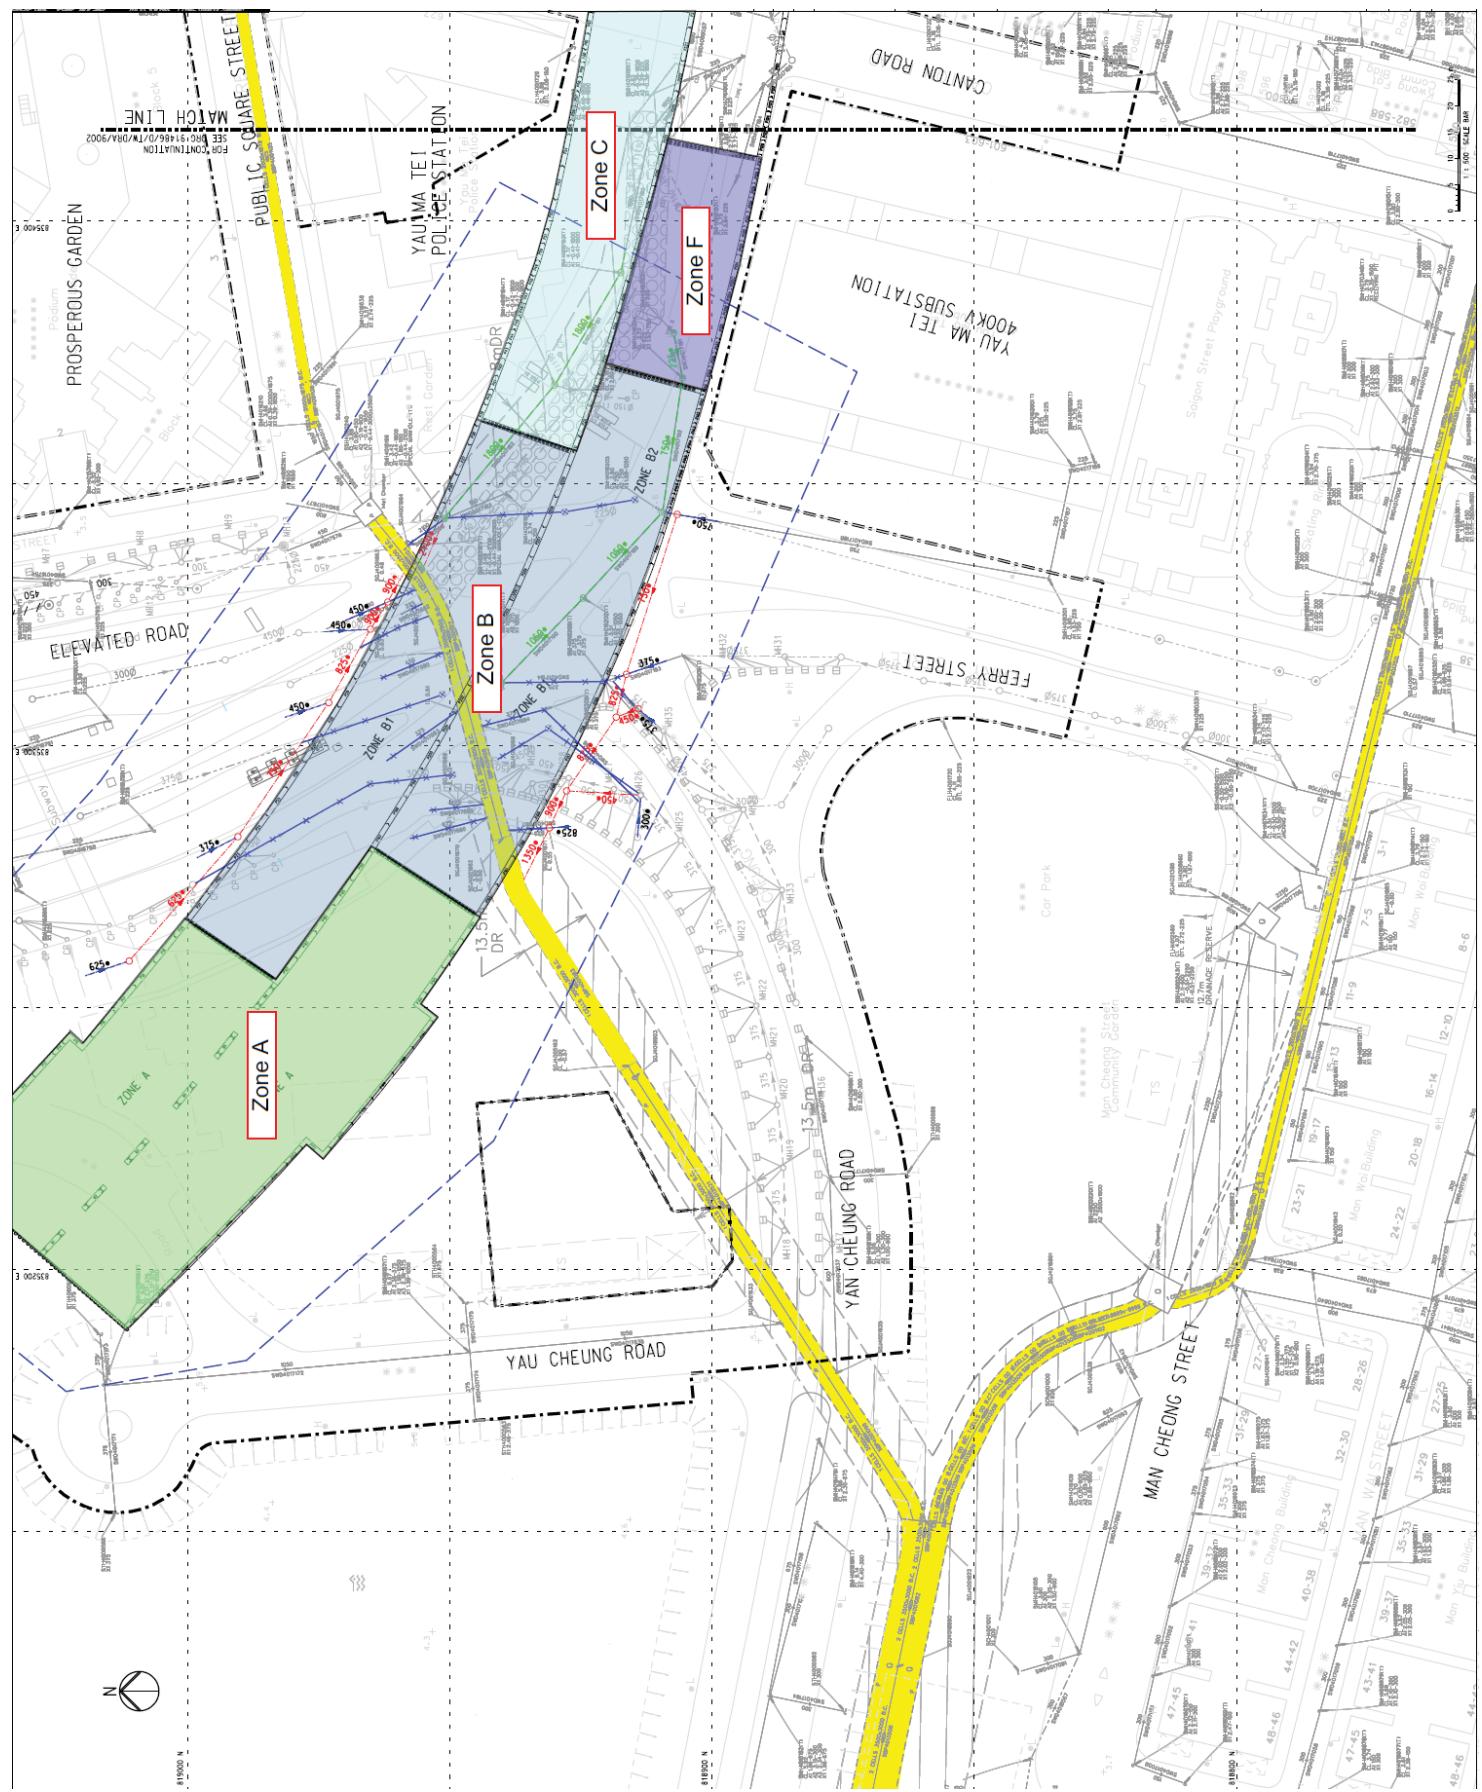
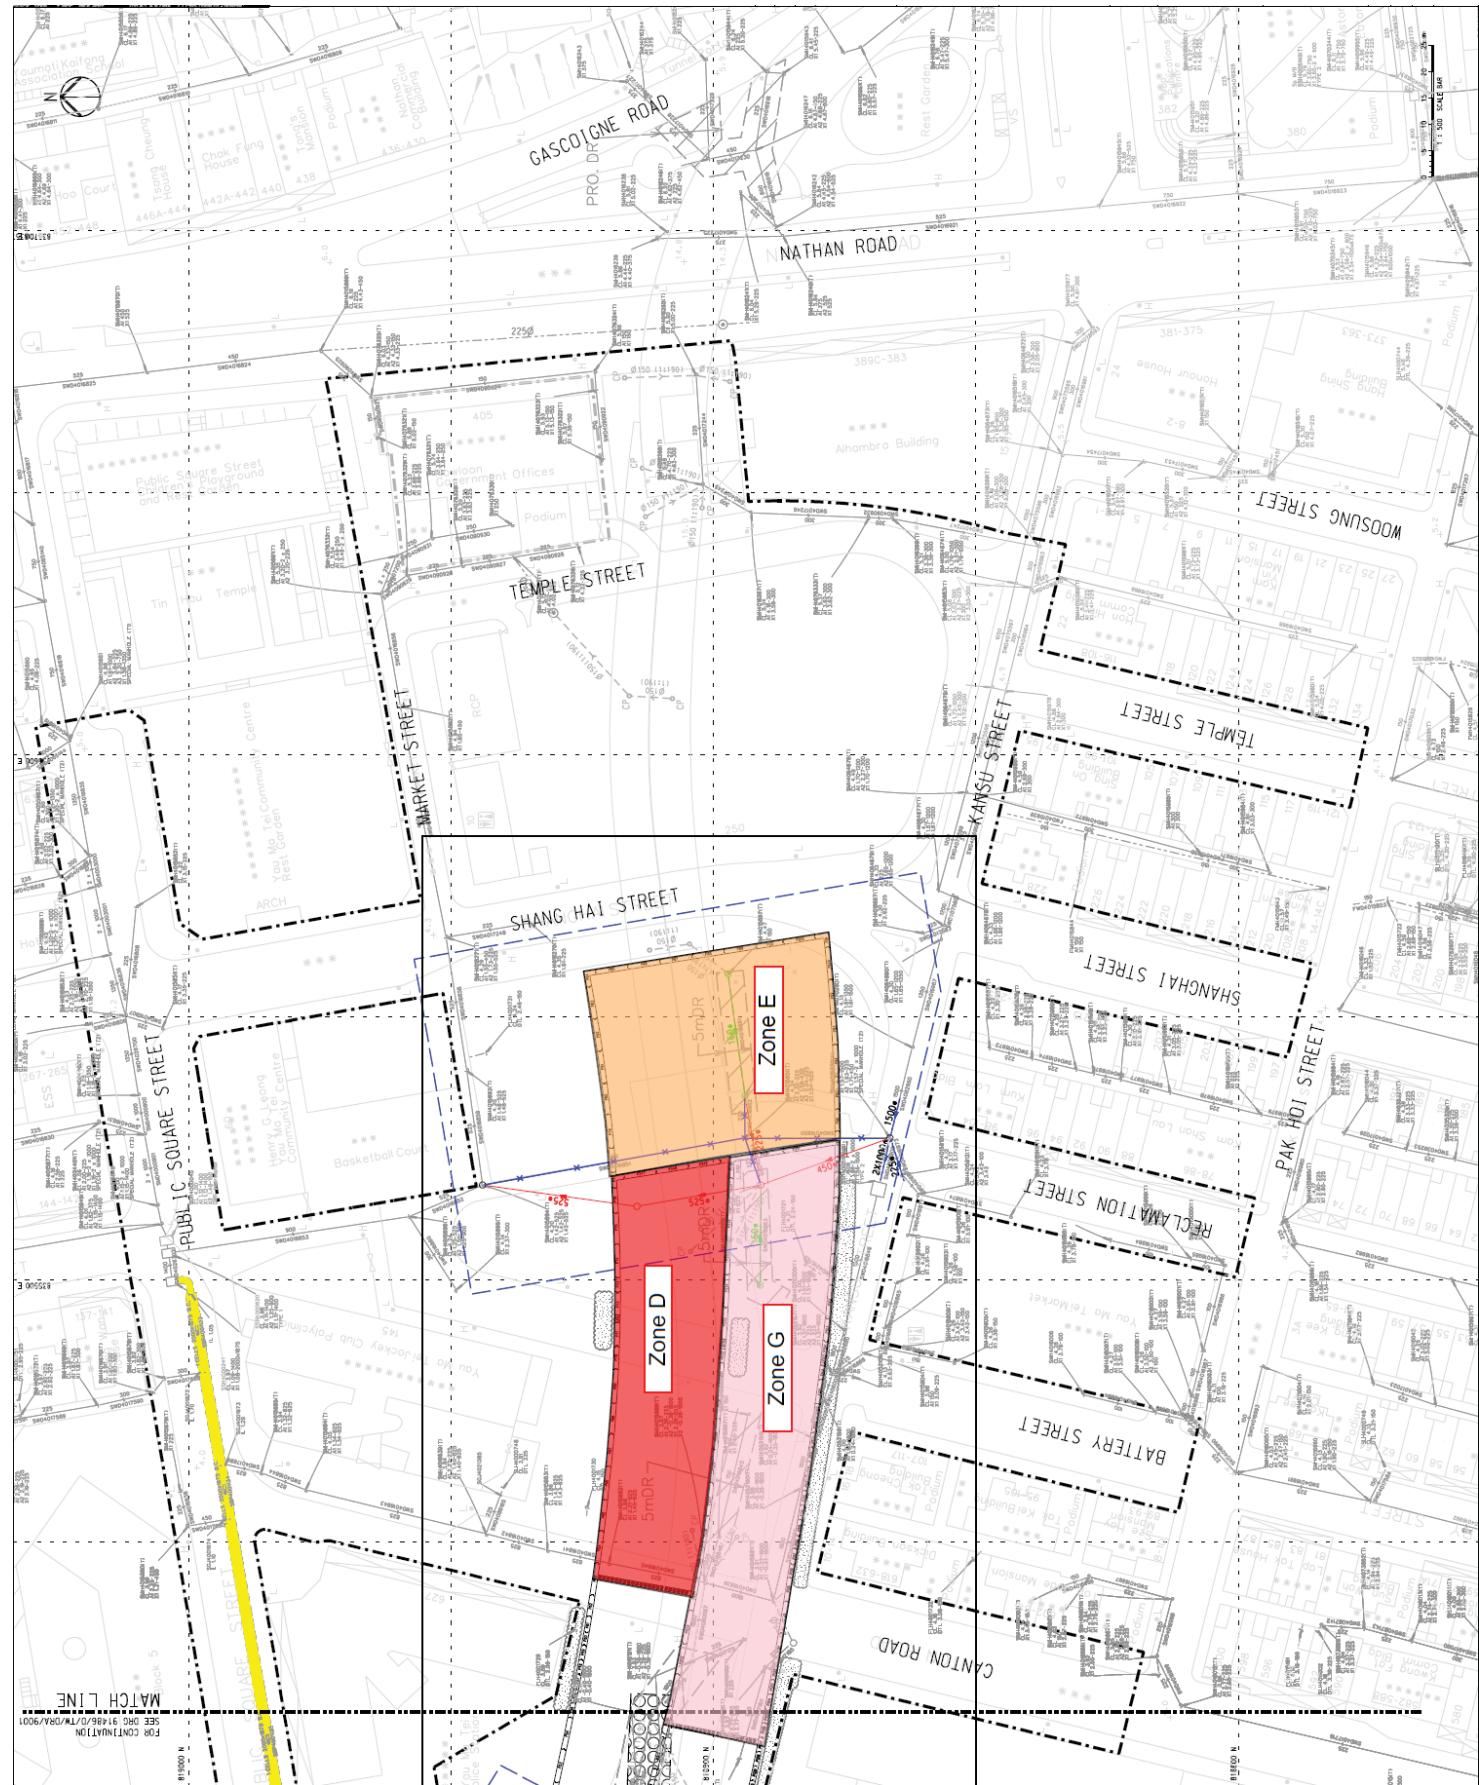
Actions taken / to be taken	As a precautionary measure, the Contractor has implemented some measures in respect to this complaint case in order to minimize nuisance to the public. The measures include regular watering of the construction works area and covering of any excavated or stockpile of dusty material entirely by impervious sheeting.
Remarks	<p>Construction works carried out on 5/1:</p> <ul style="list-style-type: none"> • Architectural Builders Works and Finishes (ABWF) and Electrical and Mechanical (E&M) works for New West Building of Methadone Clinic (MC) • Guide wall and D-wall construction at Zone E (YMTAS) • Construction of drainage works and Backfilling at MCHC • Diaphragm wall construction at Zone A • Drain pipe diversion at Zone A • Jet Grouting Works at C • Utilities Diversion at Zone C • Drilling of hole at YMTPS • Pile lying at Ferry Street <p>Works locations: (next page.)</p>

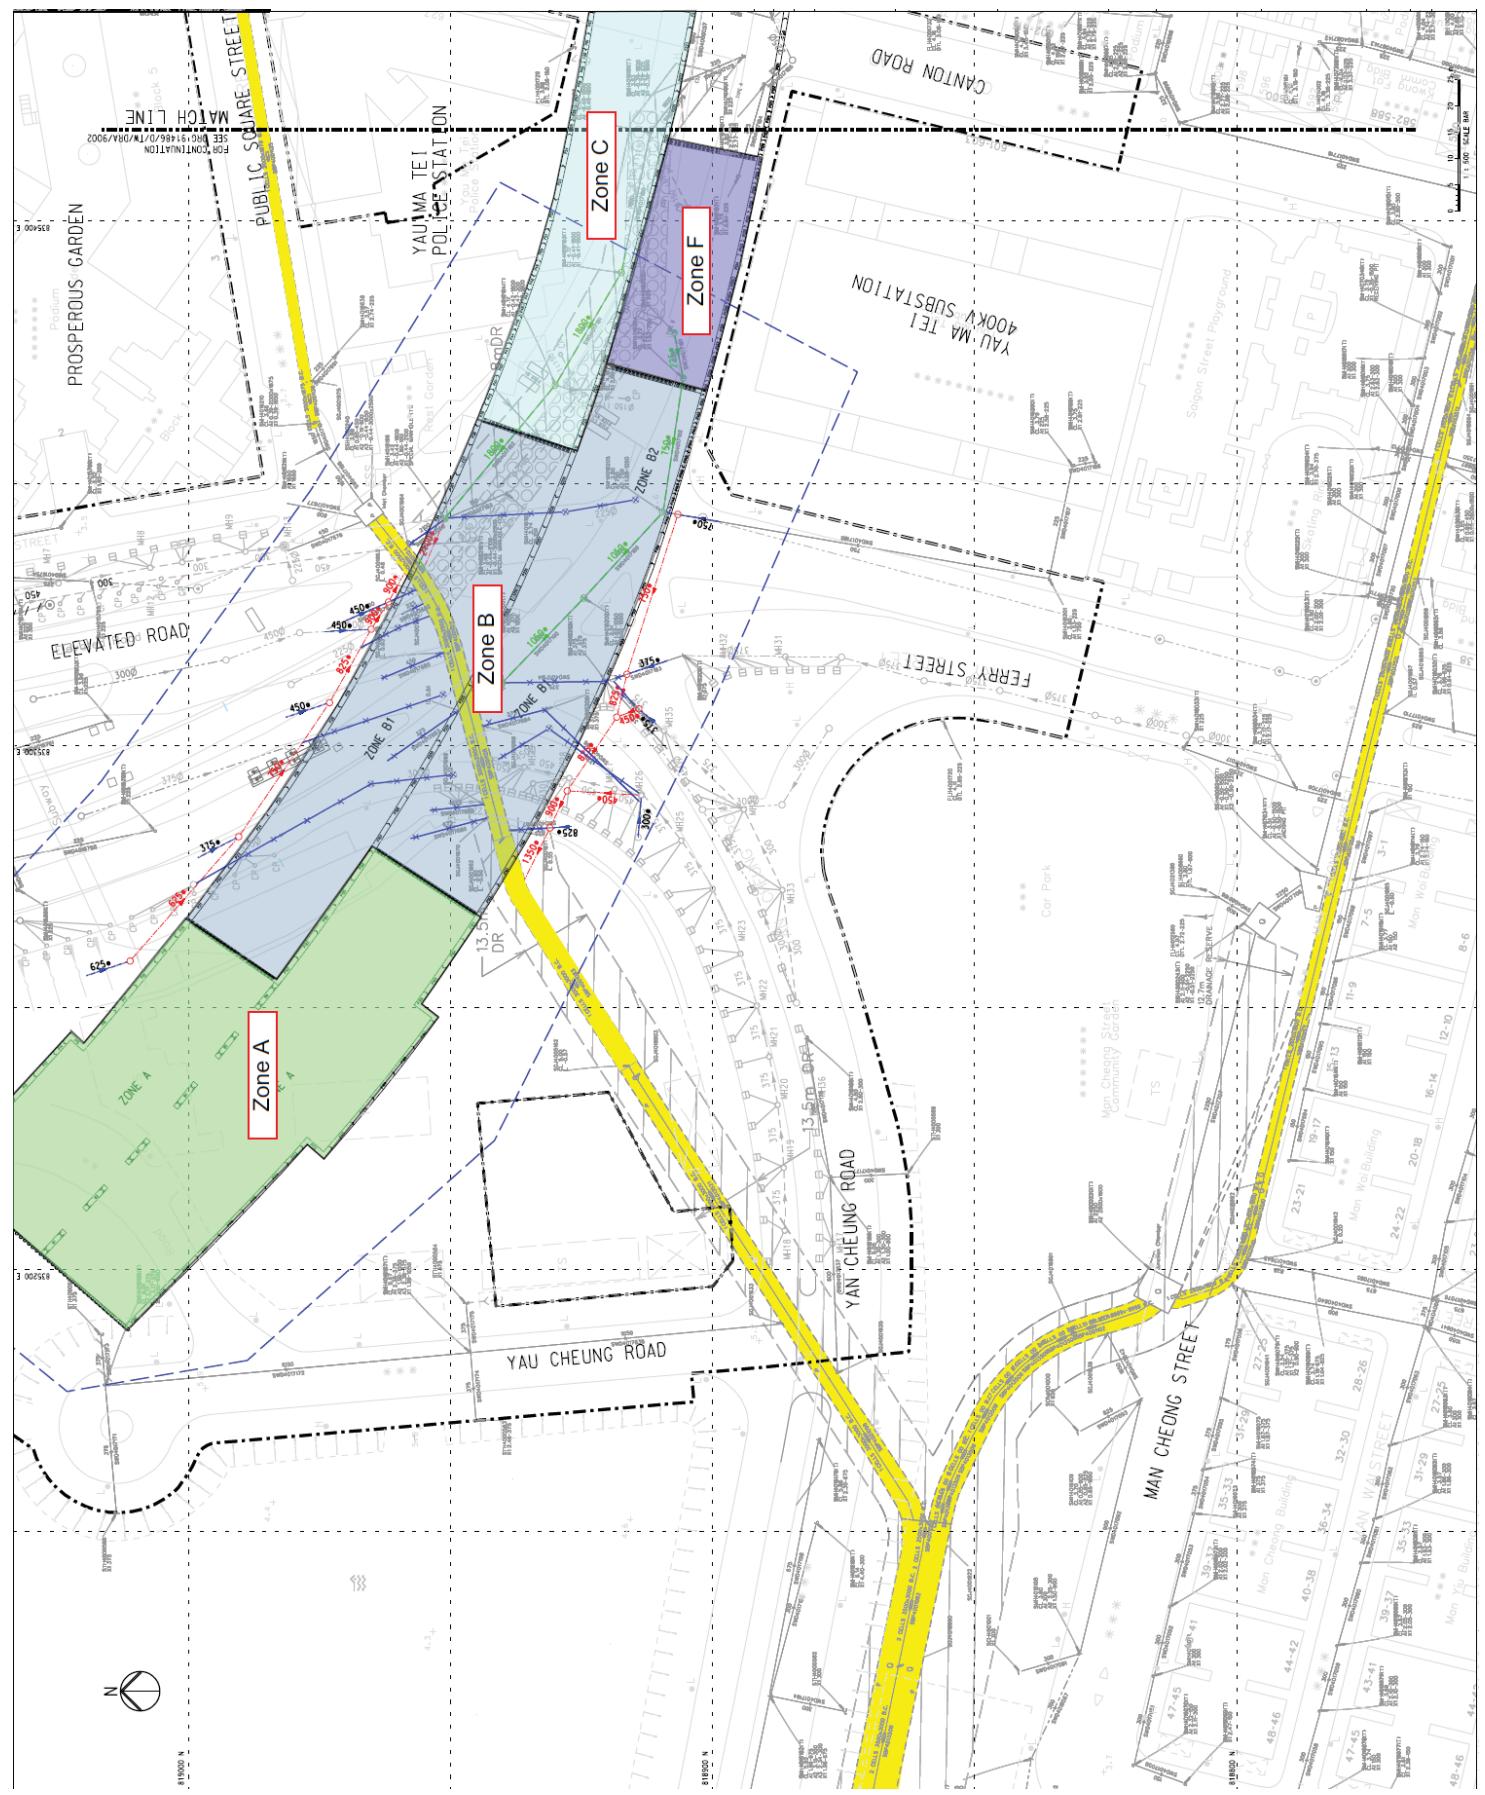
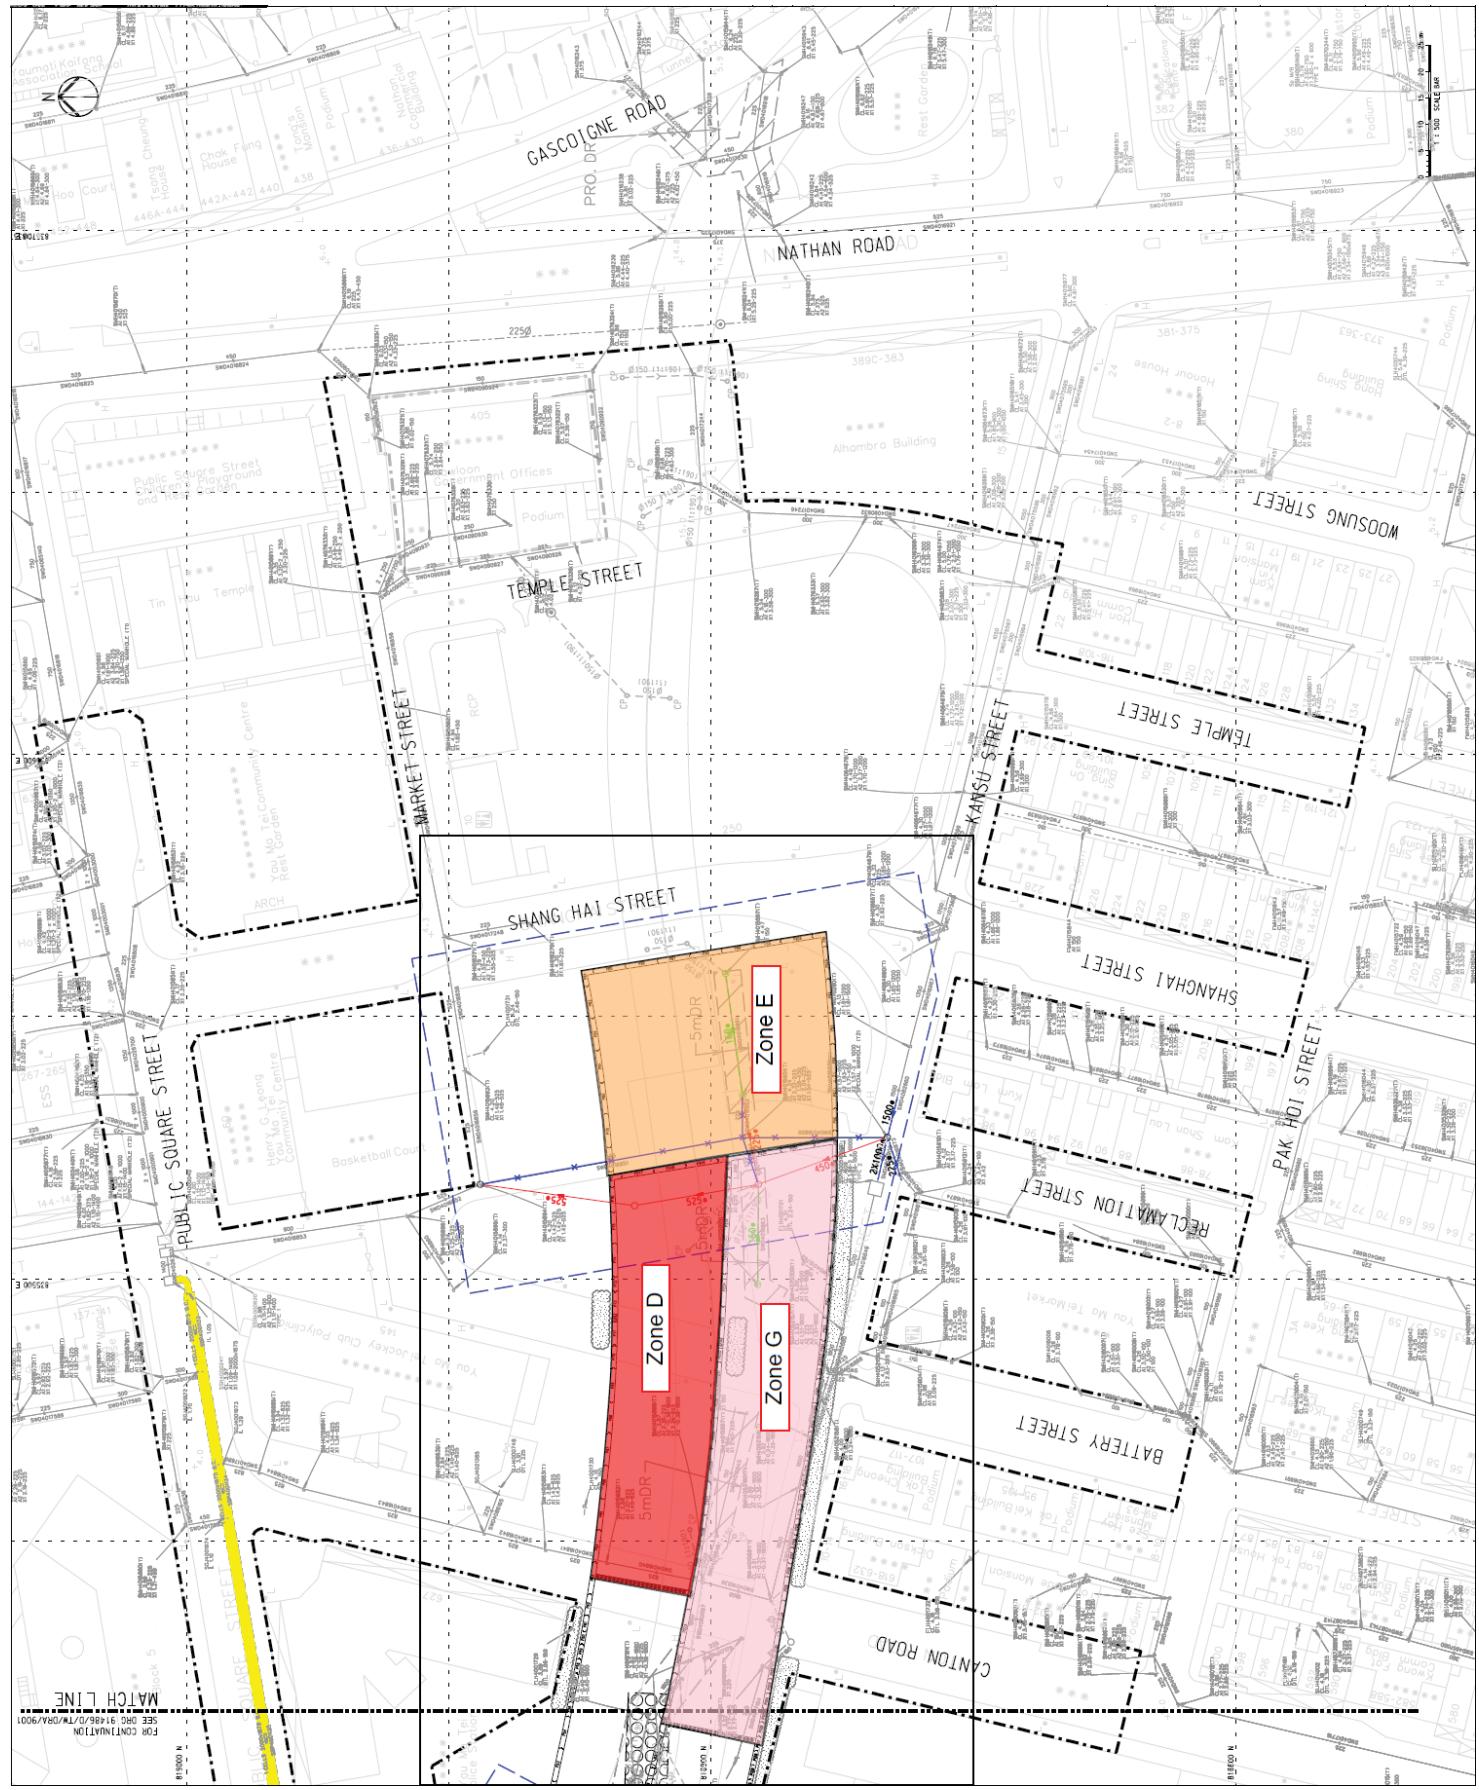
Project	Central Kowloon Route, Yau Ma Tei East Section
Complaint Code	EC004-CKRYMTE20190111_001
Complaint description	Recently, a complaint was referred by EPD on 11 January 2018 about the construction noise generation from CKR construction site. The complainant mentioned that “本人居住於上海街 228 號一單位，近月上海街和甘肅街交界的工程所發出的噪音難以忍受，每天未夠 8 點已經開工直至傍晚 6 點後 星期日除外，工程所發出的低頻噪音令人困擾不已，由於本人是在家工作，這樣直接影響到附近居民的身心健康。本人亦明白工程飛進行不得，但是隔音牆效果強差人意，低頻噪音傳上大下令人不能接受，請當局盡快派人去處理”
Parameter	Construction Noise
Investigation finding	<p>Impact noise monitoring has been carried out on 11 January 2019 and the monitoring results at the nearest monitoring station (Hydan Place) are 64.0, 63.8, 64.0, 65.0, 64.7 and 63.0 dB(A)_{5min}, which are well below the limit levels for the monitoring station at 75 dB(A)_{30min}. It was believed that the construction noise generated on 11/1/2019 did not exceed the noise limit level as stipulated under EM&A manual.</p> <p>Noisy construction activities were restricted to be conducted within 7am to 7pm as per the Contractor's information under the stipulated NCO requirement.</p>

Actions taken / to be taken	As a precautionary measure, the Contractor has implemented some measures in respect to this complaint case in order to minimize nuisance to the public. The measures include rescheduling of the construction works, regular checking on integrity of installed noise barriers and intermittent operation of plants and equipment.
Remarks	<p>Construction works carried out on 11/1:</p> <ul style="list-style-type: none"> • Architectural Builders Works and Finishes (ABWF) and Electrical and Mechanical (E&M) works for New West Building of Methadone Clinic (MC) • Guide wall and D-wall construction at Zone E (YMTAS) • Construction of drainage works and Backfilling at MCHC • Diaphragm wall construction at Zone A • Drain pipe diversion at Zone A • Jet Grouting Works at C • Utilities Diversion at Zone C • Drilling of hole at YMTPS • Pile lying at Ferry Street <p>Works locations: (next page.)</p>
