Central Kowloon Route

Yau Ma Tei West

Contract No. HY/2014/20

January 2024

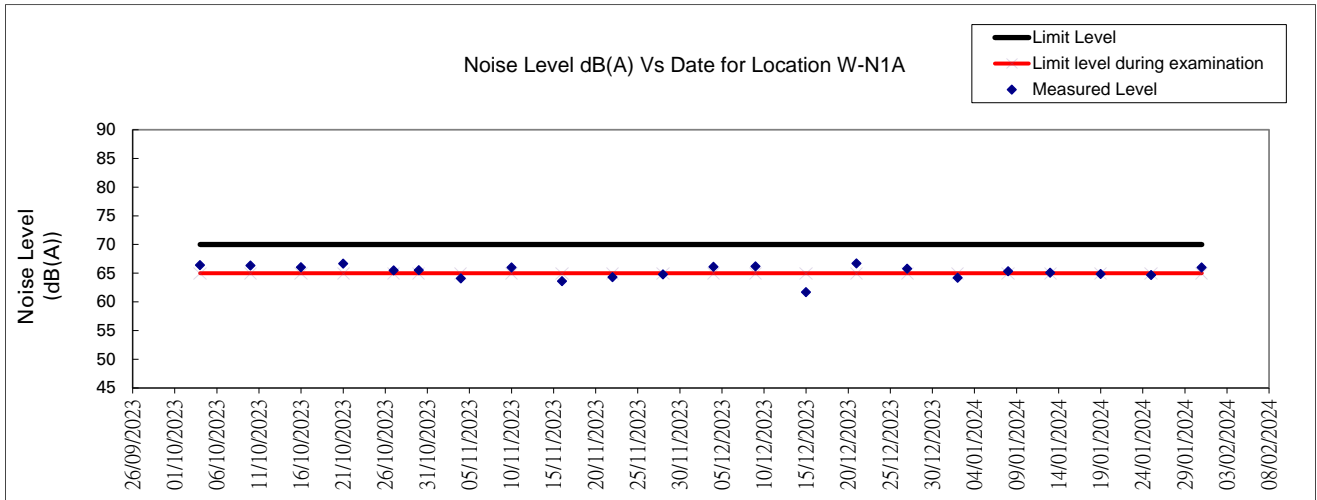
Figure 1: Graphical Illustration of Measured Noise Levels at W-N1A

Date	Weather	Start Time - End Time	L_{eq}	L_{10}	L_{90}	Wind speed (m/s)	Limit level
02/01/2024	Fine	10:51 - 11:21	65.4	71.4	60.5	4.4	75.0
08/01/2024	Fine	10:53 - 11:15	68.3	70.4	65.5	4.9	75.0
13/01/2024	Fine	10:50 - 11:20	65.1	71.7	59.1	2.2	75.0
19/01/2024	Fine	11:03 - 11:33	68.9	71.0	65.3	3.9	75.0
25/01/2024	Fine	10:52 - 11:22	63.3	72.3	60.1	1.4	75.0
31/01/2024	Fine	10:53 - 16:30	68.2	70.2	64.4	2.5	75.0
