Central Kowloon Route

Yau Ma Tei East

Contract No. HY/2014/08

Monthly EM&A Report No. 16

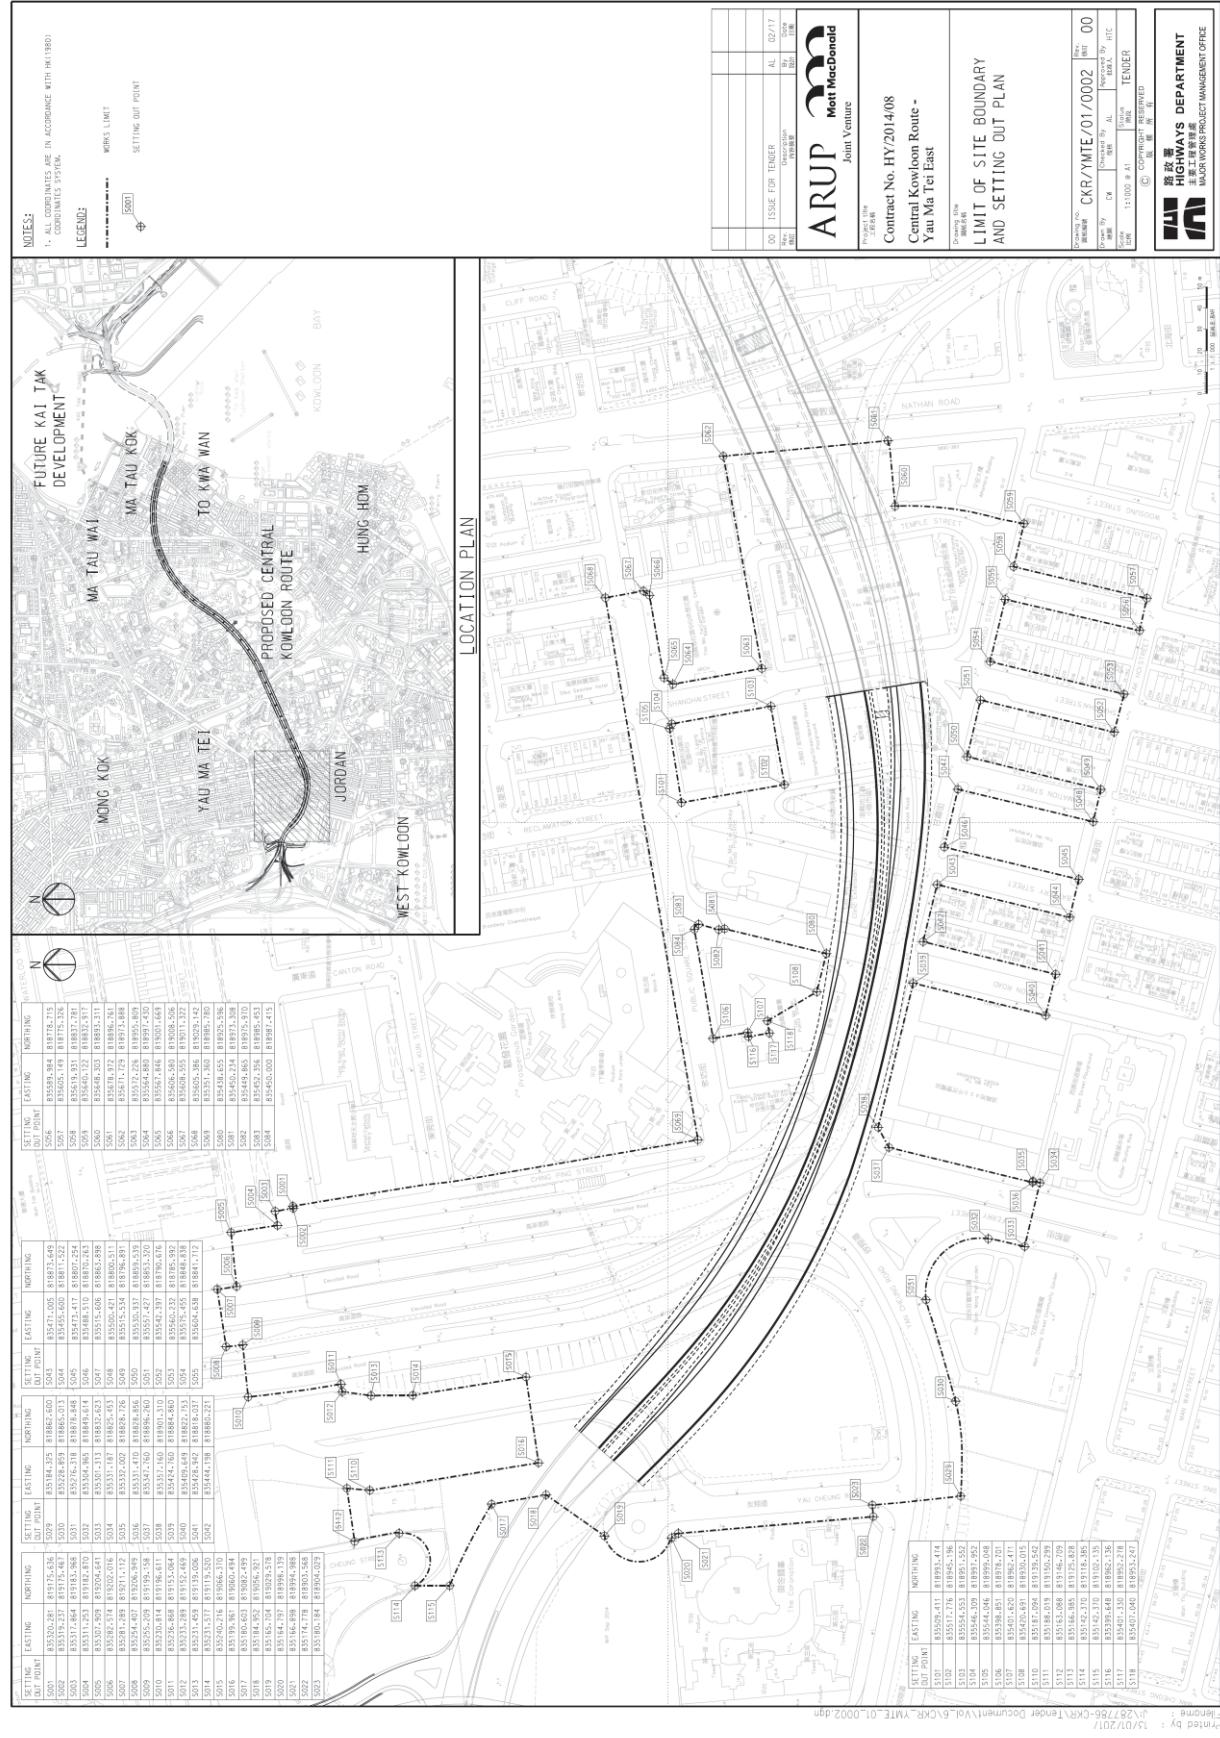
Alignment and Works Area For the Contract No. HY/2014/08

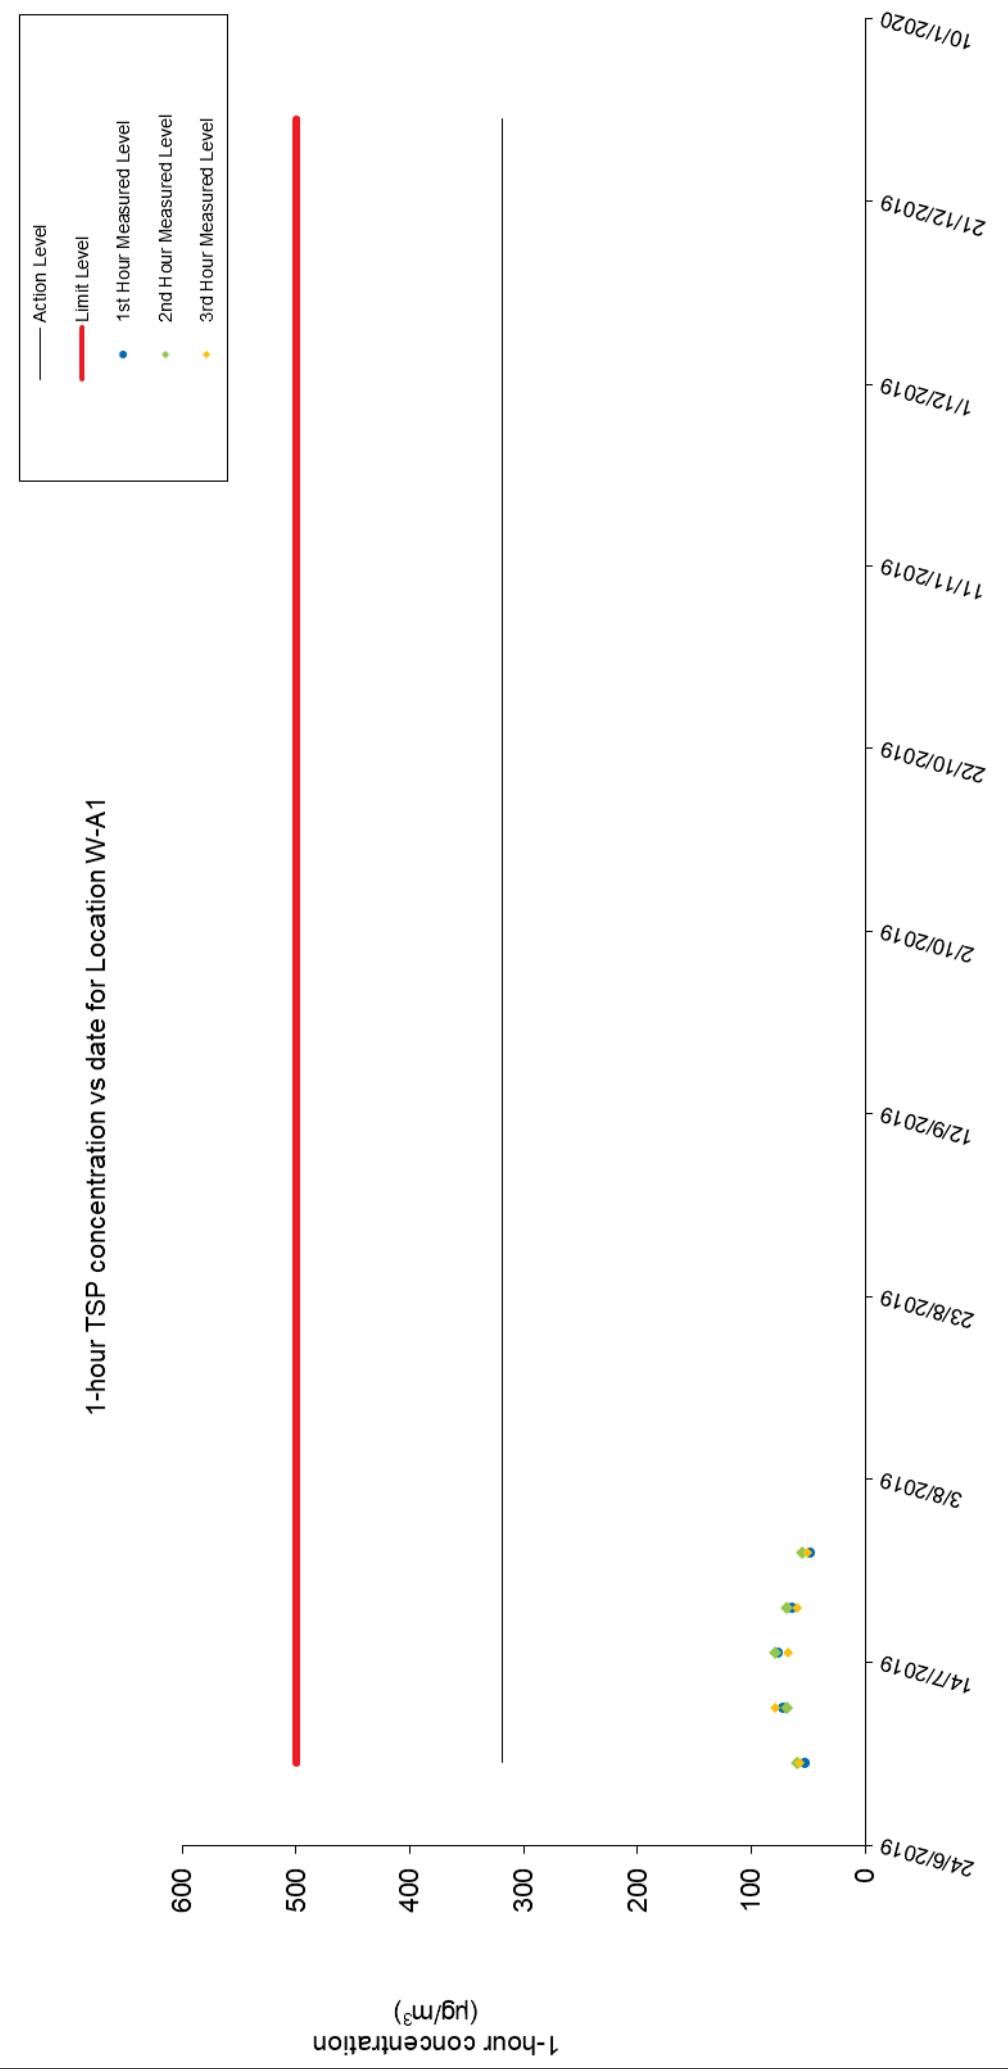
Figure 1: Graphical Illustration of Measured 1-hour TSP ($\mu\text{g}/\text{m}^3$) Levels at W-A1

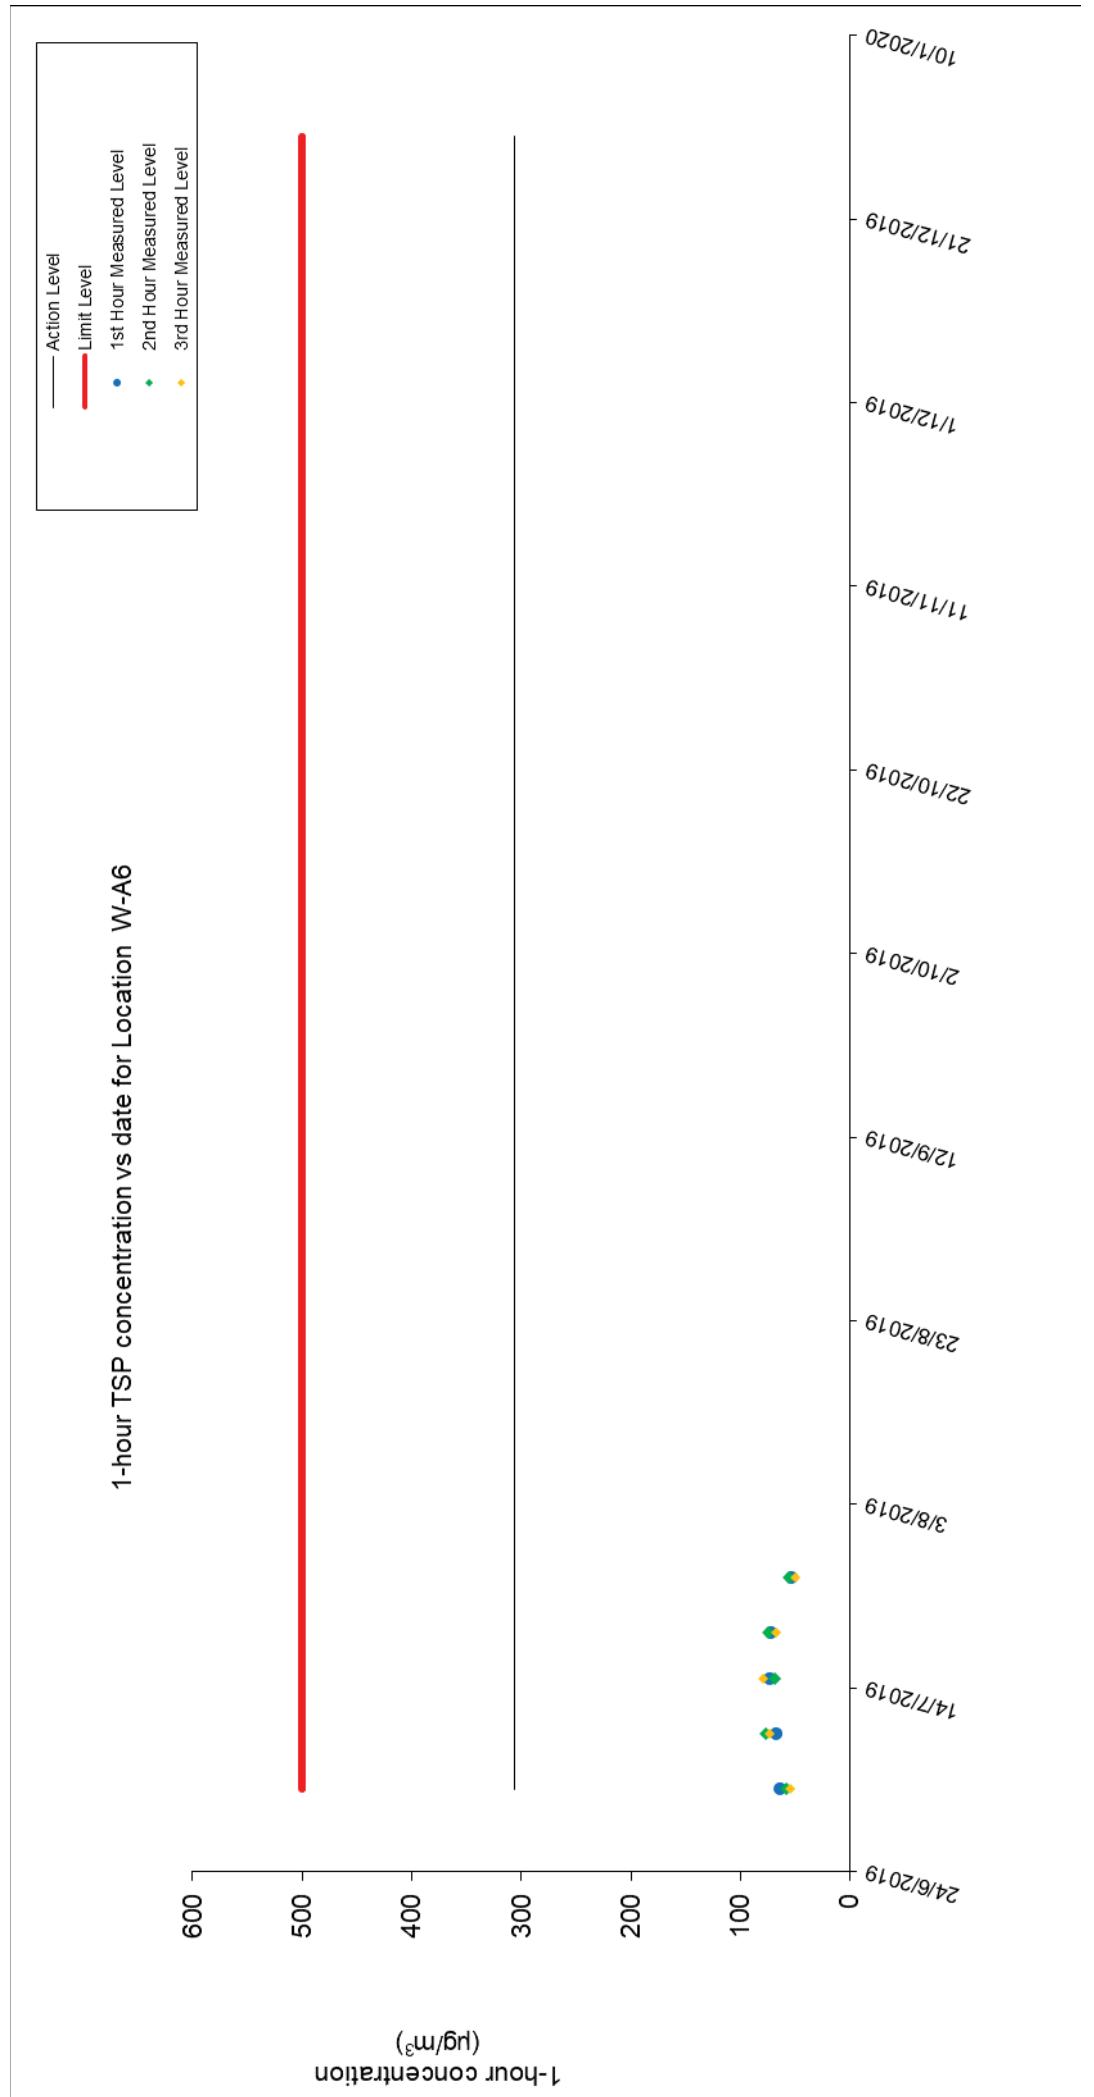
Figure 2: Graphical Illustration of Measured 1-hour TSP ($\mu\text{g}/\text{m}^3$) Levels at W-A6

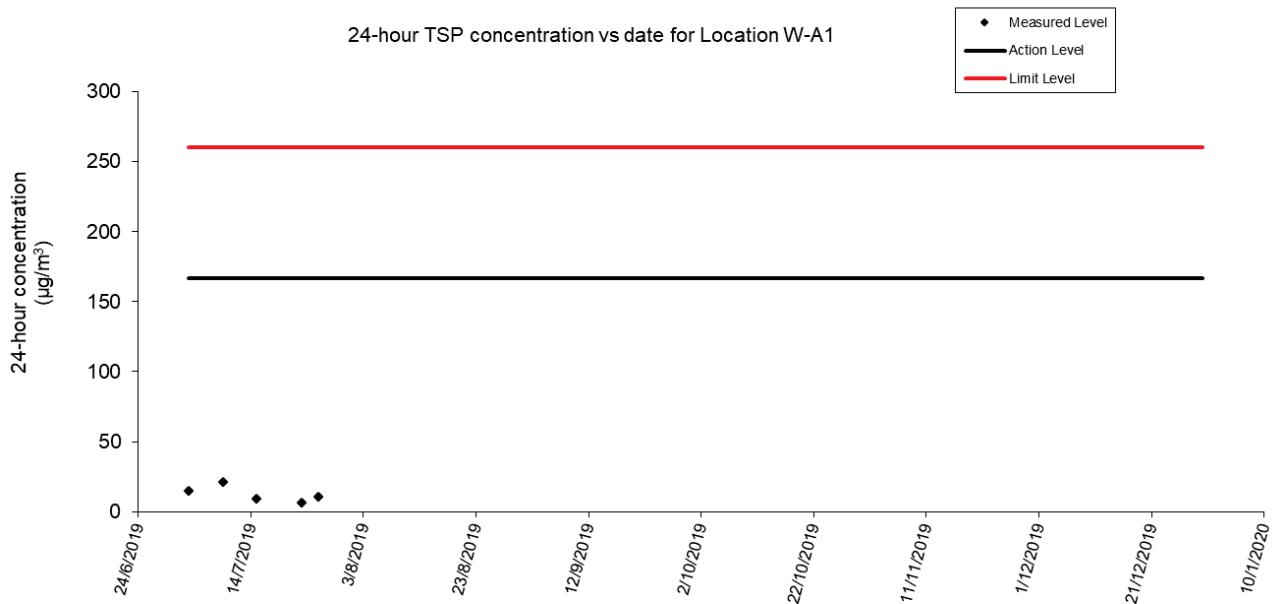
Figure 3: Graphical Illustration of Measured 24-hour TSP ($\mu\text{g}/\text{m}^3$) Levels at W-A1

- 3.6.3. Due to the unstable air flow of high volume sample (HVS) plausibly caused by unstable electricity supply at W-A1, the 24-hour TSP result on 20 July 2019 had been voided.

- 3.6.4. Immediate checking on the air flow rate control component was conducted and the Contractor had been implemented to arrange electricity supply checking. The electricity supply was found normal, monitoring for 24-hour TSP was resumed and an additional monitoring was arranged on 23 July 2019 at W-A1 as a supplement to the voided monitoring result.

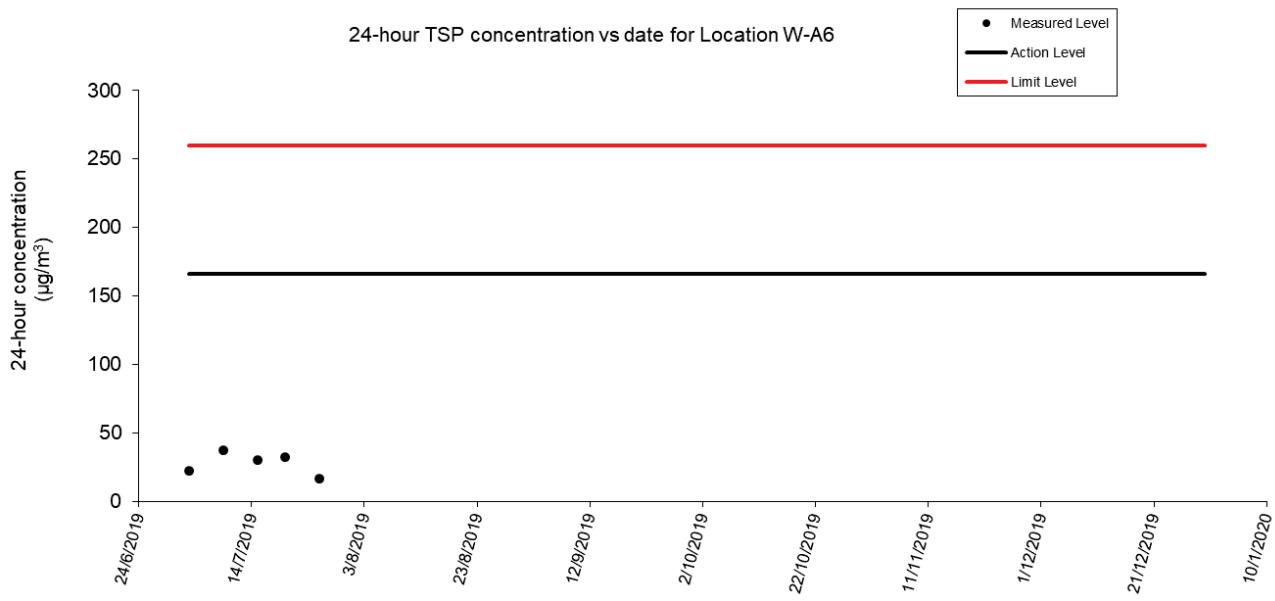
Figure 4: Graphical Illustration of Measured 24-hour TSP ($\mu\text{g}/\text{m}^3$) Levels at W-A6

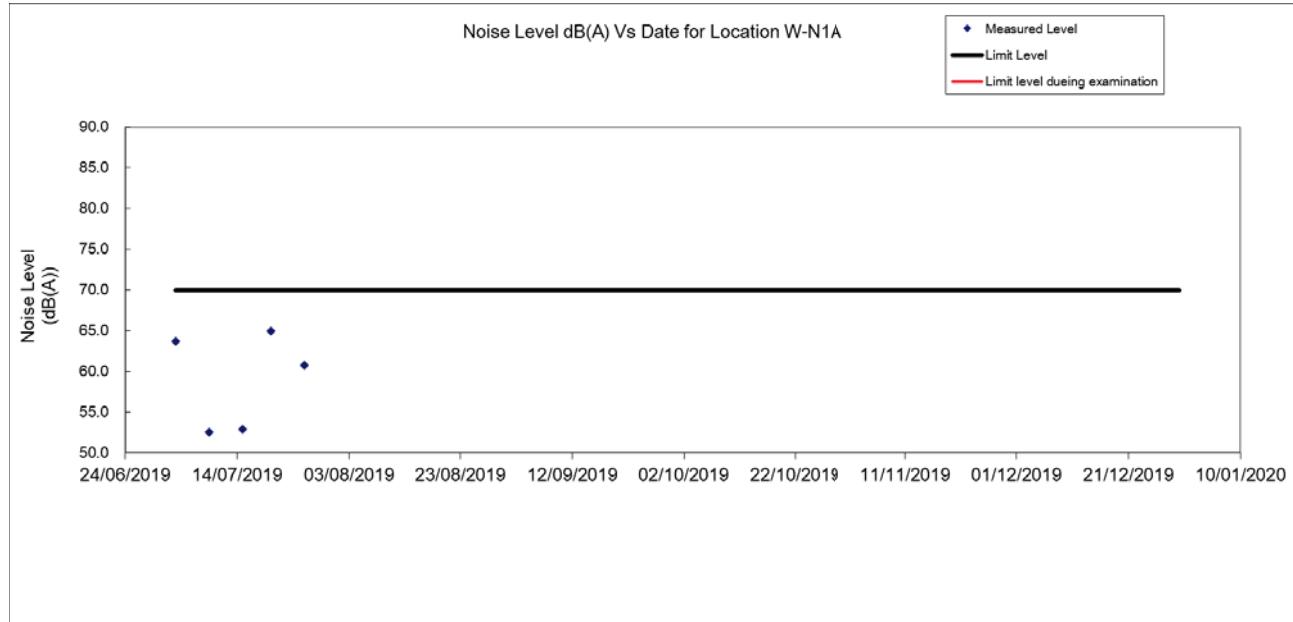
Figure 1: Graphical Illustration of Measured Noise Levels at W-N1A

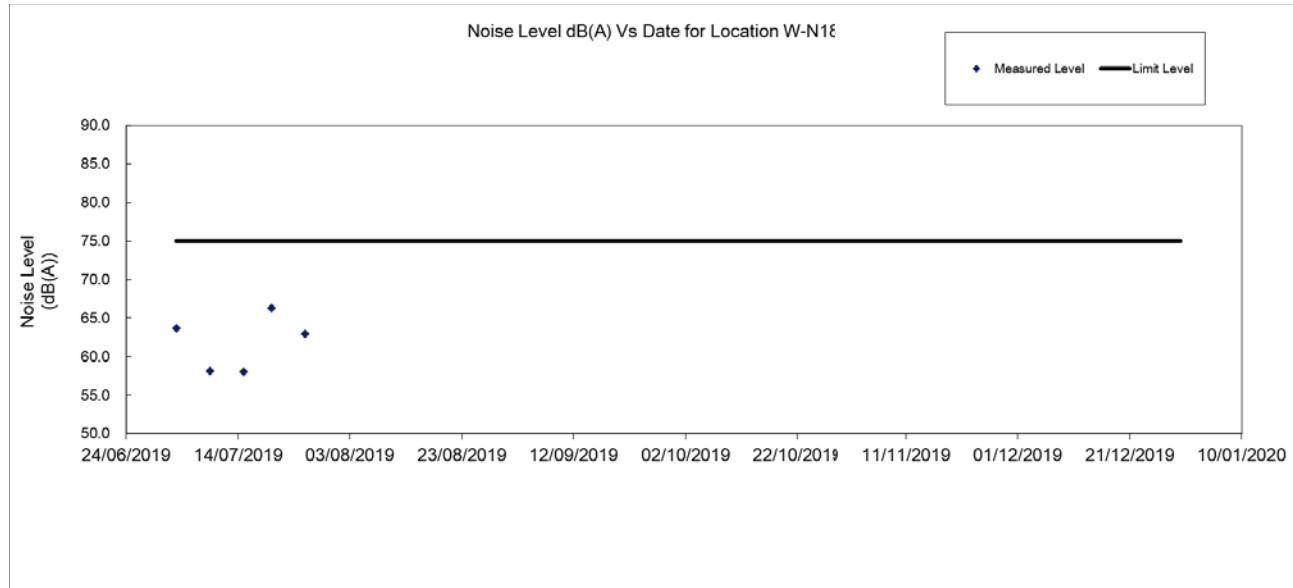
Figure 2: Graphical Illustration of Measured Noise Levels at W-N18

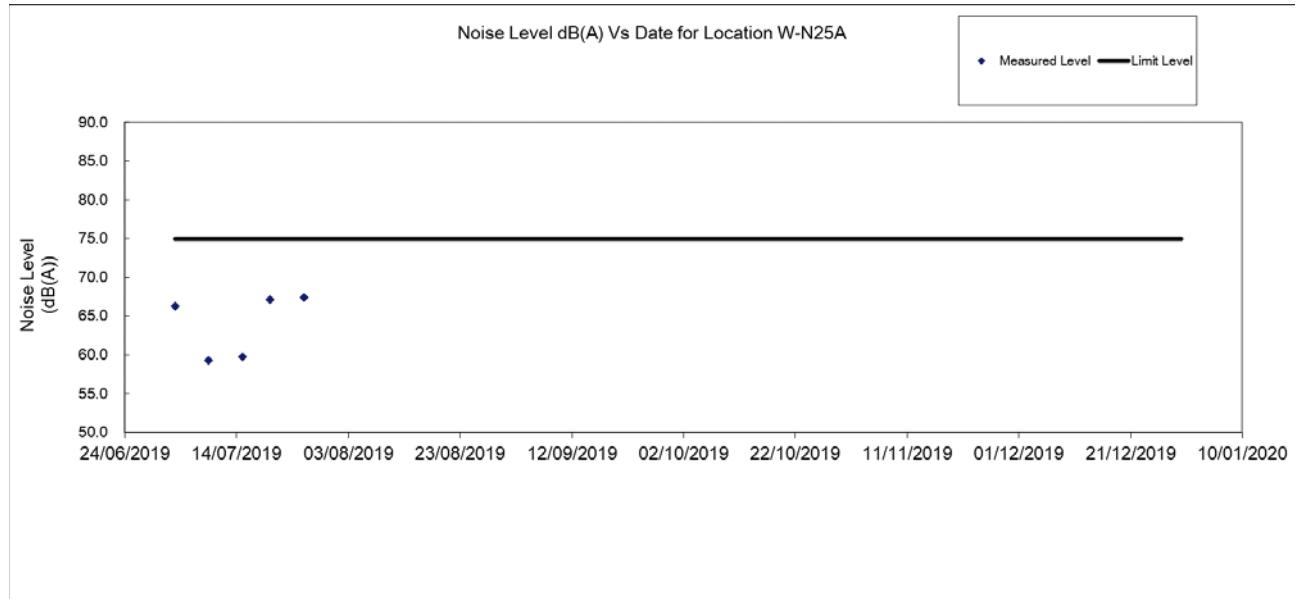
Figure 3: Graphical Illustration of Measured Noise Levels at W-N25A

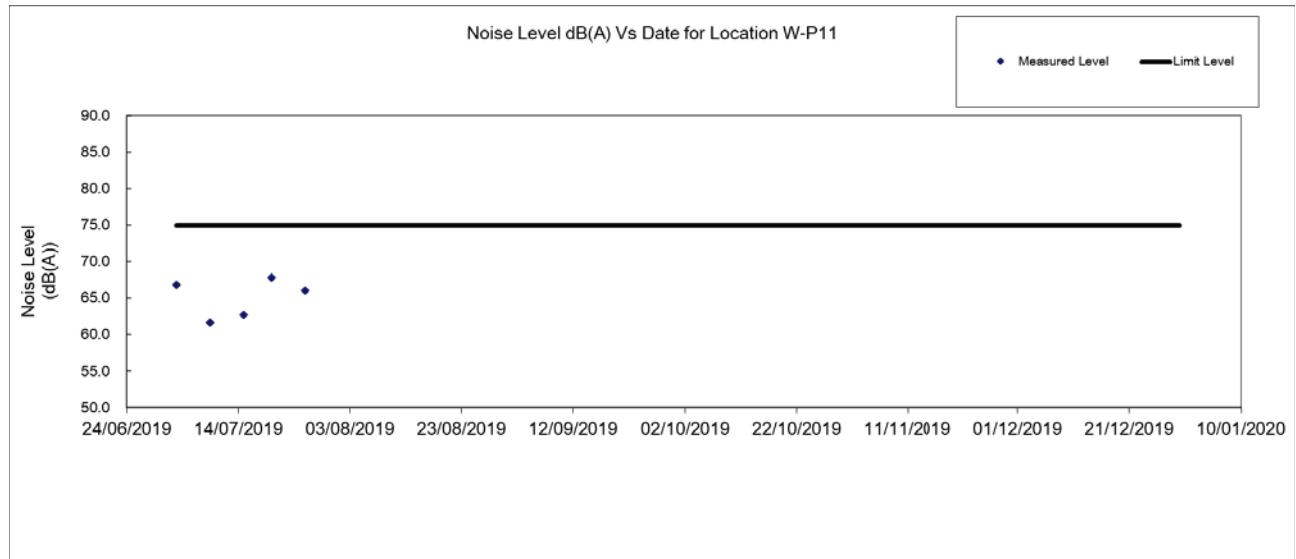
Figure 4: Graphical Illustration of Measured Noise Levels at W-P11
