Central Kowloon Route

Yau Ma Tei West

Contract No. HY/2014/20

Document/ Plan to be Certified / Verified:	Monthly EM&A Report No.22 (November 2020)
Date of Report:	9 December 2020 (Rev. 1)
Date received by IEC:	9 December 2020

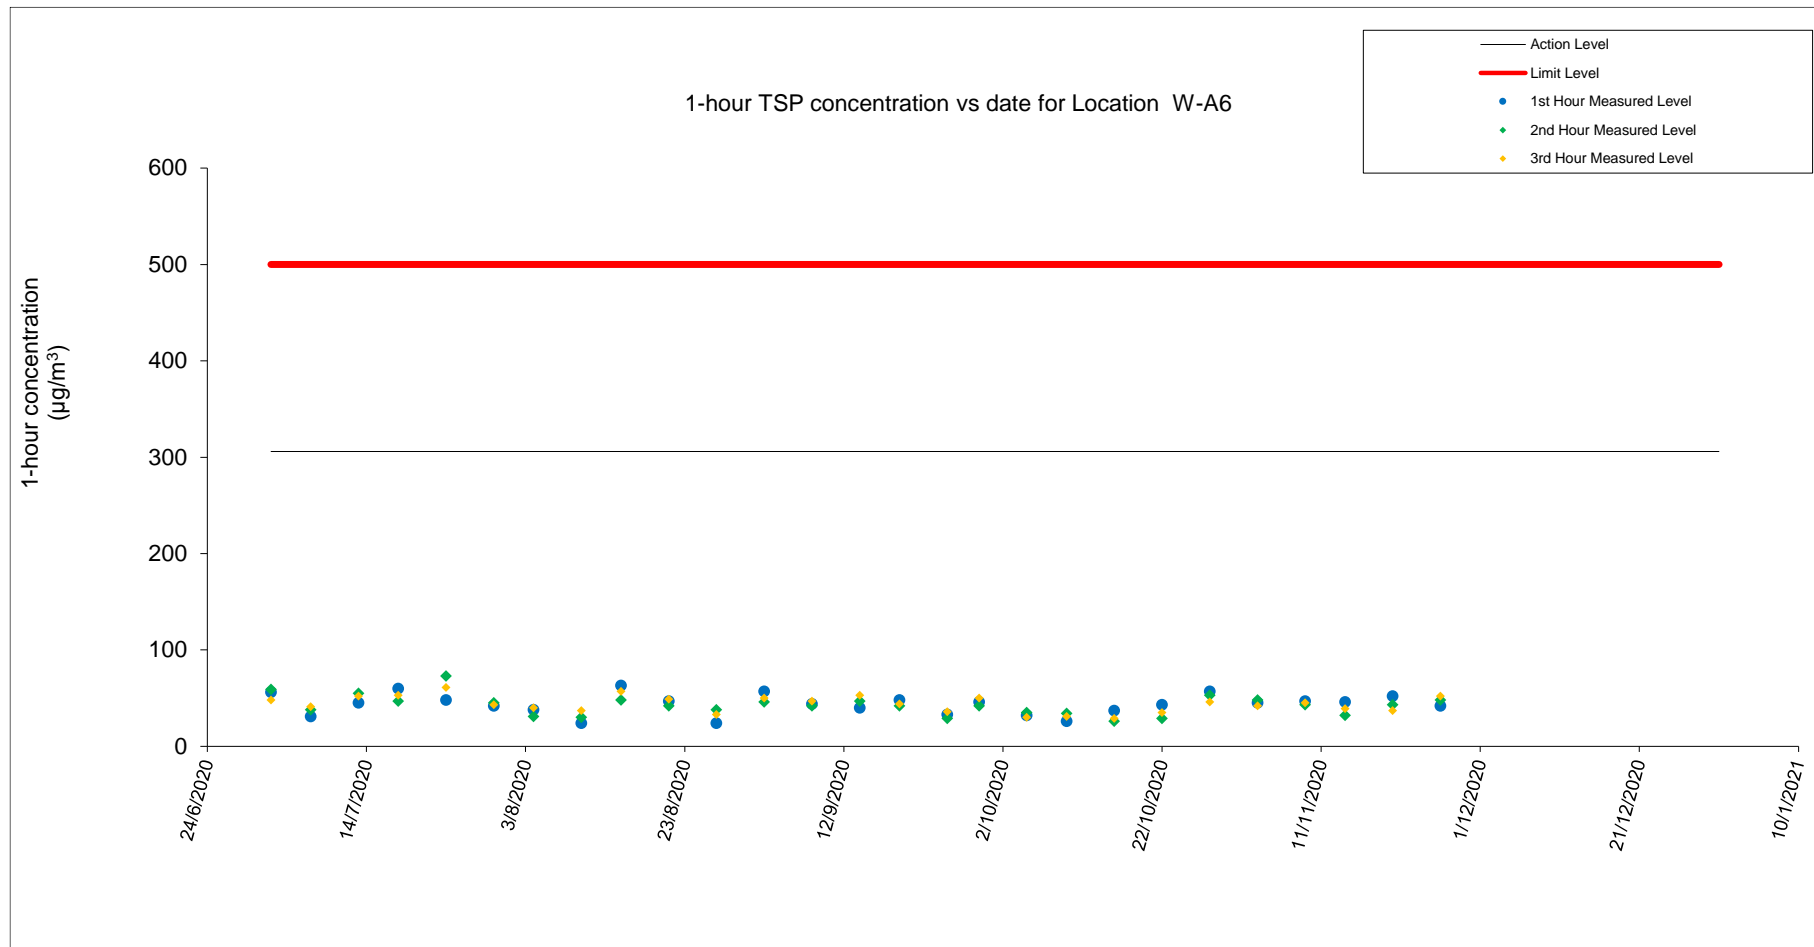
Figure 2: Graphical Illustration of Measured 1-hour TSP ($\mu\text{g}/\text{m}^3$) Levels at W-A6

Location: Man Cheong Building (W-A6)
Monitoring date: 3, 9, 14, 20, 26 November 2020
Parameter : TSP 1-hour
Other Factors Nearby traffic

3.6.3. The results for 1-hour TSP and 24-hour TSP are summarized in Table 3.7 and Table 3.8. The measurement data and details of influencing factors such as weather conditions and site observation are presented in Appendix L.

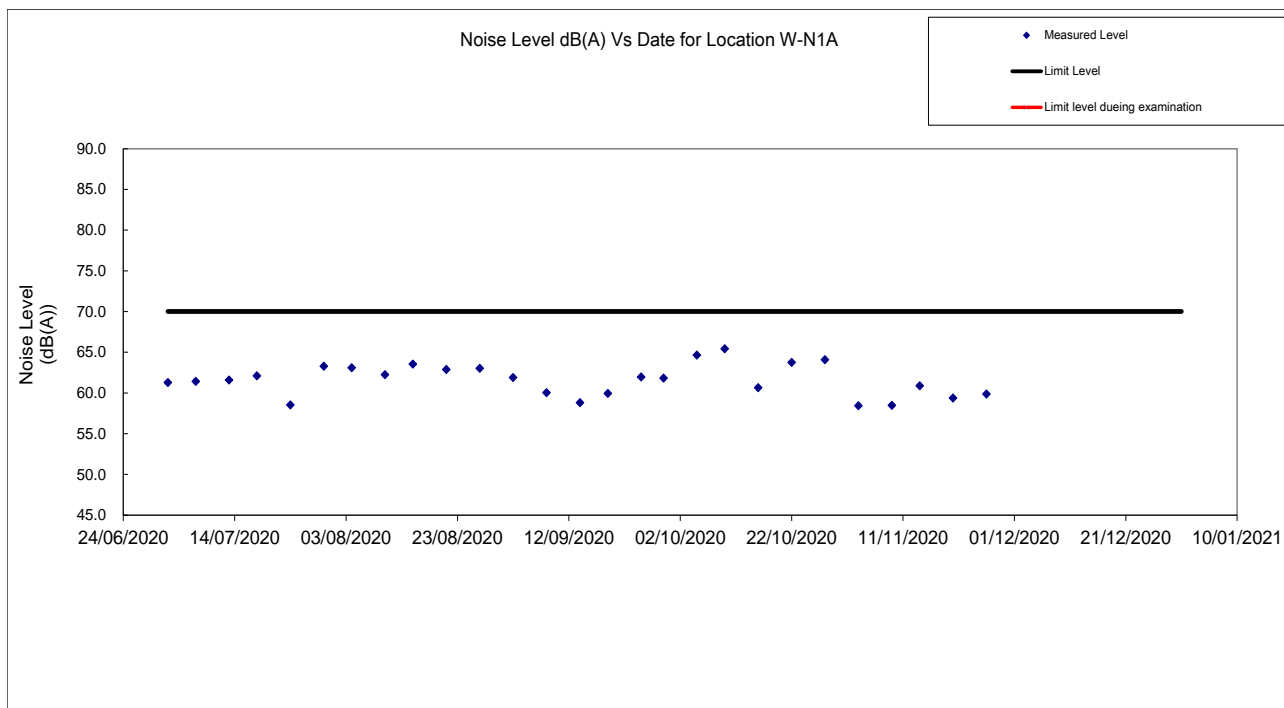
Figure 1: Graphical Illustration of Measured Noise Levels at W-N1A

- Remarks:
- # If works are to be carried out during restricted hours, the conditions in the construction noise permit by the Noise Control Authority have to be followed.
 - Limit level was 65dB(A) during examination period from 12 to 17 November 2020 at W-N1A.
