EP-457/2013/D Central Kowloon Route Yau Ma Tei West Contract No. HY/2014/20 &

Buildings, Electrical and Mechanical Works Contract No. HY/2019/13 (Yau Ma Tei West area) November 2021

Independent Environmental Checker Verification

Monthly EM&A Report No. 34

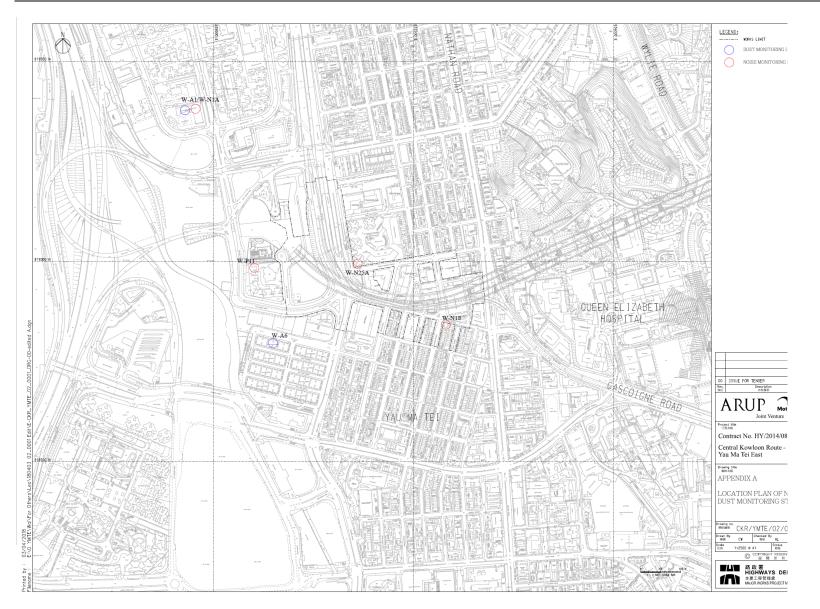
Appendix K Location Plan of Noise and Air Quality Monitoring Station

3.4.1. During the site visit, both of the original proposed dust monitoring locations were rejected due to the condition at The Coronation was not favorable for monitoring and the access was declined by the management office of Hong Kong Community College (HKCC) of PolyU. Two alternative air monitoring stations Yau Ma Tel Catholic Primary School (Hoi Wang Road) and Man Cheong Building had been proposed by ET and approved by IEC. 2 designated air monitoring locations were identified and agreed with IEC and EPD. Details of air monitoring stations are described in Table 3.3. The location plan of air quality monitoring stations is shown in Appendix K.

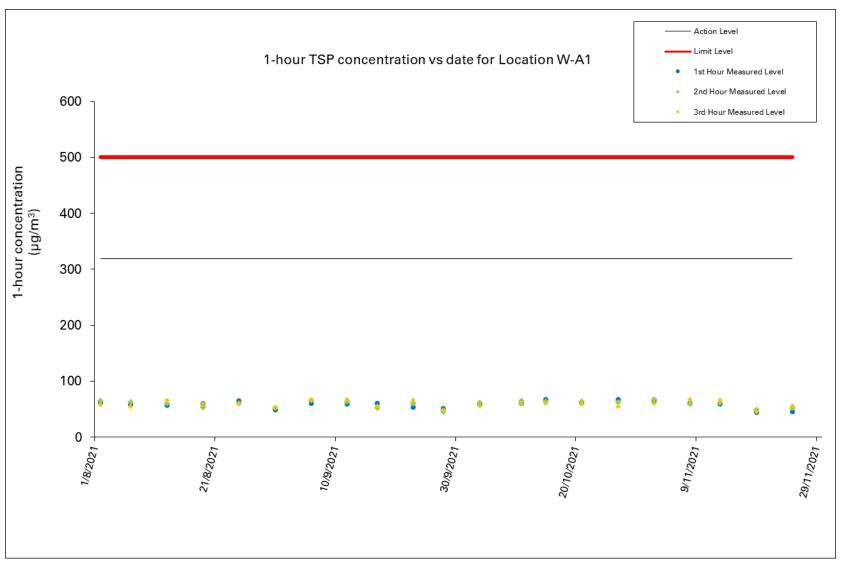
Figure 1: Graphical Illustration of Measured 1-hour TSP (μ g/m³) Levels at W-A1

1	-hour TSP (µ	ug/m ³)	
Date	Weather	Start Time		st Hour μg/m³)	2 nd Hour (μg/m ³)	3 rd Hour (μg/m ³)
02/11/2021	Fine	9:24		67	61	64
08/11/2021	Sunny	11:19		68	73	65
13/11/2021	Sunny	9:34		62	69	70
19/11/2021	Sunny	9:32		56	50	52
25/11/2021	Sunny	13:31		71	68	64
]	Minimum: 50	ug/m ³		Maximum: 73 µg	g/m ³

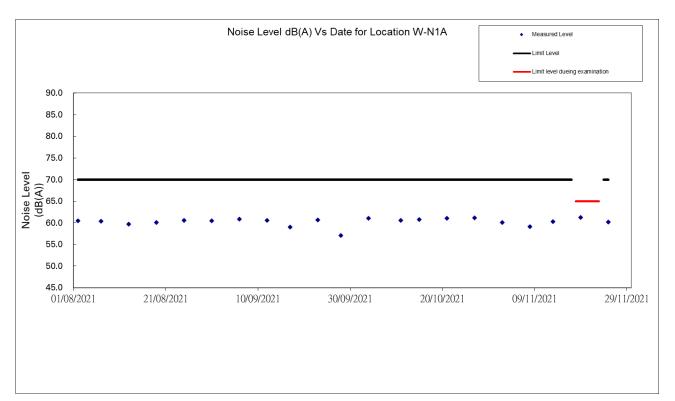
Figure 1: Graphical Illustration of Measured Noise Levels at W-N1A

Remark: Examination was held from 18/11 to 23/11 at W-N1A so the limit level on 19/11 was 65 dB(A). Limit levels for other monitoring days were 70 dB(A).

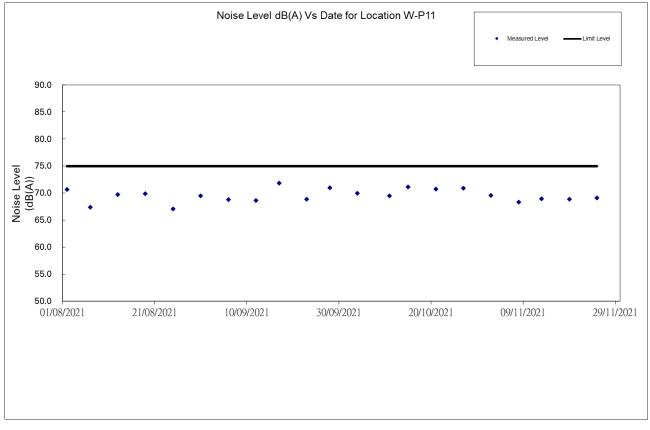
Figure 4: Graphical Illustration of Measured Noise Levels at W-P11

Date	Weather	Start Time	-	End Time	I	L_{10}	L90	Wind
Date	weather	Start Time	-	End Time	Leq	L10		speed (m/s)
02/11/2021	Fine	11:14	-	11:44	69.5	72.5	65.2	3.6
08/11/2021	Sunny	10:27	-	10:57	68.3	70.4	65.5	3.3
13/11/2021	Sunny	12:38	-	13:08	68.9	71.5	65.6	1.9
19/11/2021	Sunny	11:40	-	13:30	68.9	71.0	65.3	3.3
25/11/2021	Sunny	16:29	-	16:59	69.1	72.9	66.8	1.7
