Central Kowloon Route

Yau Ma Tei West

Contract No. HY/2014/20

Monthly EM&A Report No. 57

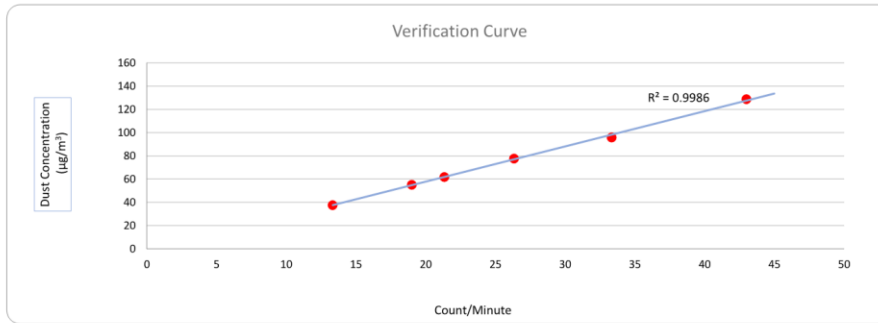
Linear Regression of y on x

Slope, K factor:	3.0313	Intercept:	-2.8495	*Correlation Coefficient, R:	0.9993
Verification Test Result:	Strong Correlation, Results were accepted.			* If the Correlation Coefficient, R is <0.5. Checking and Re-verification are required.

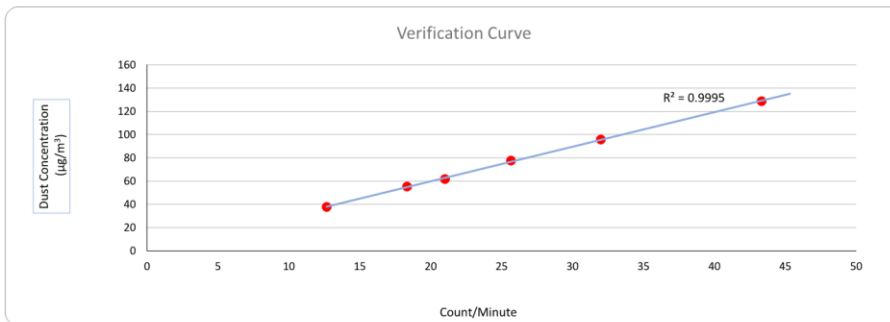
Linear Regression of y on x

Slope, K factor:	2.9749	Intercept:	0.2715	*Correlation Coefficient, R:	0.9998
Verification Test Result: <u>Strong Correlation, Results were accepted.</u>			* If the Correlation Coefficient, R is <0.5. Checking and Re-verification are required.

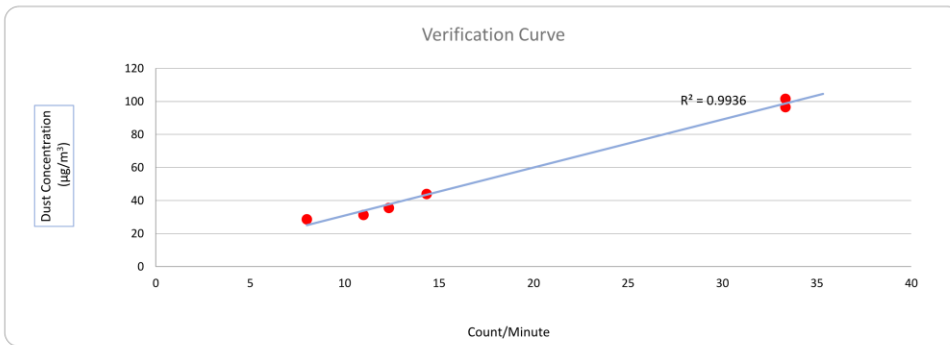
Linear Regression of y on x

Slope, K factor:	<u>2.9083</u>	Intercept:	<u>1.8061</u>	*Correlation Coefficient, R:	<u>0.9968</u>
Verification Test Result: <u>Strong Correlation, Results were accepted.</u>			* If the Correlation Coefficient, R is <0.5. Checking and Re-verification are required.

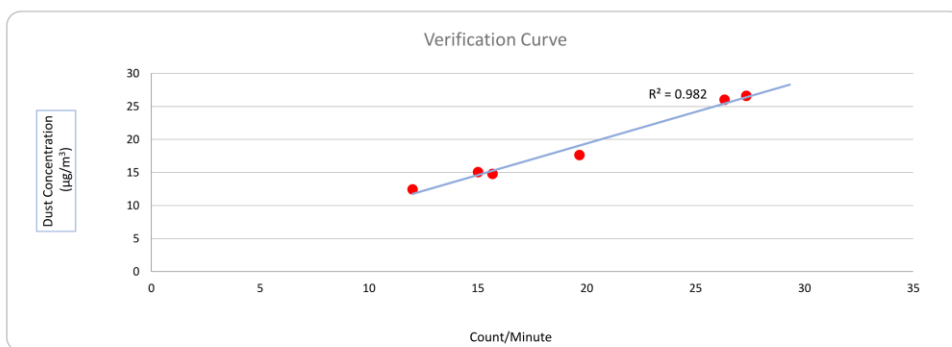
Linear Regression of y on x

Slope, K factor:	0.9545	Intercept:	0.2986	*Correlation Coefficient, R:	0.9910
Verification Test Result: Strong Correlation, Results were accepted.			* If the Correlation Coefficient, R is <0.5. Checking and Re-verification are required.
