Central Kowloon Route

Central Tunnel

Contract No. HY/2018/08

Monthly EM&A Report No. 13 (September 2020)

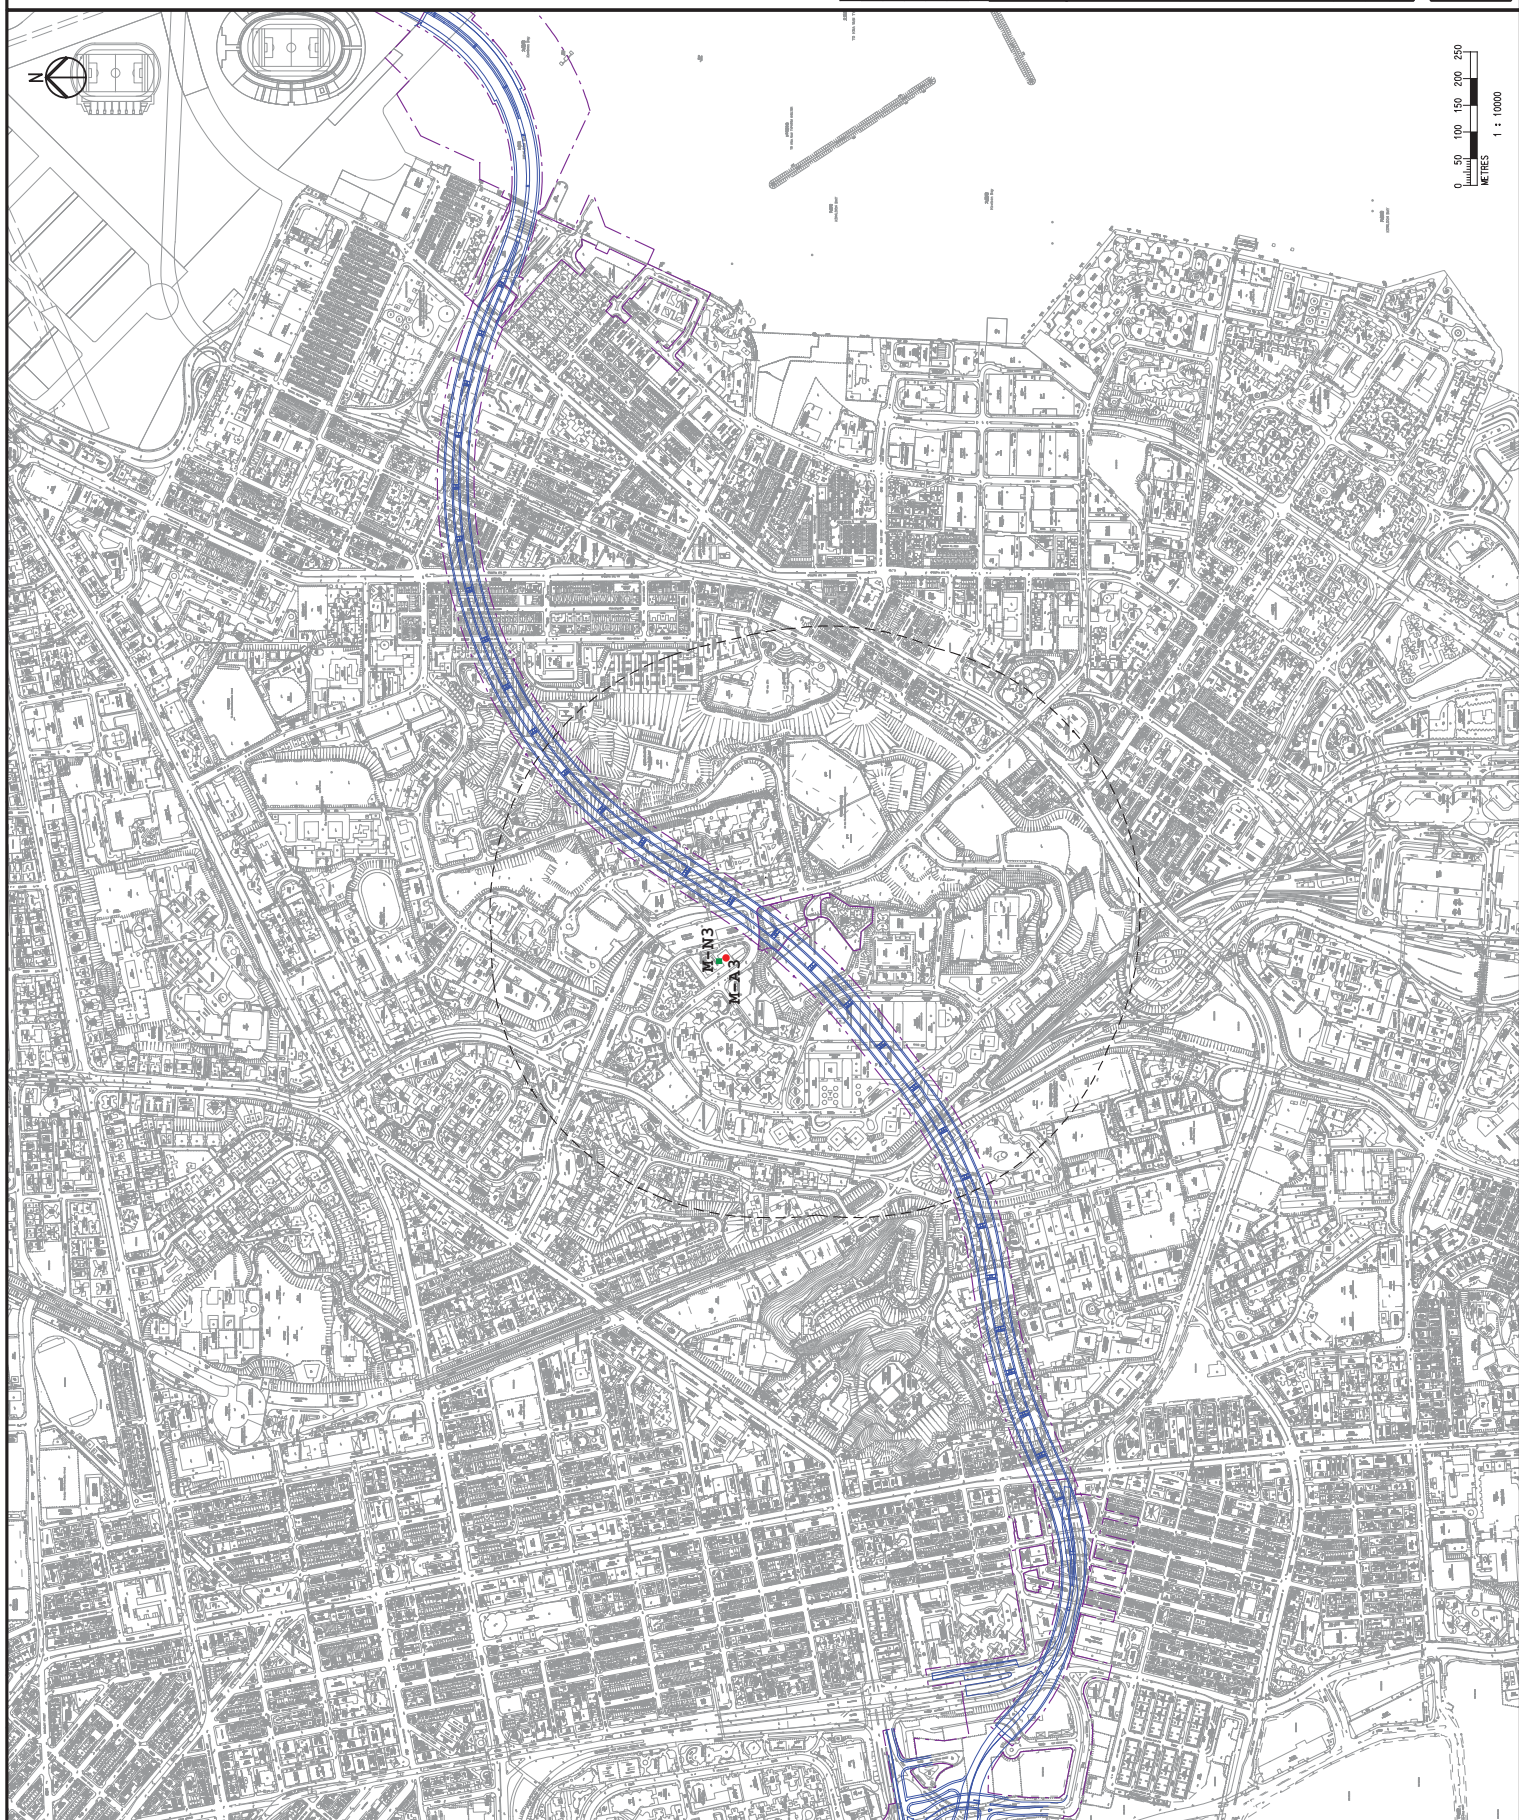
Figure 2.1

The Location of the Construction
Dust and Noise Monitoring
Stations
