Vol. 4 of 5 EP-457/2013/D Central Kowloon Route Yau Ma Tei West Contract No. HY/2014/20 &

Buildings, Electrical and Mechanical Works

Central Kowloon Route

Monthly EM&A Report No. 41

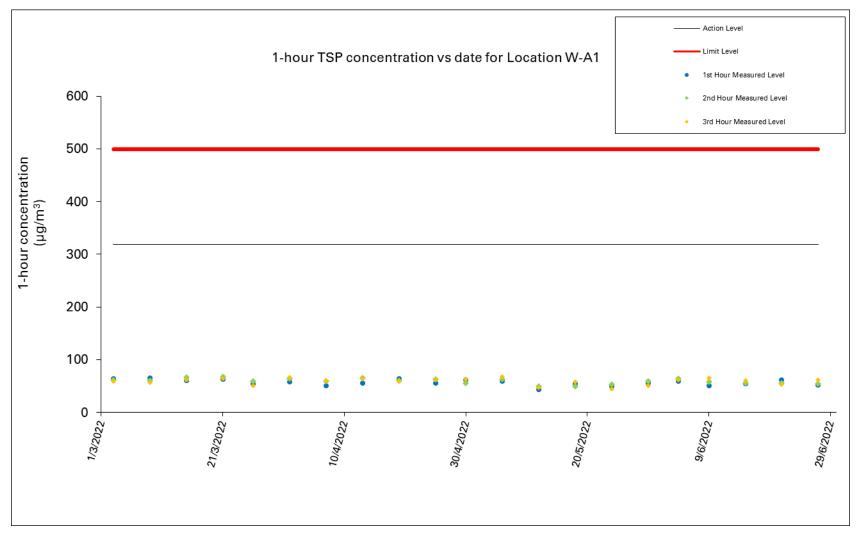
Figure 1: Graphical Illustration of Measured 1-hour TSP ($\mu g/m^3$) Levels at W-A1

1-hour TSF	$\rho (\mu g/m^3)$				
Date	Weather	Start Time	1 st Hour (μg/m³)	2 nd Hour (μg/m³)	3 rd Hour (μg/m³)			
04/06/2022	Fine	10:01	66	78	70			
09/06/2022	Cloudy	14:02	73	65	62			
15/06/2022	Fine	11:19	62	77	74			
21/06/2022	Sunny	13:46	69	73	64			
27/06/2022	Sunny	9:40	60	68	71			
	Minimum: 60	μg/m ³		Maximum: 78 μg/m ³

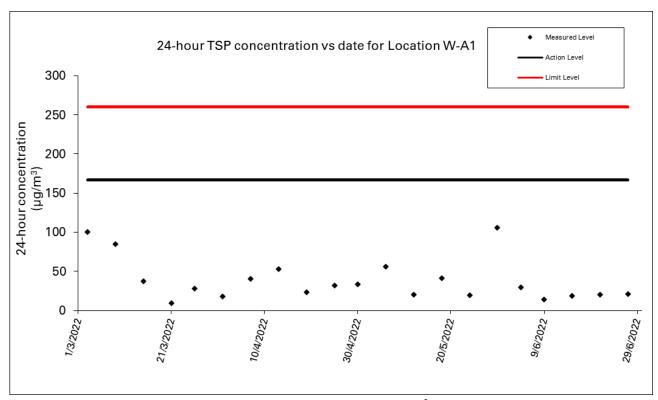
Figure 3: Graphical Illustration of Measured 24-hour TSP (μg/m³) Levels at W-A1

Start Date Weather Condition		Elapse Time			Cl	nart Reading	3	Avg Air Temn	Avg Atmospheric Pressure	Iklow Rate Air			Particulate weight	Conc.	
	Condition	Initial	Final	Actual (min)	Min	Max	Avg	(°C)	(hPa)	(m³/min)	(m ³)	Initial	Final	(g)	$(\mu g/m^3)$
4/6/2022	Fine	6358.1	6382.1	1440.00	40	40	40.0	29.6	1005.8	1.39	1999	2.6895	2.7475	0.0580	29
9/6/2022	Cloudy	6382.1	6406.1	1440.00	38	38	38.0	26.3	1005.5	0.73	1058	2.6983	2.7372	0.0389	37
15/6/2022	Fine	6406.1	6430.1	1440.00	38	38	38.0	26.7	1009.2	0.78	1118	2.6722	2.7194	0.0472	42
21/6/2022	Sunny	6430.4	6454.4	1440.00	39	39	39.0	29.4	1005.9	1.06	1525	2.7424	2.794	0.0516	34
27/6/2022	Sunny	6454.4	6478.4	1440.00	39	40	39.5	30.0	1008.6	1.22	1763	2.7126	2.7427	0.0301	17
										Maximum:	42	μg/m ³	Minimum:	17	μg/m ³

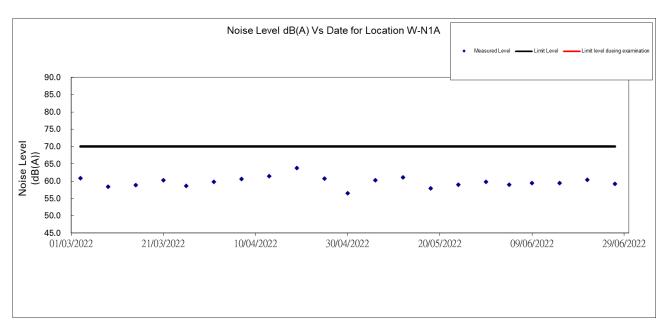
Figure 1: Graphical Illustration of Measured Noise Levels at W-N1A

Date	Weather	Start Time	_	End Time	$L_{\rm eq}$	L_{10}	L ₉₀	Wind
					1			speed (m/s)
04/06/2022	Fine	9:18	-	9:48	66.9	69.0	64.2	3.3
09/06/2022	Cloudy	11:29	-	11:15	68.3	70.4	64.5	2.2
15/06/2022	Fine	10:35	-	11:05	66.5	67.9	64.5	1.9
21/06/2022	Sunny	9:30	-	10:00	68.9	71.0	66.8	3.9
27/06/2022	Sunny	11:41	-	12:11	66.7	69.0	64.4	3.8
