Central Kowloon Route

Yau Ma Tei West

Contract No. HY/2014/20

Document/~~Plan~~ to be ~~Certified~~/ Verified: Monthly EM&A Report No.38 (March 2022)

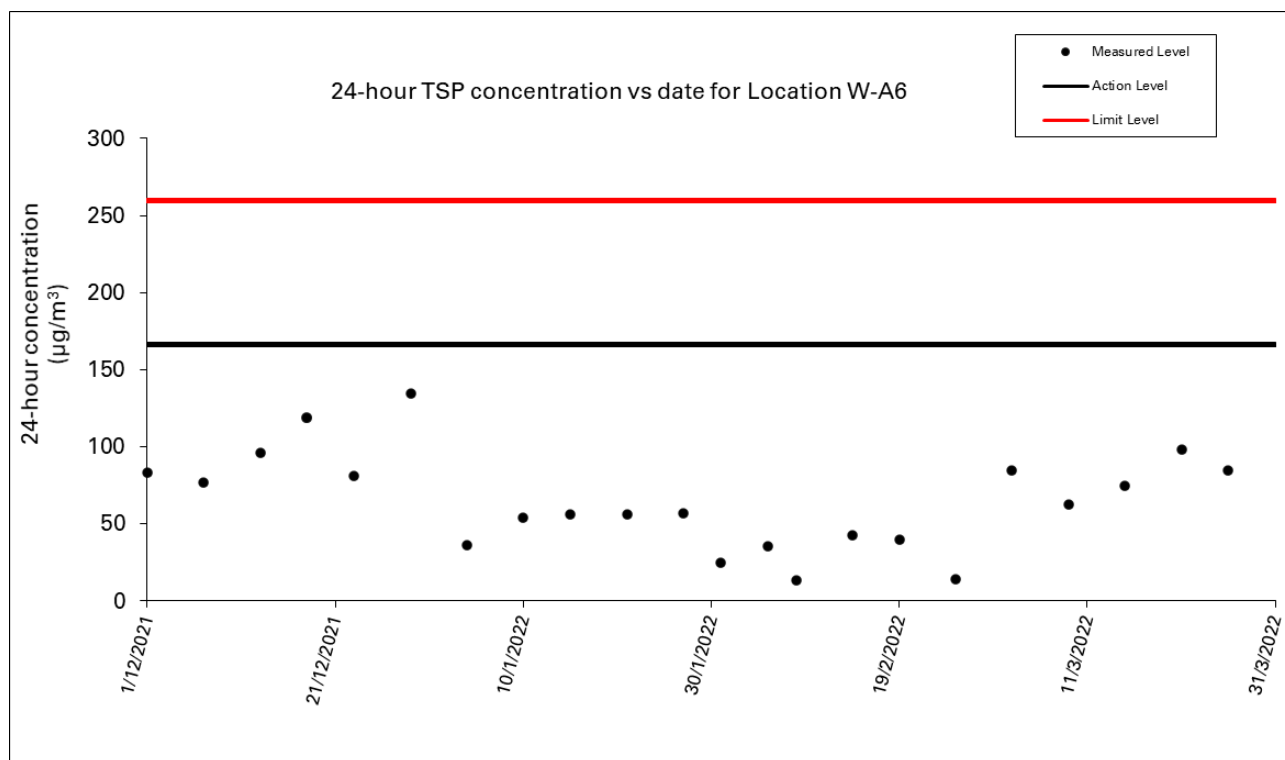
Figure 4: Graphical Illustration of Measured 24-hour TSP ($\mu\text{g}/\text{m}^3$) Levels at W-A6

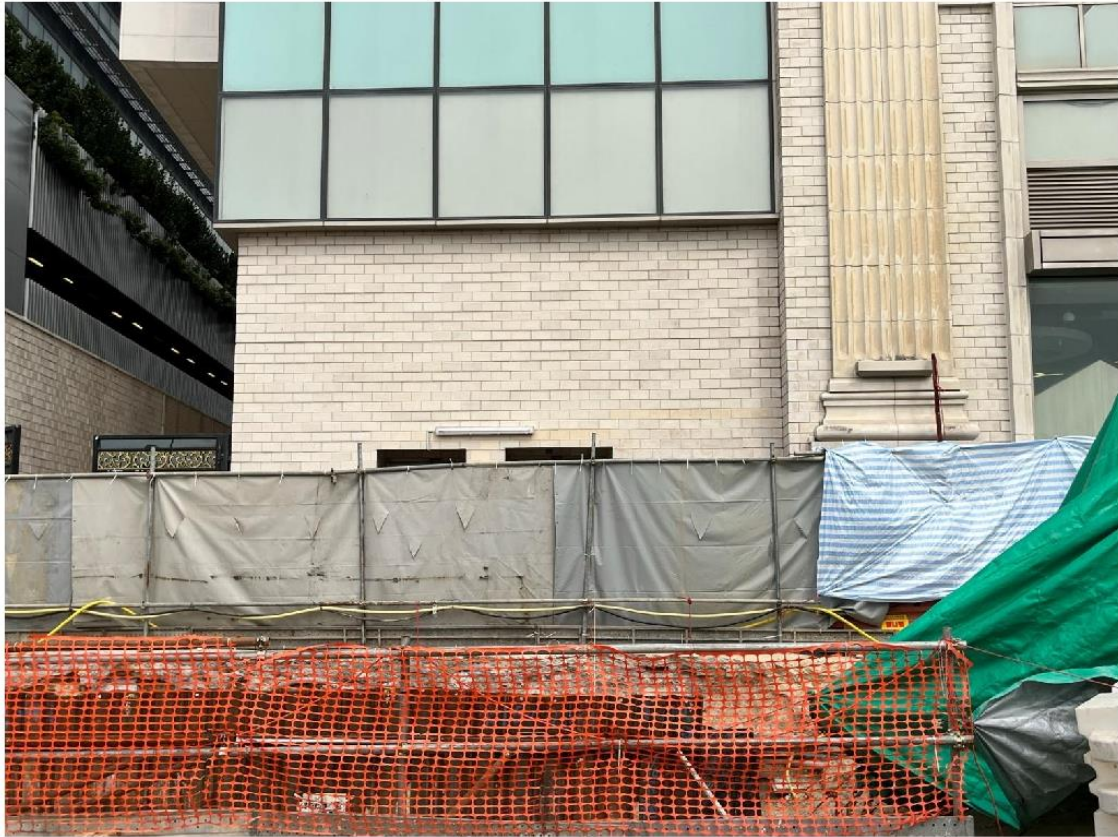
Figure A1 Noise barrier mat erected along site boundary
