Central Kowloon Route

Yau Ma Tei East

Monthly EM&A Report No. 86

(Period from 1 to 31 May 2025)

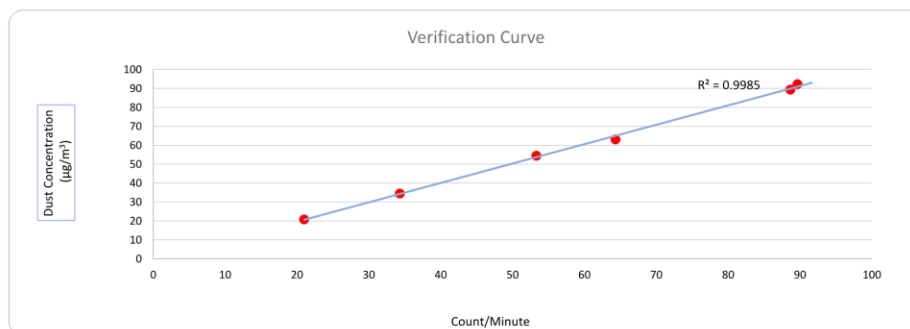
Slope, K factor:	1.0232	Intercept:	-0.8300	*Correlation Coefficient, R:	0.9992
Verification Test Result: <u>Strong Correlation. Results were accepted.</u>			* If the Correlation Coefficient, R is <0.5. Checking and Re-verification are required.

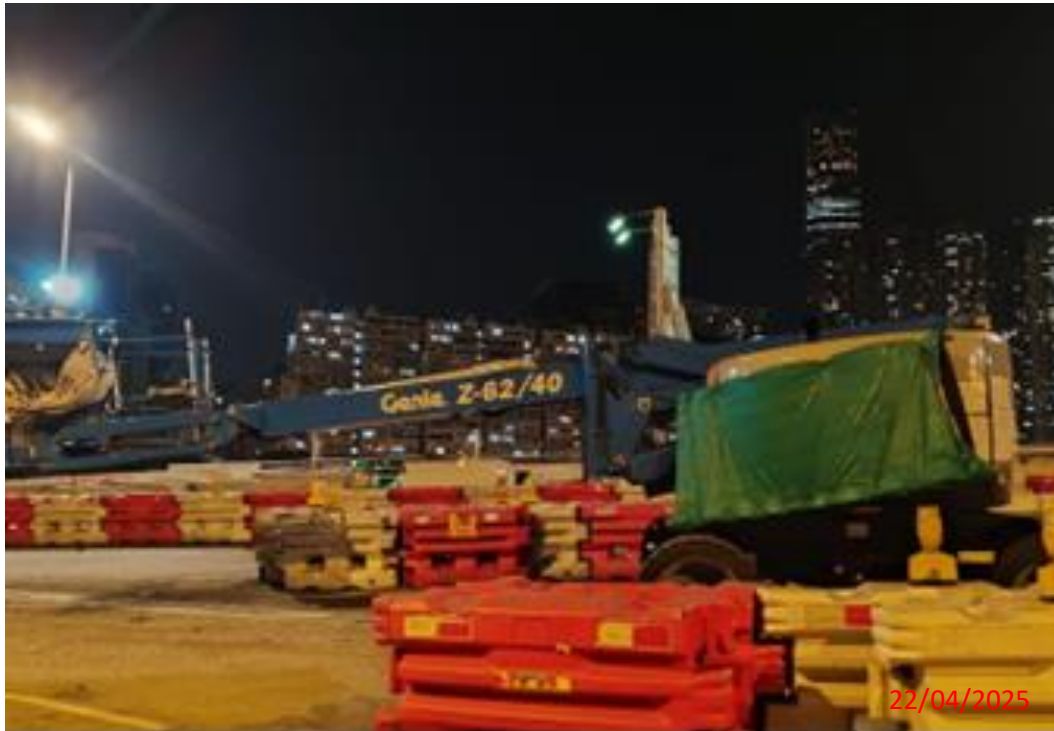
Remark 3: Site photo of noise mitigation measure

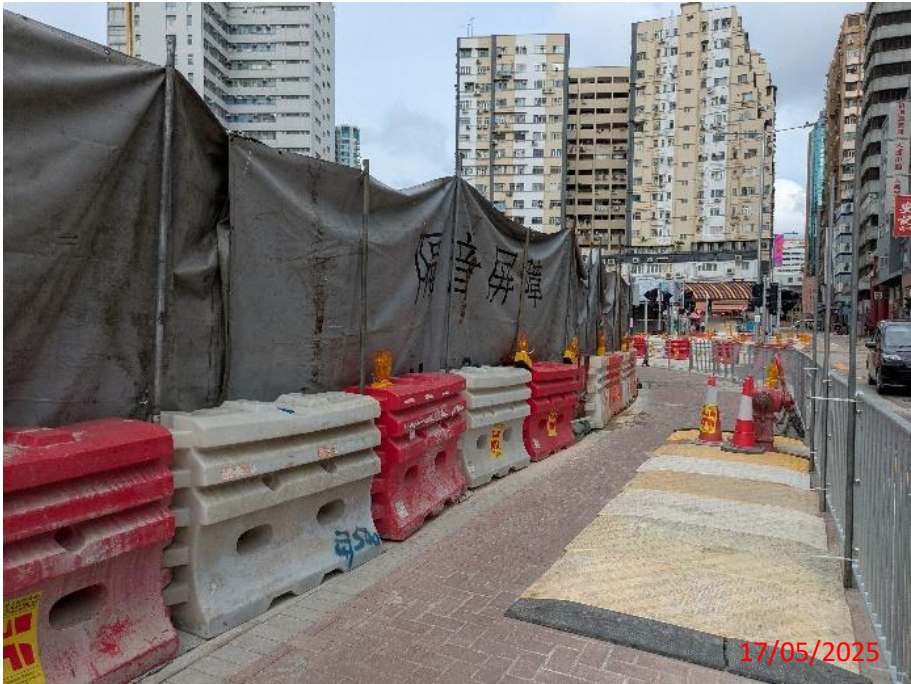
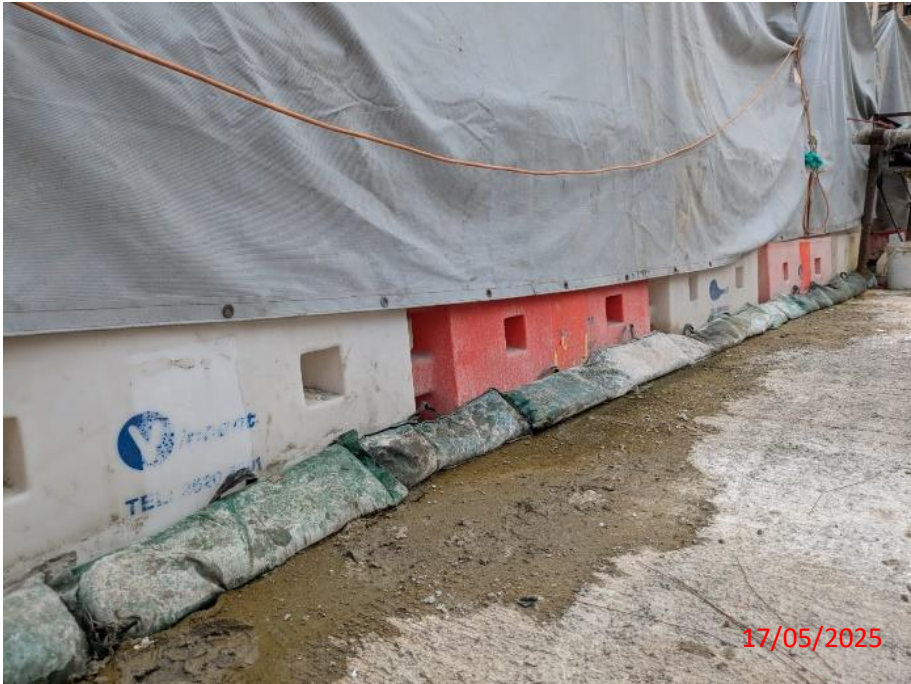
Remark 3: Site photos of mitigation actions

Project	Central Kowloon Route, Yau Ma Tei East Section	
Complaint Code	EC168-CKRYMTE20250522_001	
Complaint description	The 1823 complaint case lodged on 17 May 2025 was referred to the Contractor and the Environmental Team (ET) on 22 May 2025. The complaint pertained to water flowing onto the pedestrian walkway from the site area.	
Parameter	Wastewater	
Investigation finding	<p>The complaint was concerned about the water flowed onto the pedestrian walkway from Working Zone E at Kansu Street^[1]. According to the site records, no construction activities were carried out in the concerned working zone on 17 May 2025.</p> <p>Based on the photos and a video recording provided by the complainant, a worker was observed handwashing and washing cloth by hand with portable water near the site boundary, adjacent to the concerned area where water was complained flowing onto the pedestrian walkway. Since no construction activities were carried out in Zone E and no precipitation was recorded on the date of complaint^[2], the water flowing to the concerned area was suspected to have originated from the worker's handwashing activity near site boundary at Zone E.</p> <p>Upon being notified of the complainant's concern on 17 May 2025, the Contractor promptly cleaned up the water on the pedestrian walkway^[3]. The Contractor had also provided additional sandbags along the site boundary beneath the water-filled barriers to prevent any site-runoff from entering the public road^[3]. The potable water facilities were relocated away from the site boundary to prevent recurrence of the case. Training was provided to the workers about the proper handling of wastewater on the same day.</p>
