**Central Kowloon Route**

**Yau Ma Tei West**

**Contract No. HY/2014/20**

**May 2025**

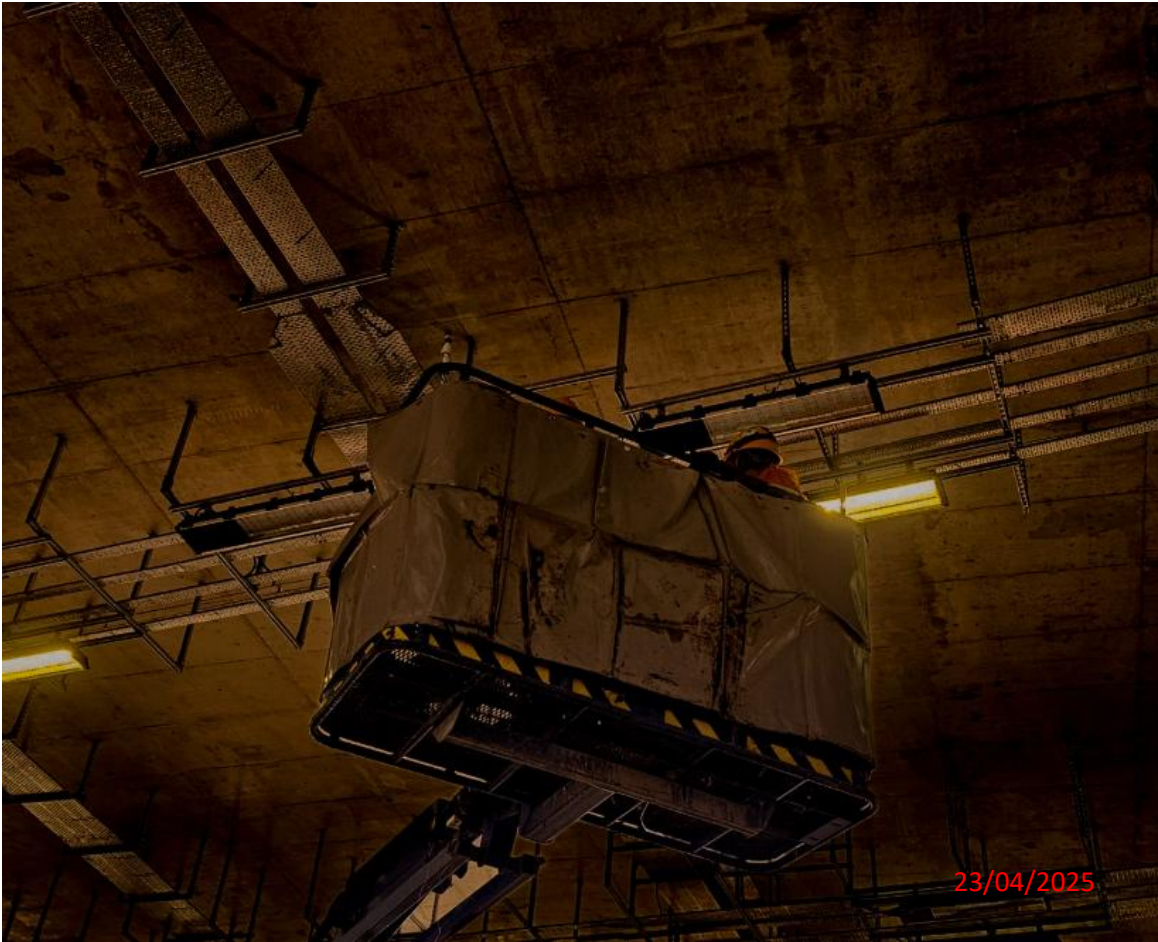
Remark 3: Site photo of noise mitigation measure
