Central Kowloon Route

Yau Ma Tei West

Contract No. HY/2014/20

Monthly EM&A Report No. 46

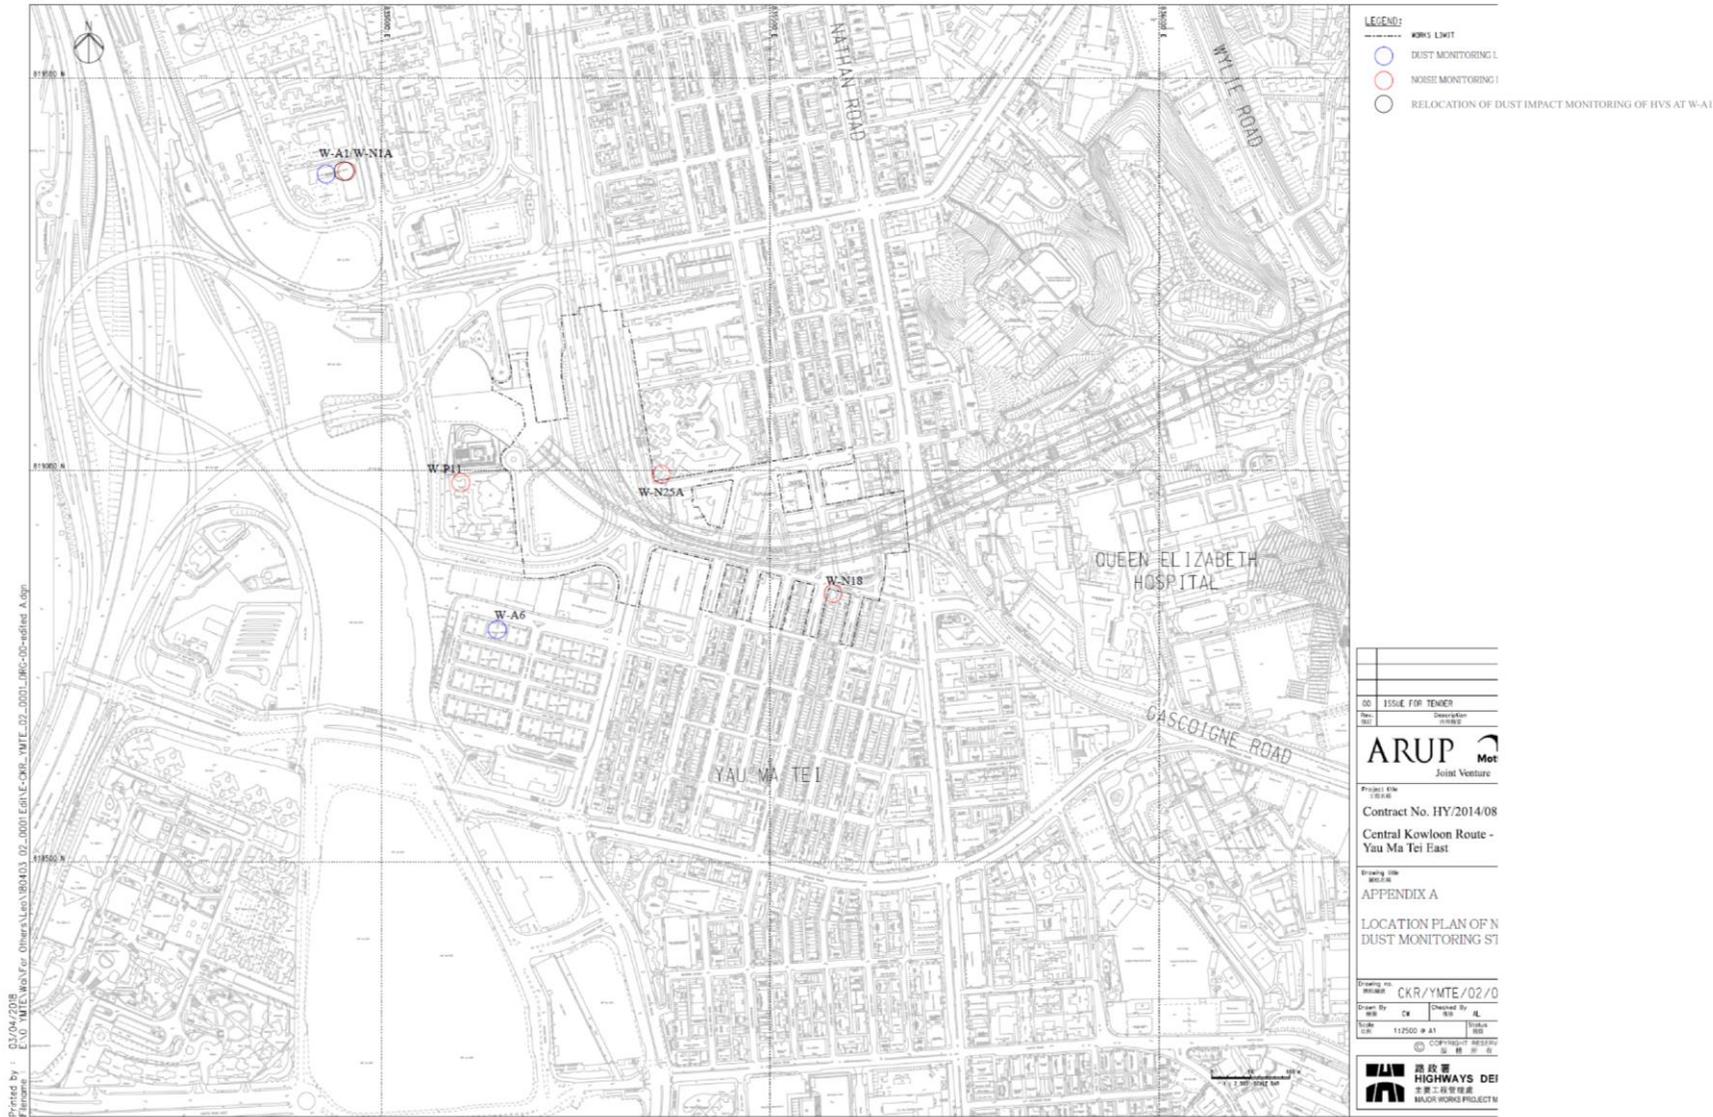
Location Plan of Noise and Air Quality Monitoring Station

- 3.4.1. During the site visit, both of the original proposed dust monitoring locations were rejected due to the condition at The Coronation was not favourable for monitoring and the access was declined by the management office of Hong Kong Community College (HKCC) of PolyU. Two alternative air monitoring stations Yau Ma Tei Catholic Primary School (Hoi Wang Road) and Man Cheong Building had been proposed by ET and approved by IEC. 2 designated air monitoring locations were identified and agreed with IEC and EPD. Details of air monitoring stations are described in Table 3.3. The location plan of air quality monitoring stations is shown in Appendix K.
